SUBJECT: Jaycee Park Pedestrian Bridge Inspection

A detailed inspection of the old railroad trestle in Jaycee Park over the Kalamazoo River in the City of Allegan was completed on December 8, 2023. Enclosed is a copy of the report and pictures for your bridge files, supplemented with the comments below.

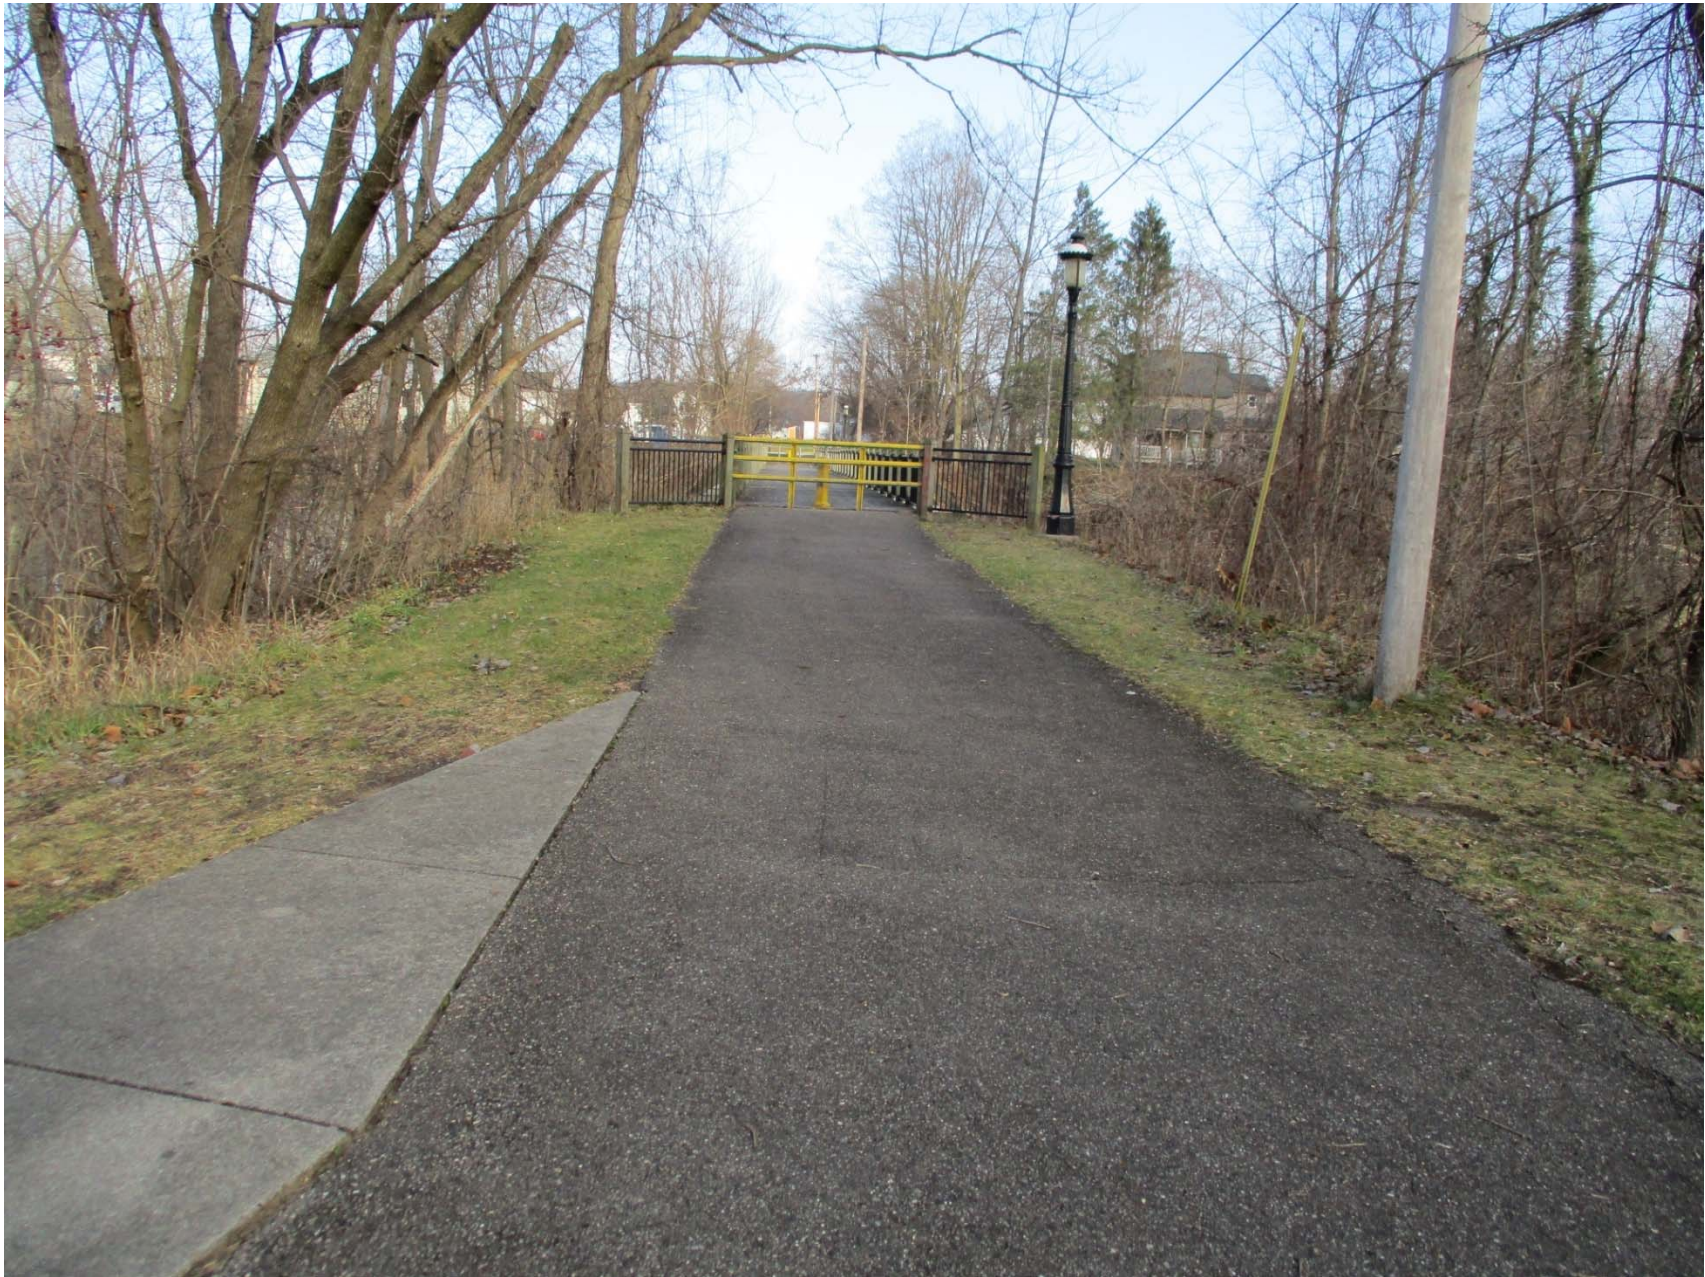
South path approach, bridge closed to pedestrians

With the imminent failure of the pier caps 1S, 3S, and 9S, the bridge needs to remain closed.

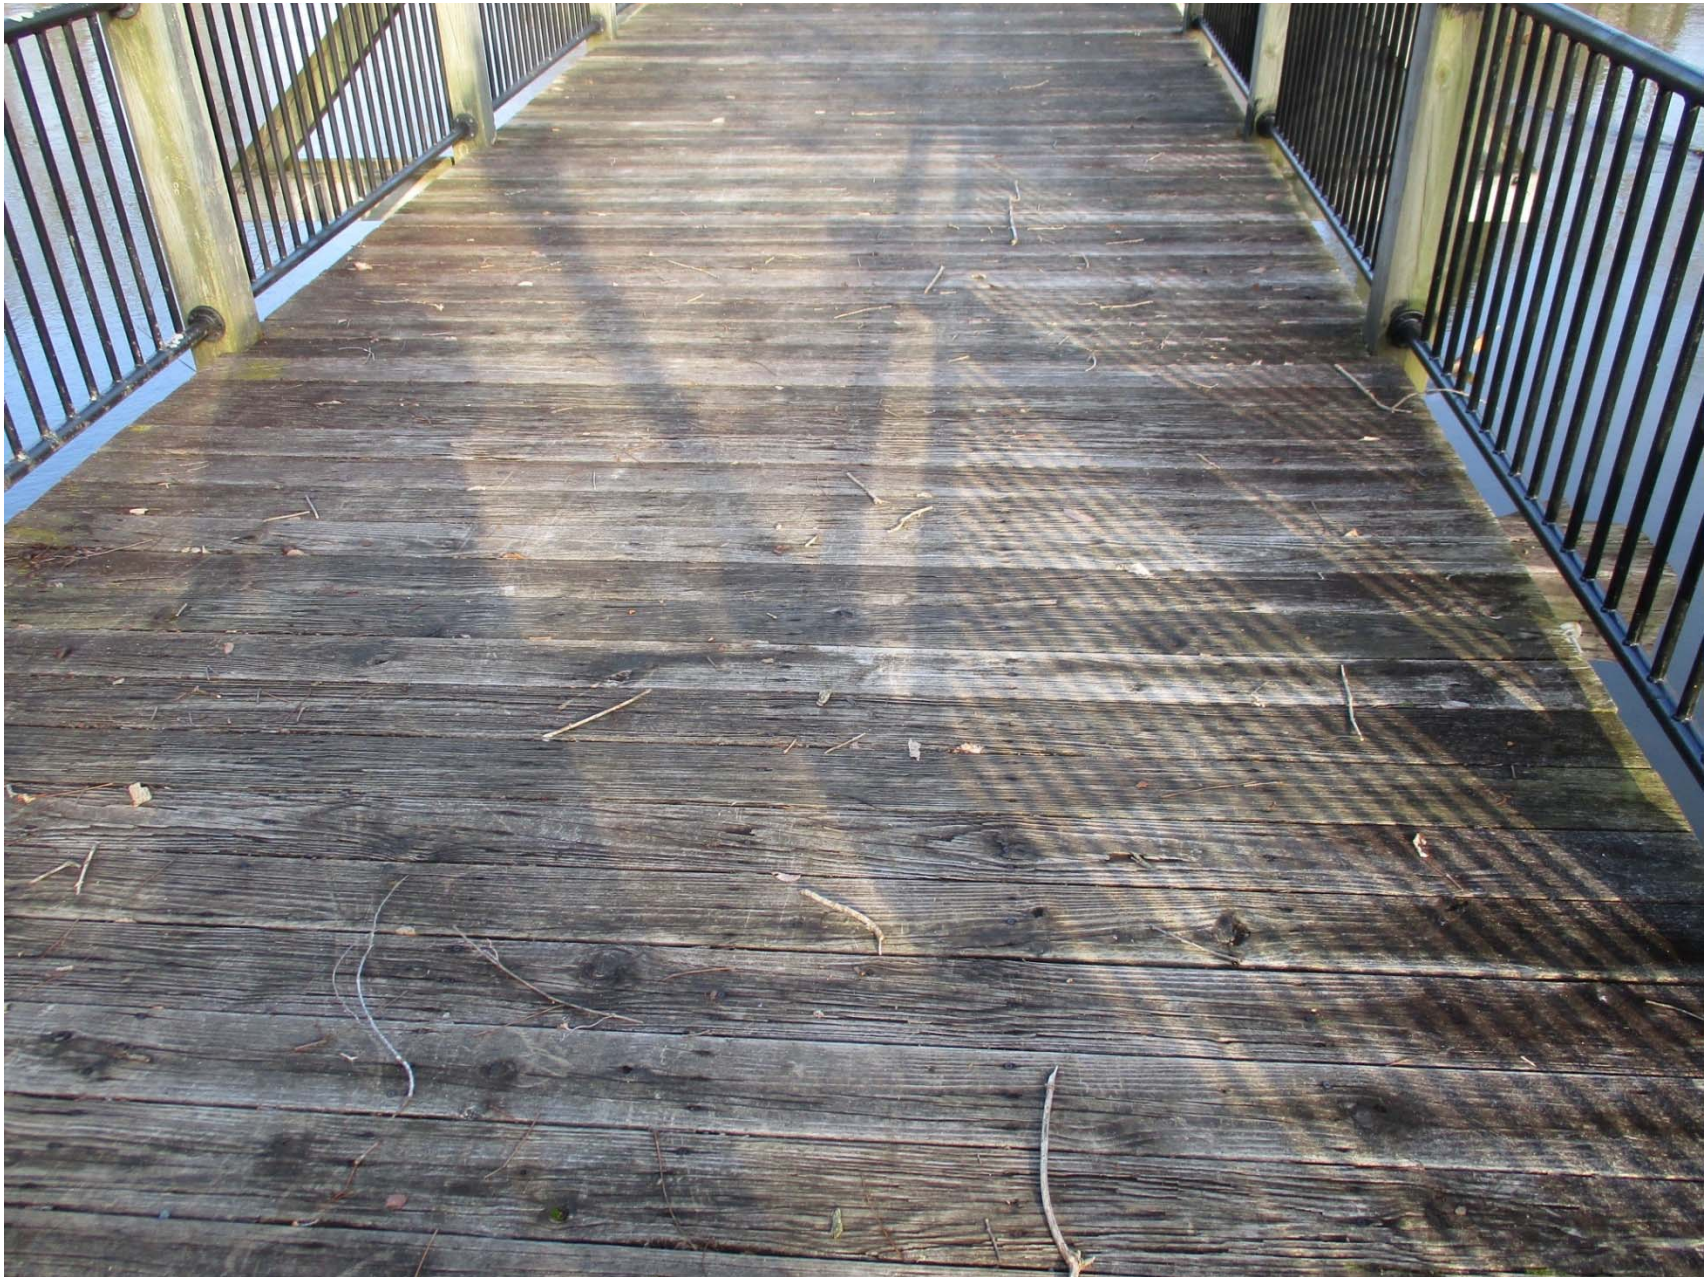
Decking is weathered and checked. Fasteners are rusting.

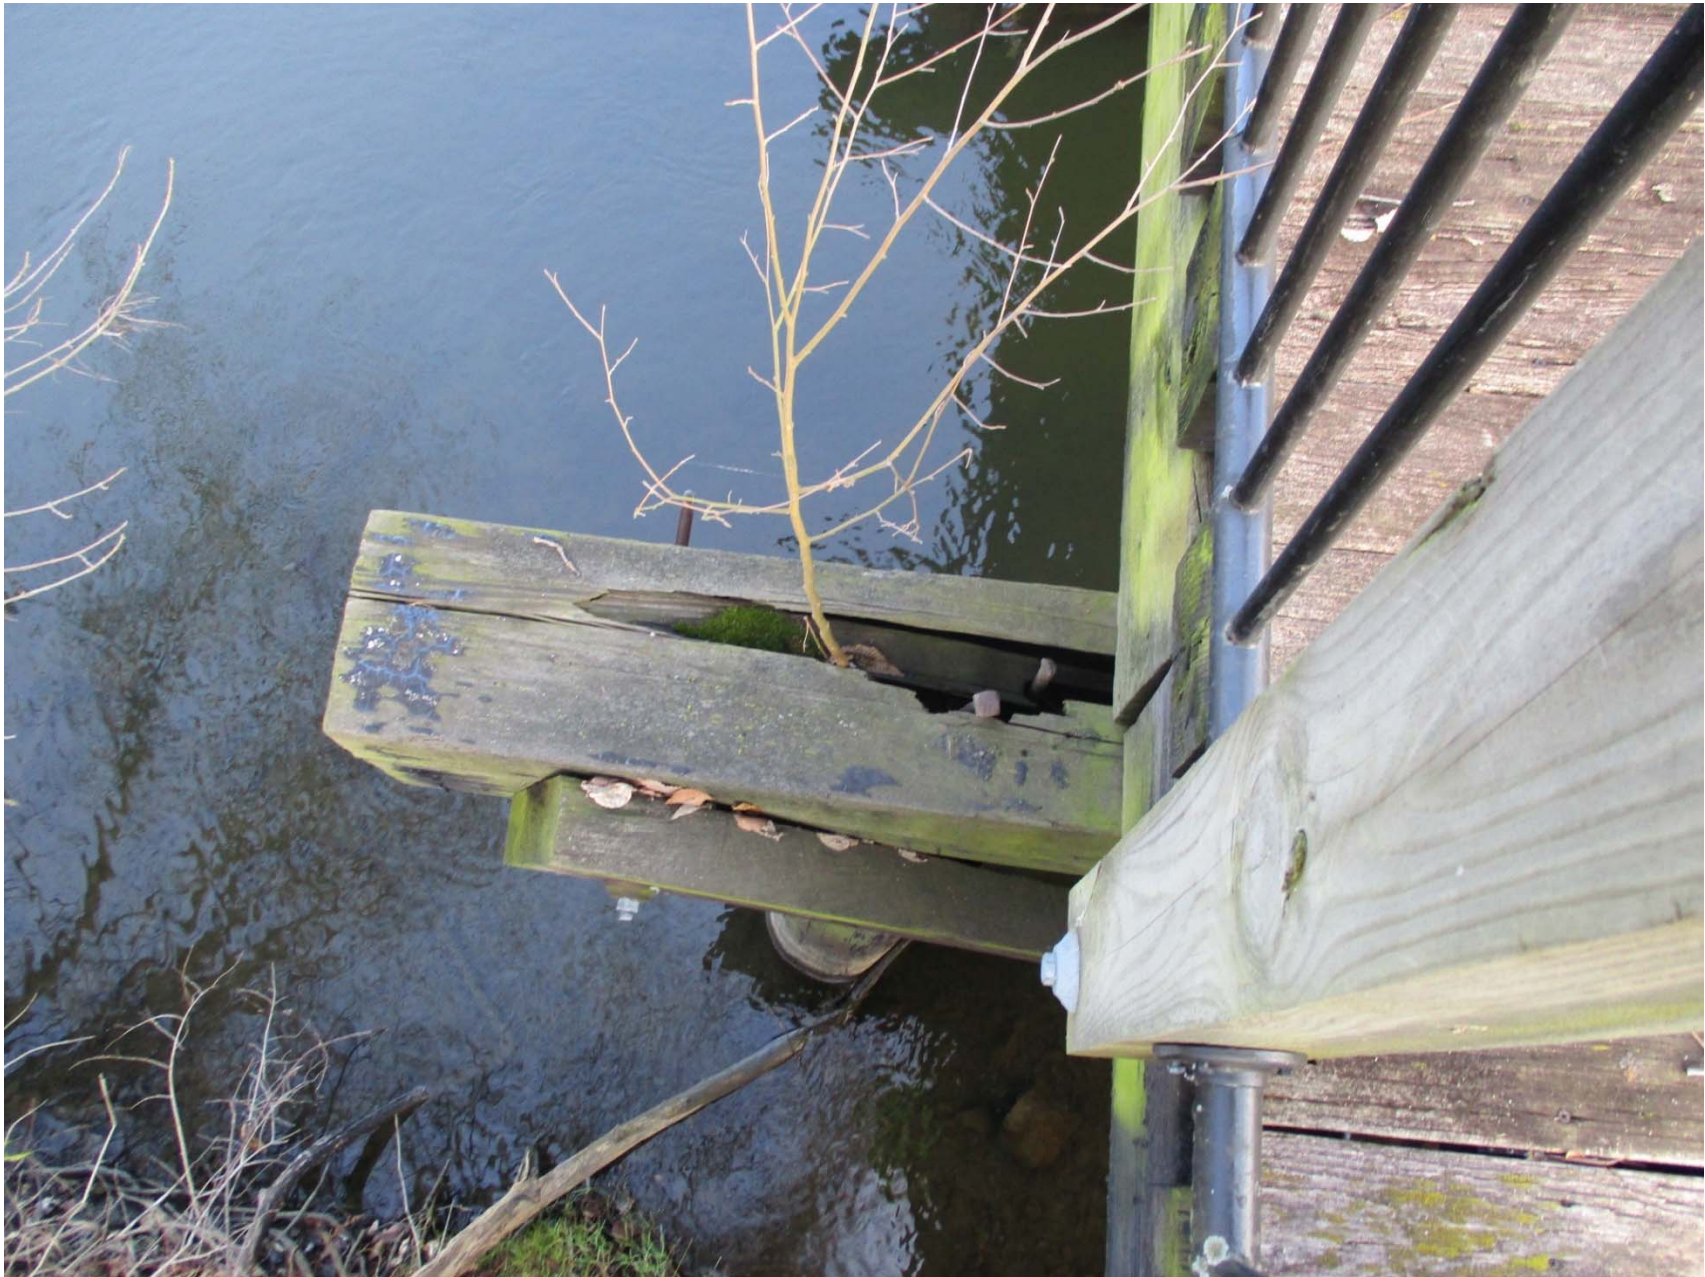
Pier 1S west end interior rotted with only an exterior shell left in place, tree growing in rotted interior

Pier 1S (1st pier from south abutment): Complete interior rot of the cap with full section loss along the bottom and into the top at each end. Approximately, the outer ½"-1" of thickness remains intact. This equates to at least 85% section loss of the cap cross-sectional area. The west end of the cap is crushing (sides buckling). The timber piles have an outer loss at the water surface. Pile 2W has internal rot, only the outer 1" remains. Very little support strength is left in the cap.

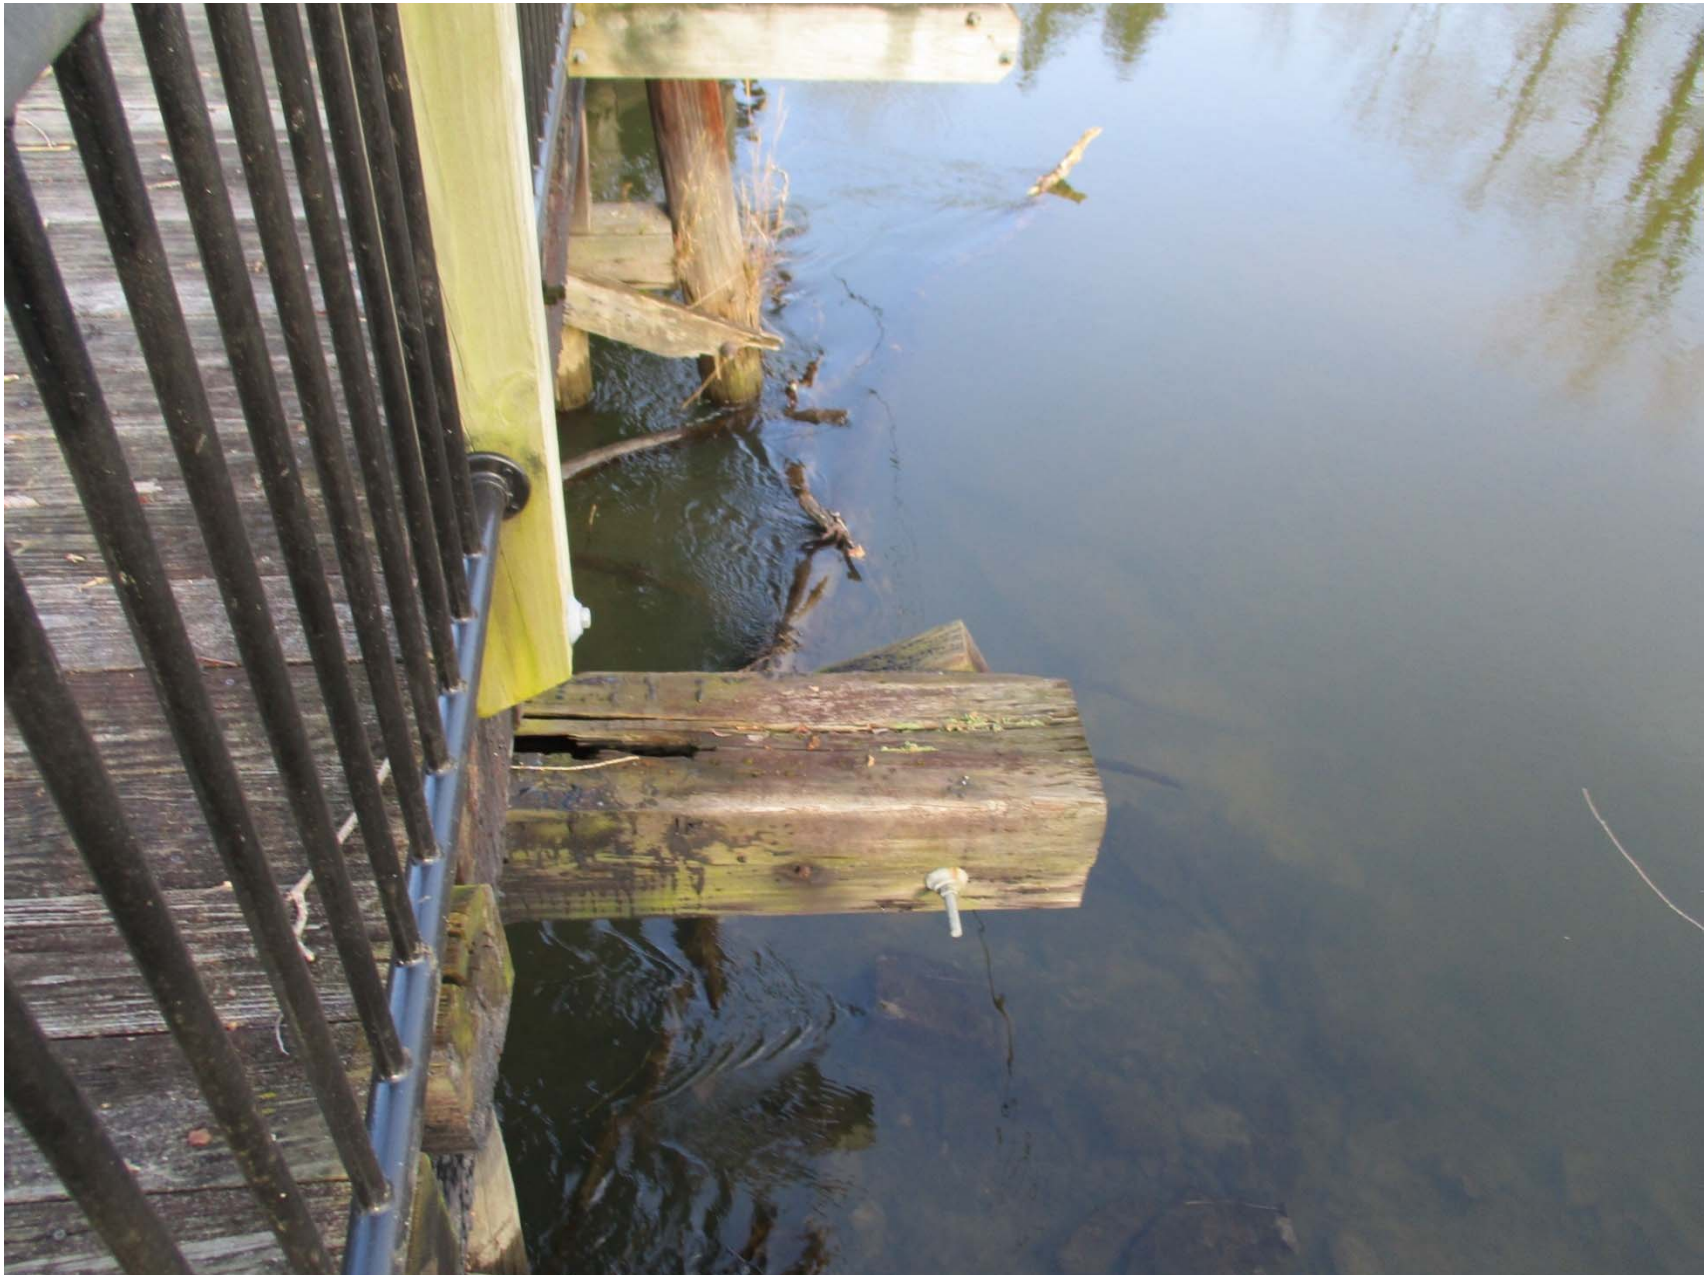
Pier 3S east end rotted interior

Pier 3S: Extensive interior rot of the cap with a shell remaining. The east end shows signs of crushing. Two piles have section loss of the outer 2" at the water surface, 1" or less of loss to the remaining piles. Pile 1E has split at the top.

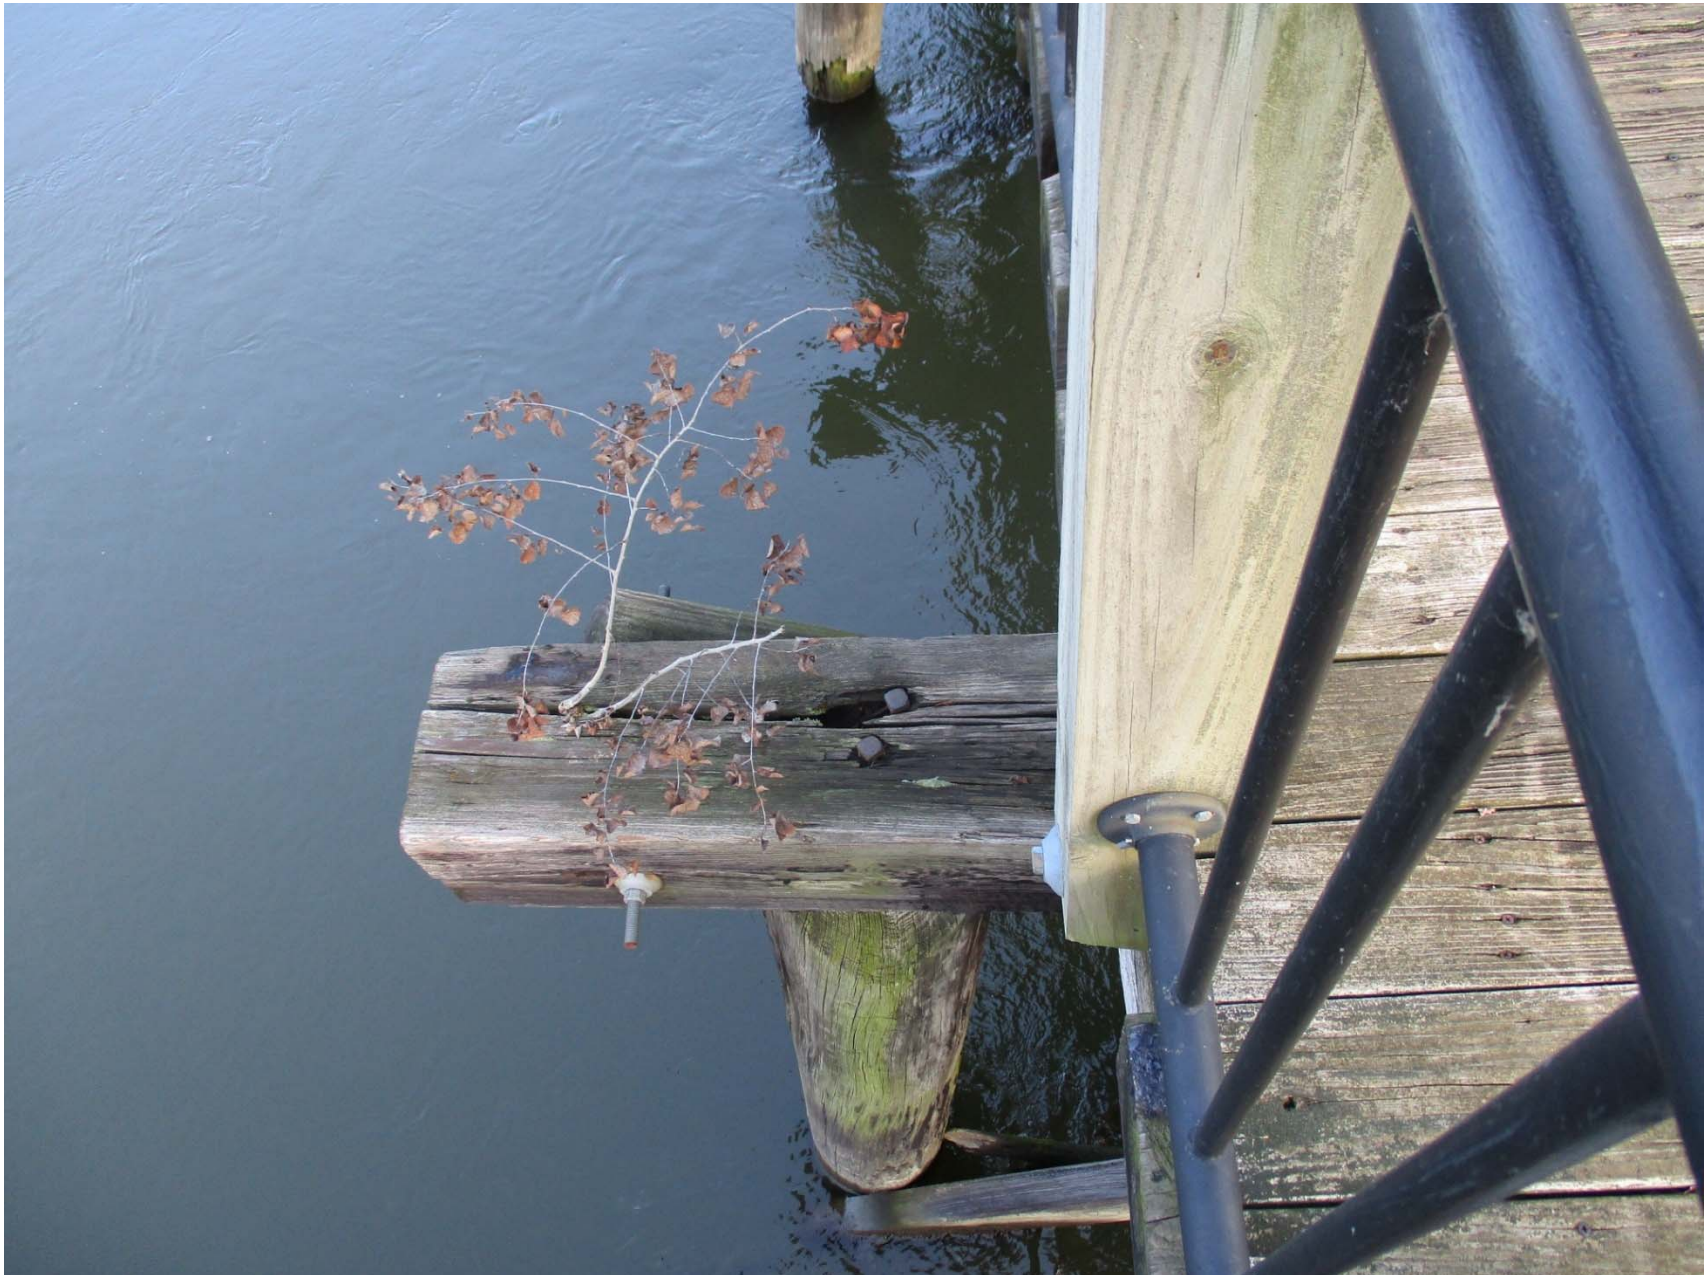
Pier 3S west end rotted with tree sapling growing

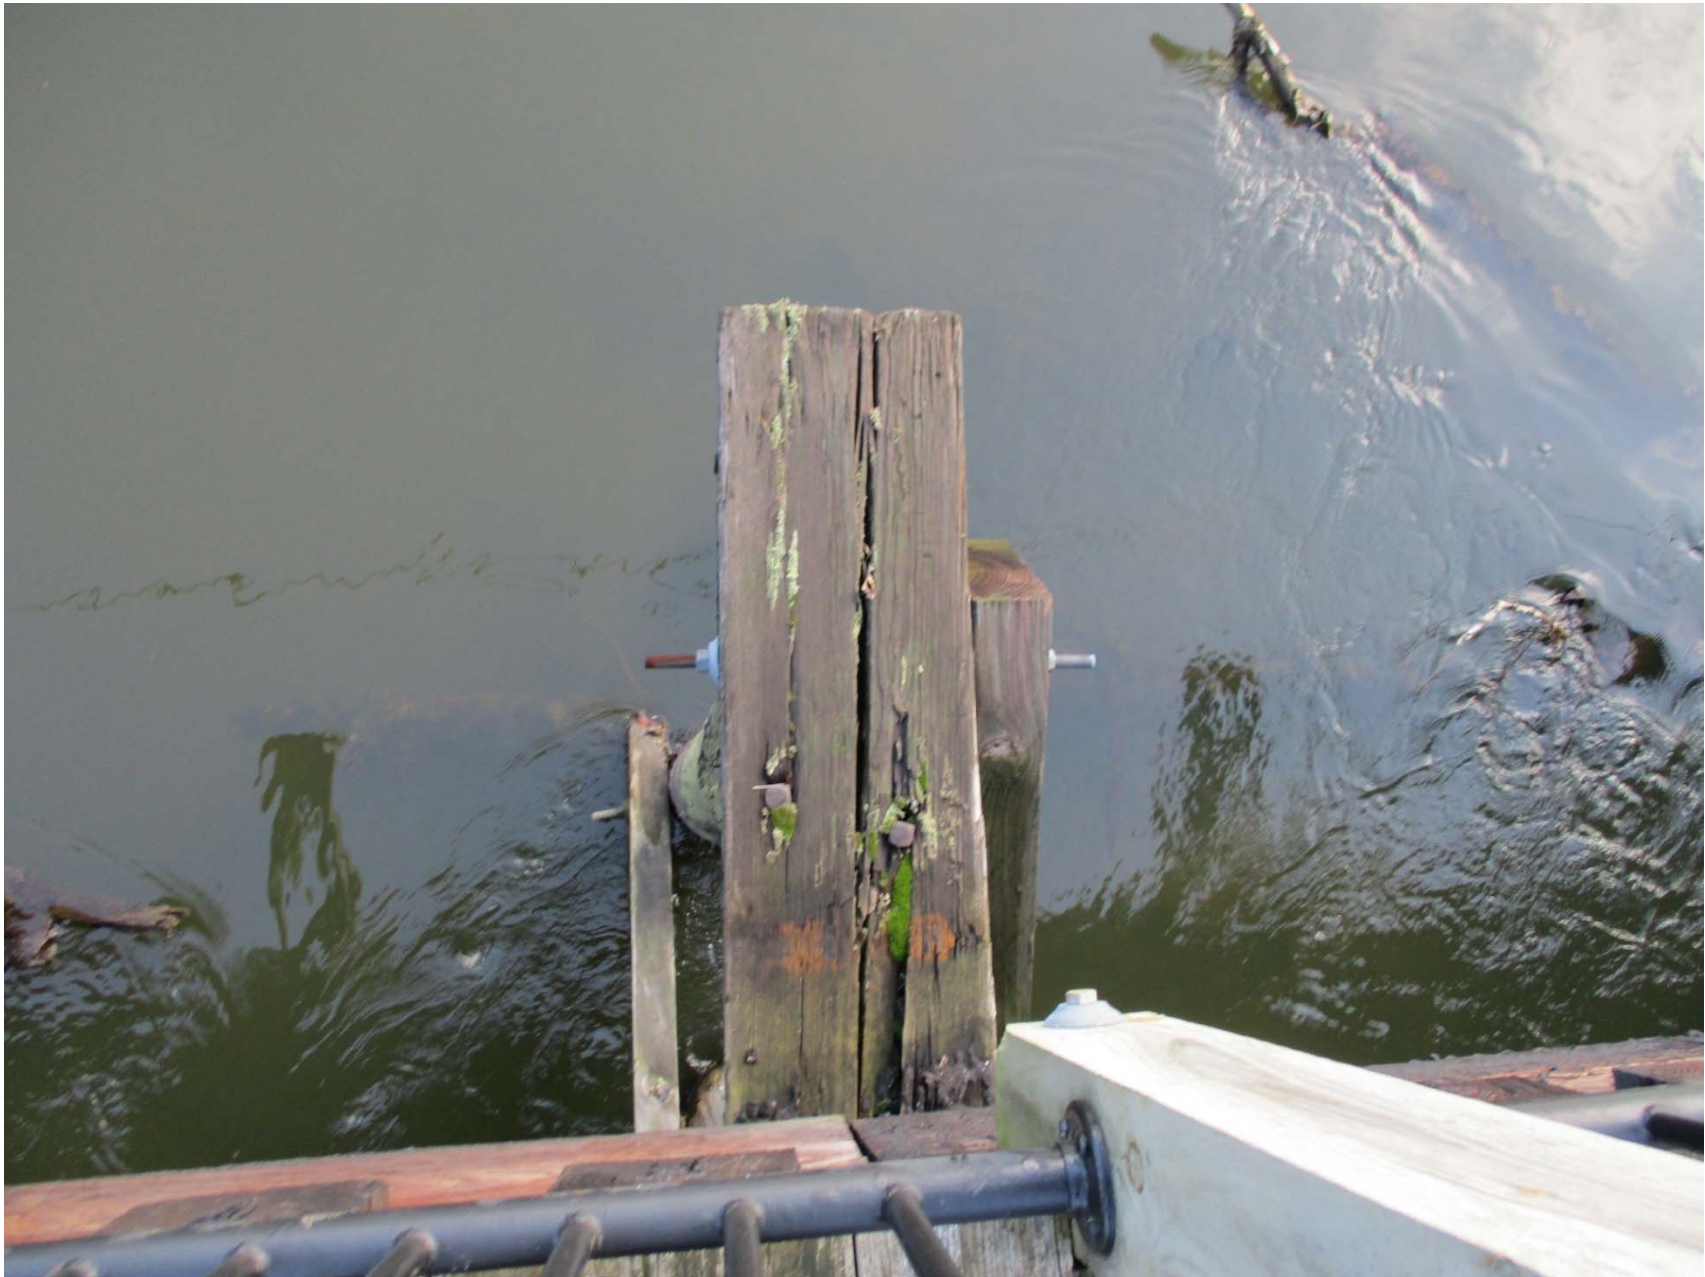
Pier 3S east end split, depressed section at beam, internal rot likely

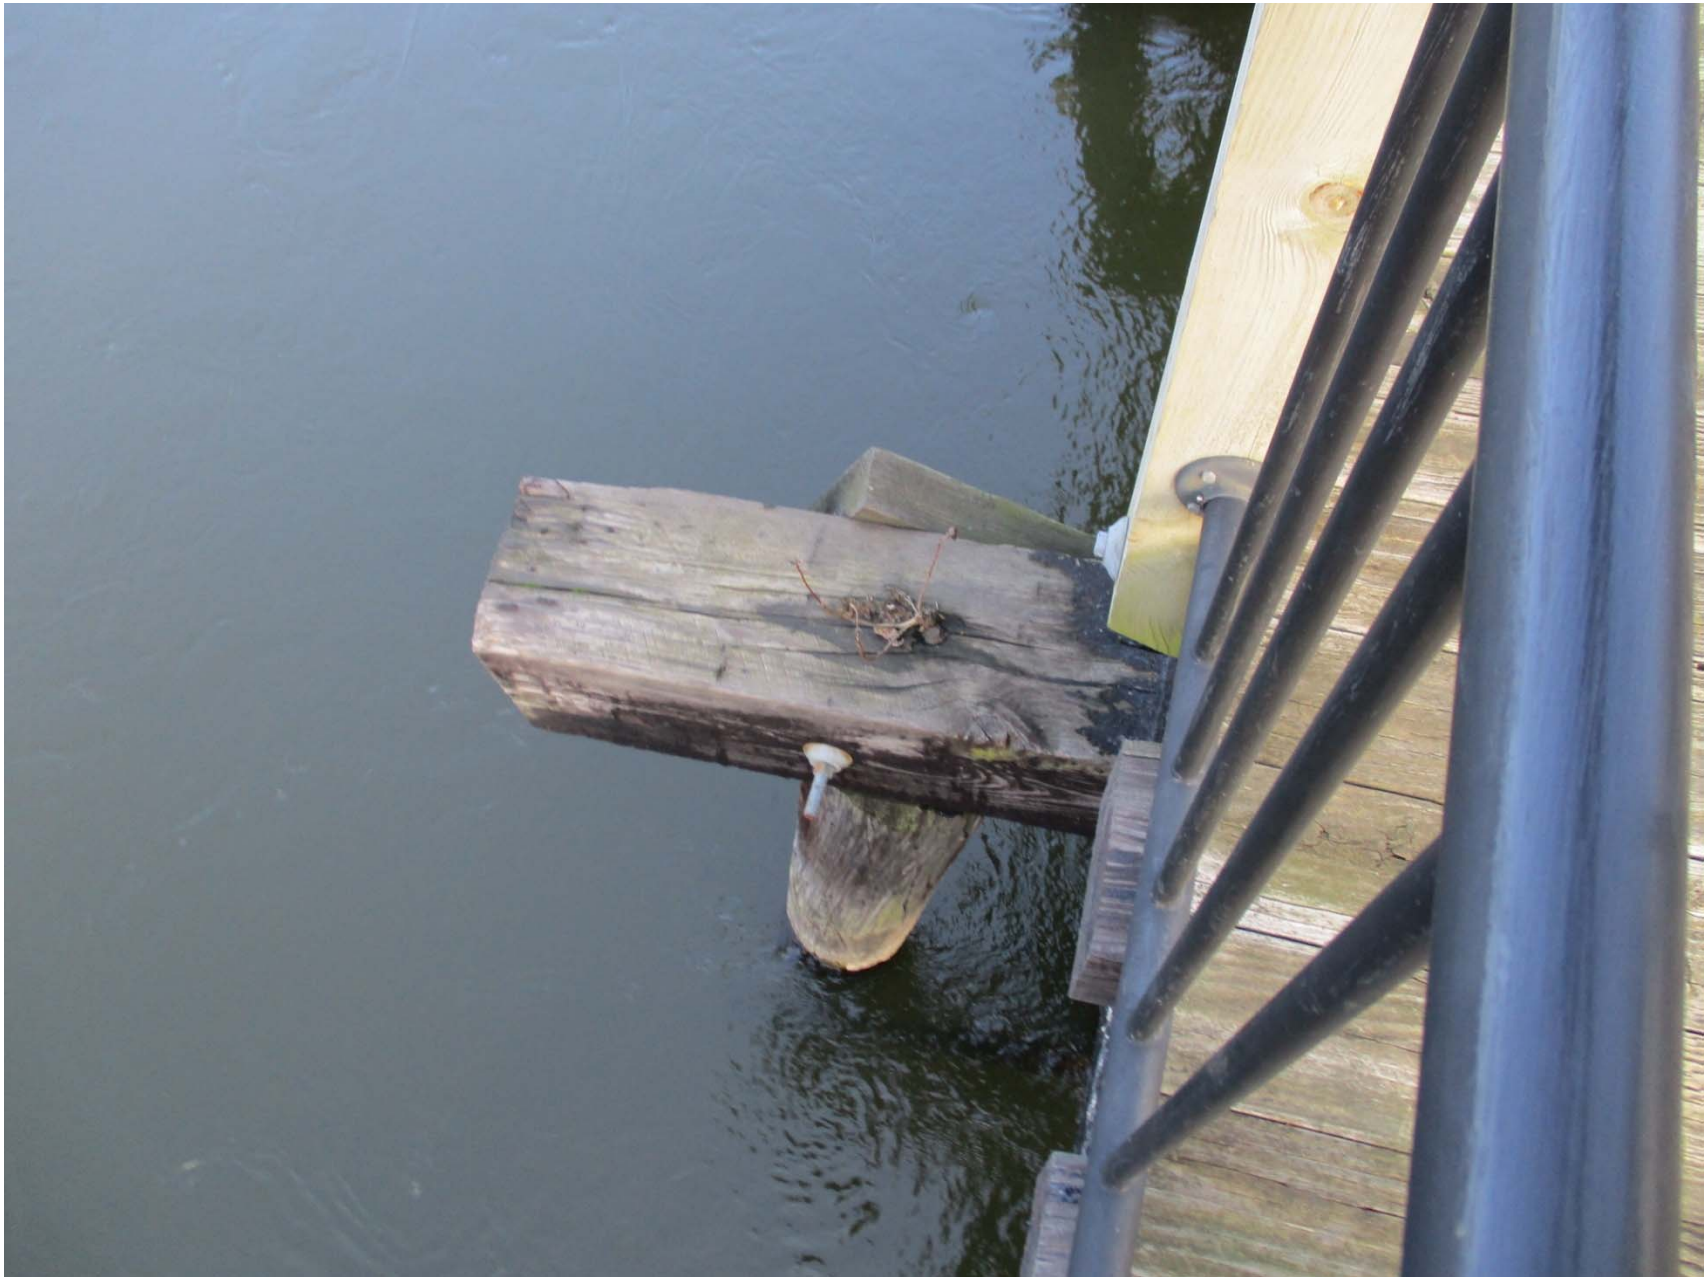
Pier 4S split with vegetation growing in bolt hole

Pier 4S: Some rotting of the pier cap ends indicated by vegetation growing. Some indication of crushing at the east end. Extensive interior section loss to pile 1W and 3W, about a 1/3 gone. The rest of the piles have up to 2" of outer surface loss at the water surface.

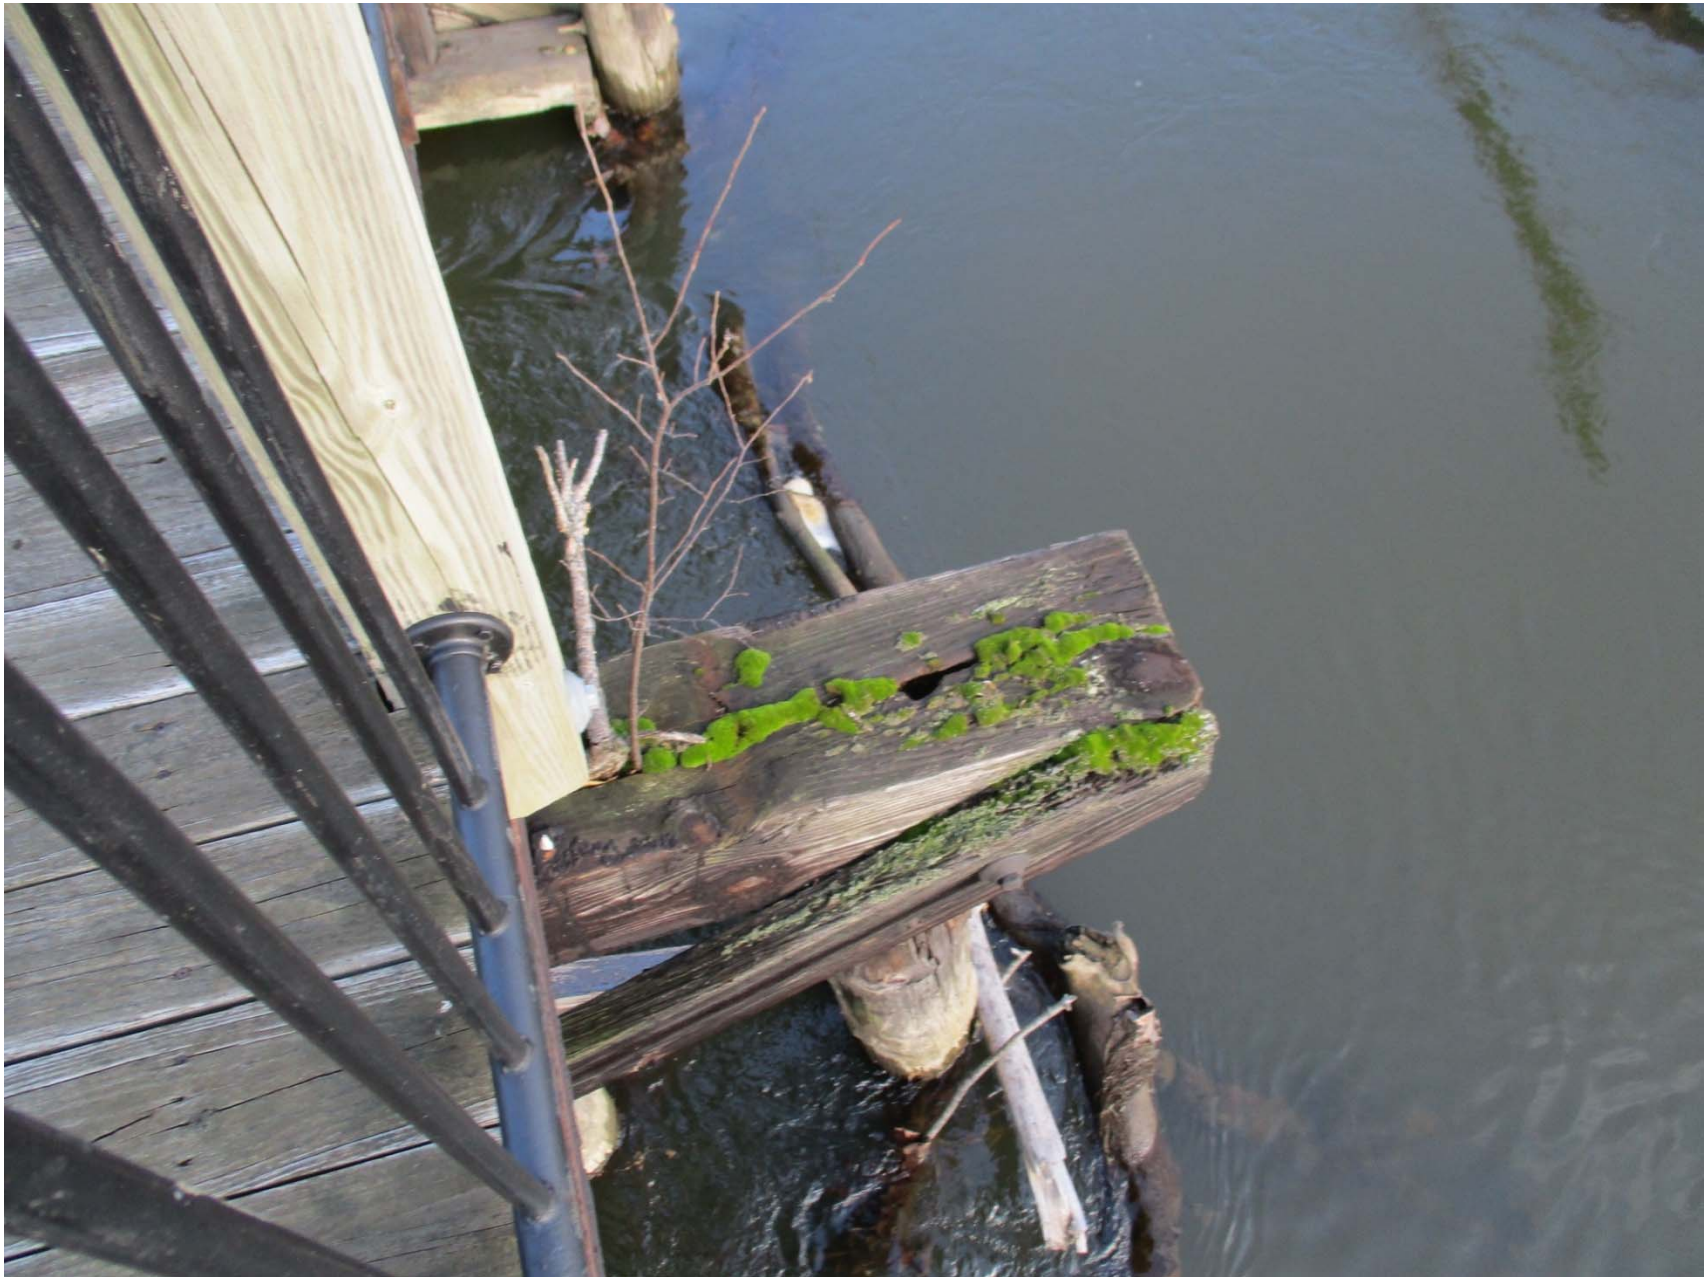
Pier 4S east end with internal rot with tree growth

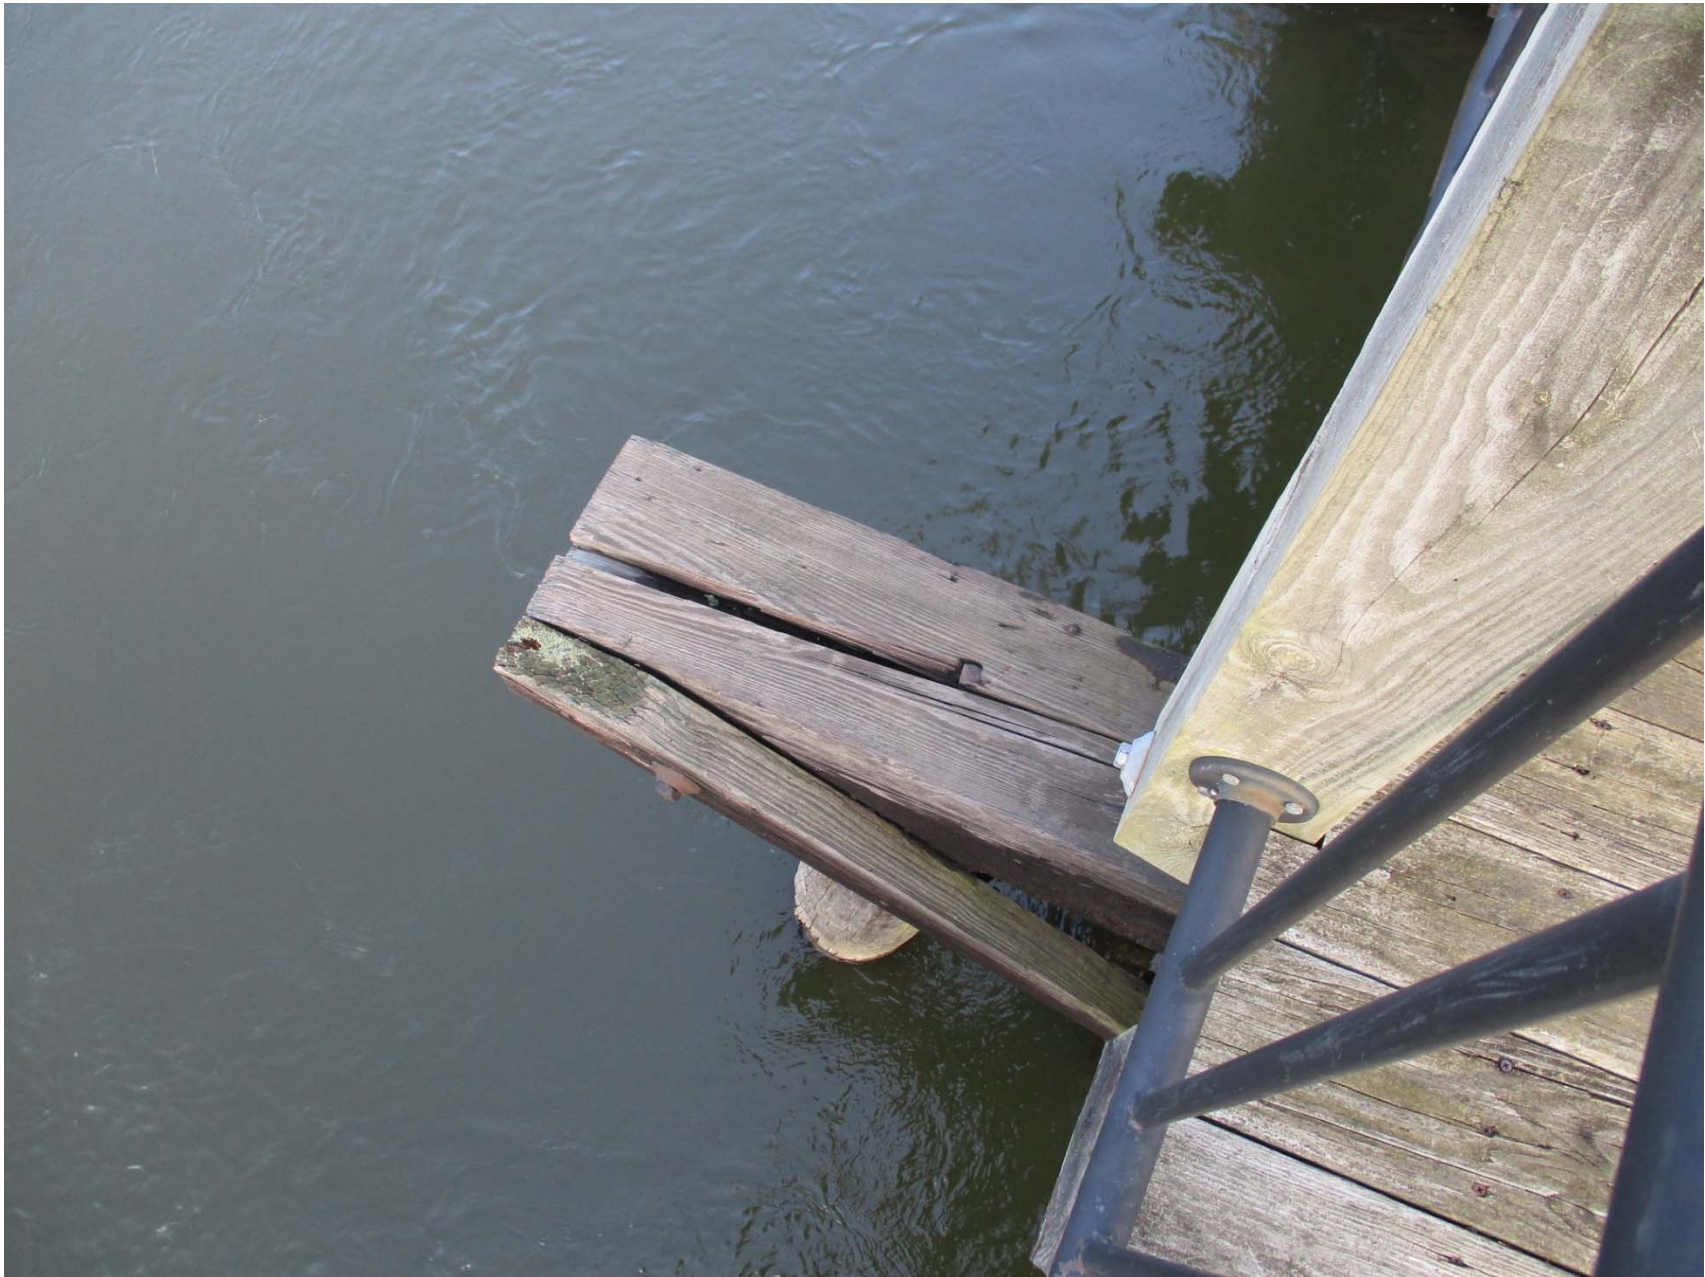
Pier 6S west end split with internal rot likely

Pier 6S: Cap ends are split with some vegetation growing. Pile 3W has some internal rot. All piles have an inch or less of surface loss to piles at the water elevation.

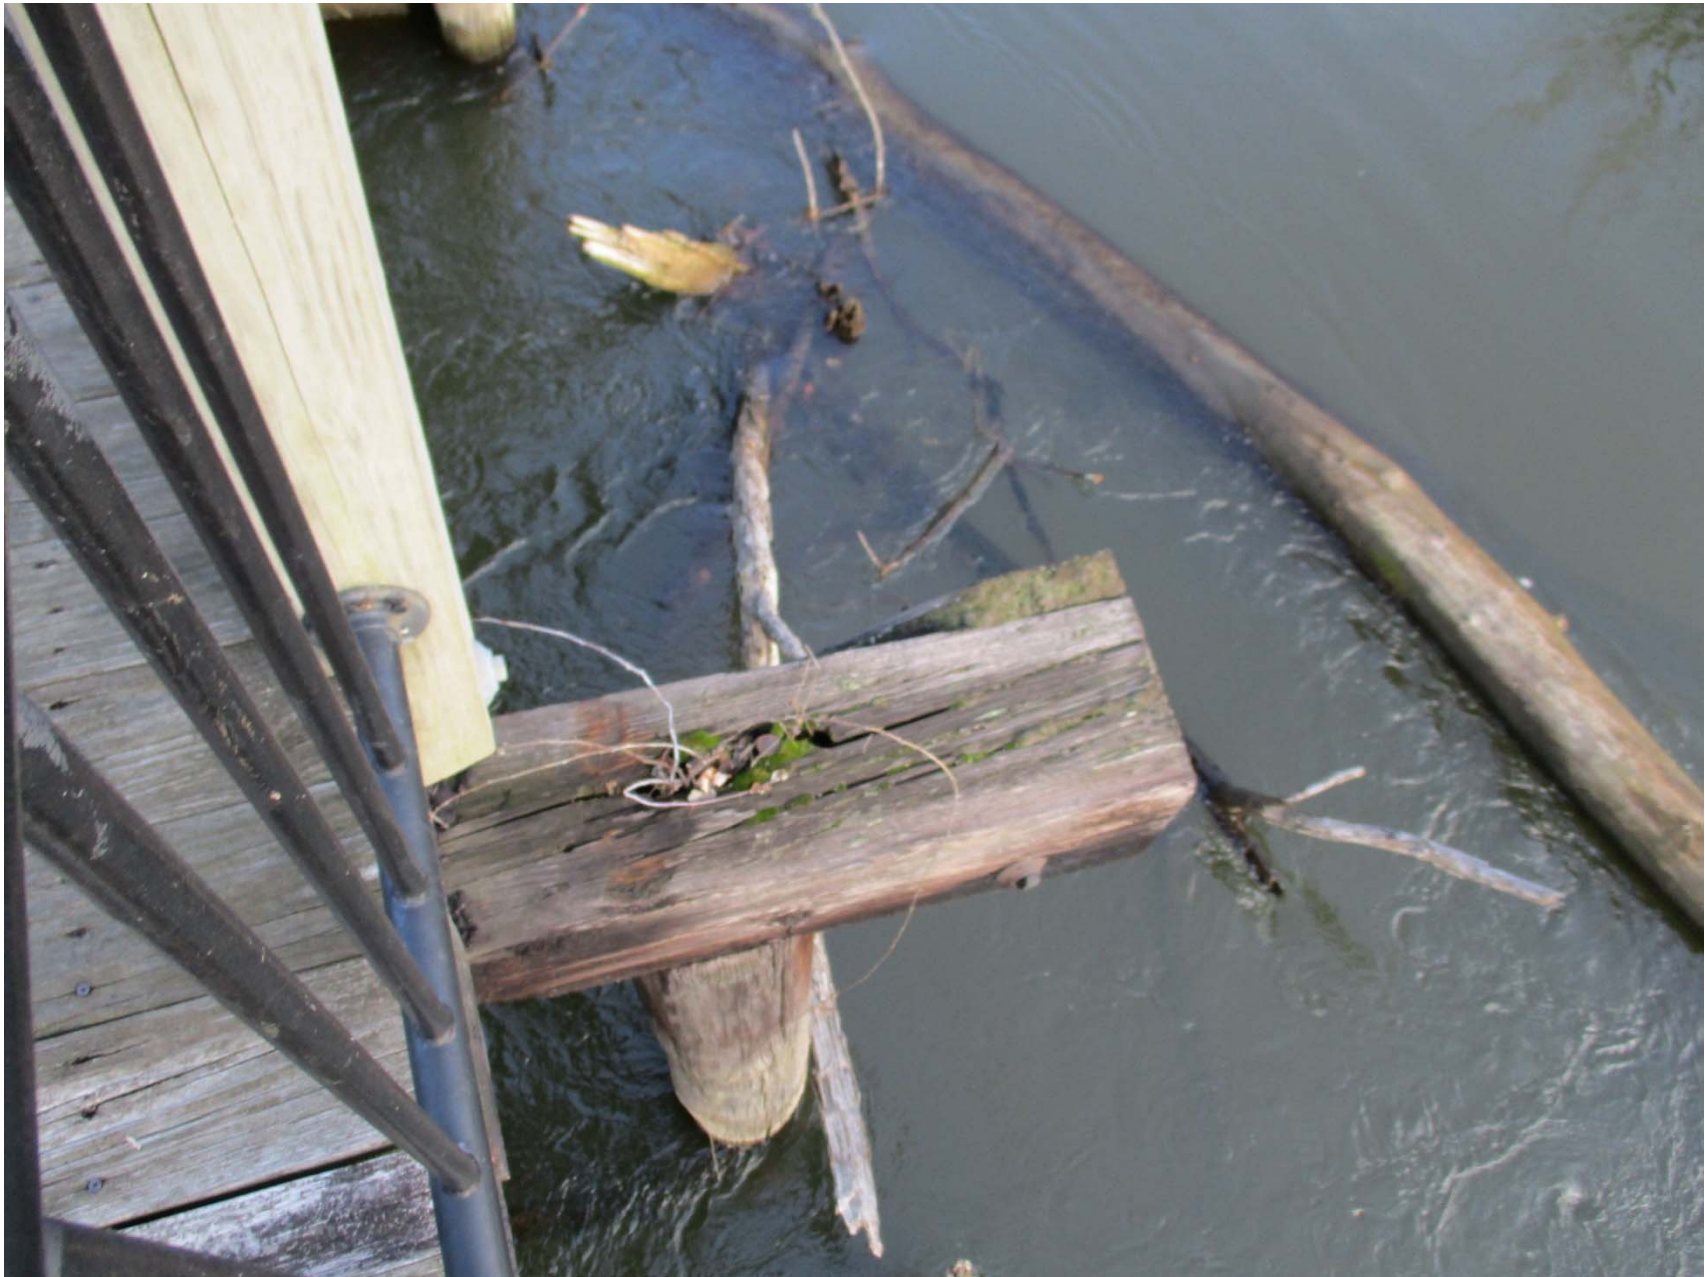
Pier 6S east end with internal rot
