SUBJECT: Jaycee Park Pedestrian Bridge Inspection

A detailed inspection of the old railroad trestle in Jaycee Park over the Kalamazoo River in the City of Allegan was completed on December 8, 2023. Enclosed is a copy of the report and pictures for your bridge files, supplemented with the comments below.

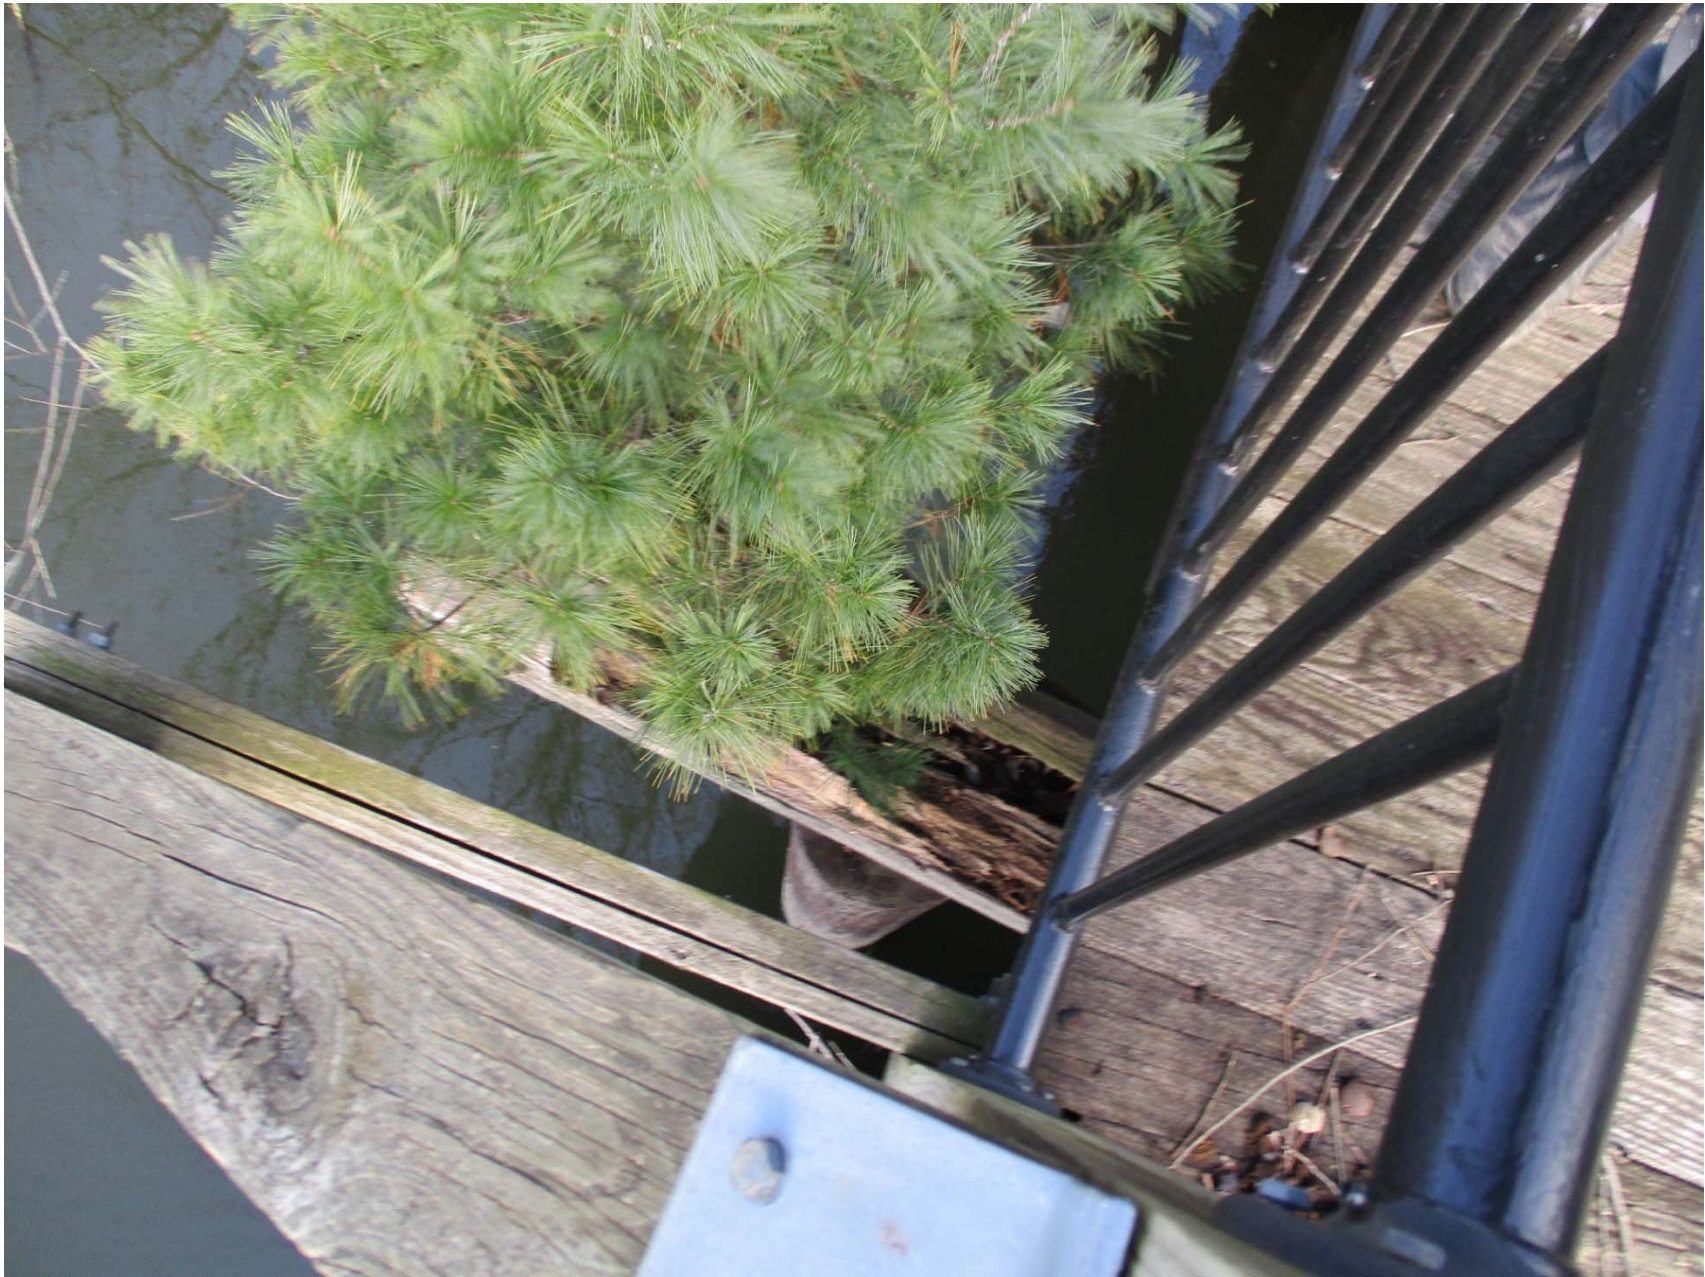
Pier 9S west end rotted with 4ft white pine

Pier 9S: The top half of the cap has rotted away. A 4ft white pine tree growing in the west end. There is no bearing support for the beams. The span is being held by west beam end pressure against the steel span cross bracing. The beams are beginning to split at the end bearing point. Extensive rot at the water surface to piles 3-5E. The adjacent cribbing supports the north end of the steel girders is rotting and has settled with rotation toward the north. The roller bears are offset from the girder bearing plates.

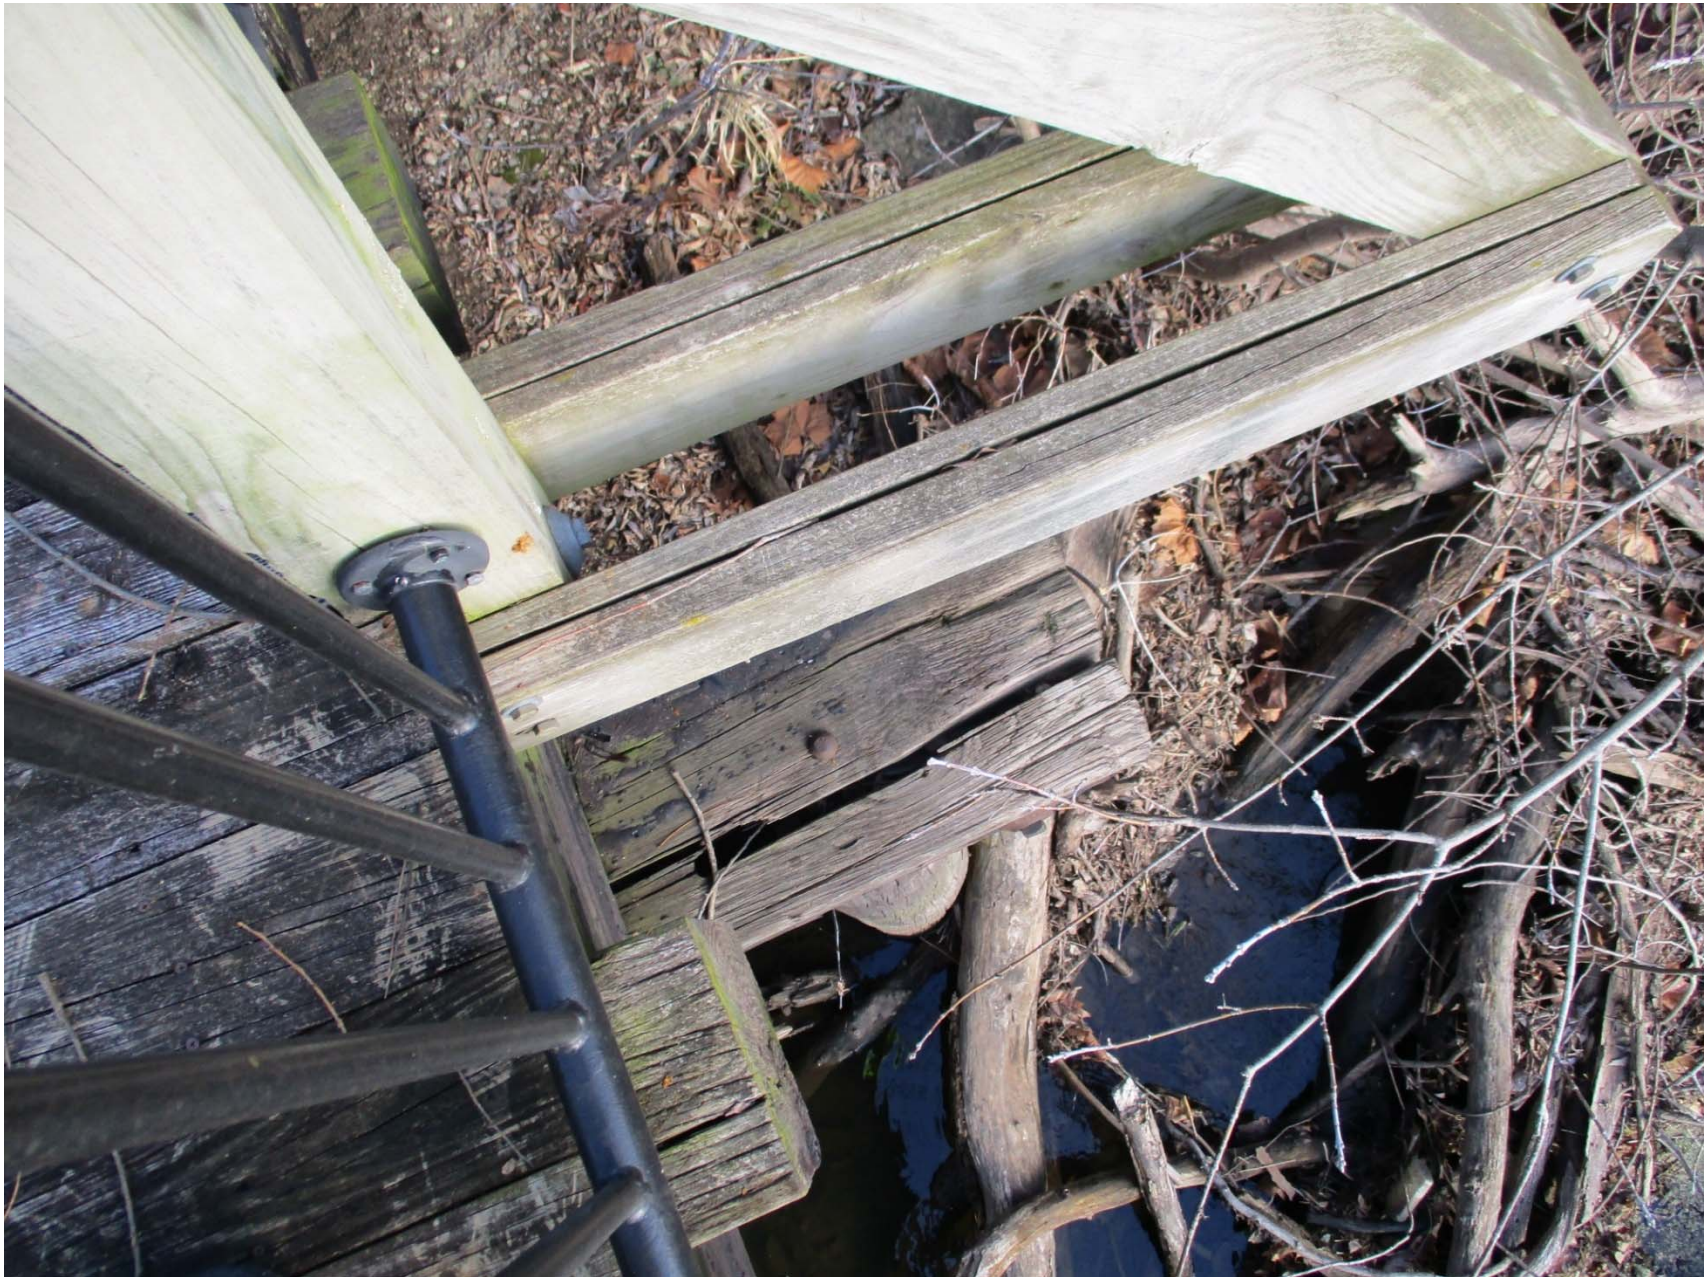
Pier 10S east end split with internal rot

Pier 10S: East end of the cap has rotted, top and bottom of the cap are split. Estimated 60-70% loss to Pile 1W at the water surface, about 40% loss to Pile 2W & 5W. Three-inch deep rot to top of pile 5W.

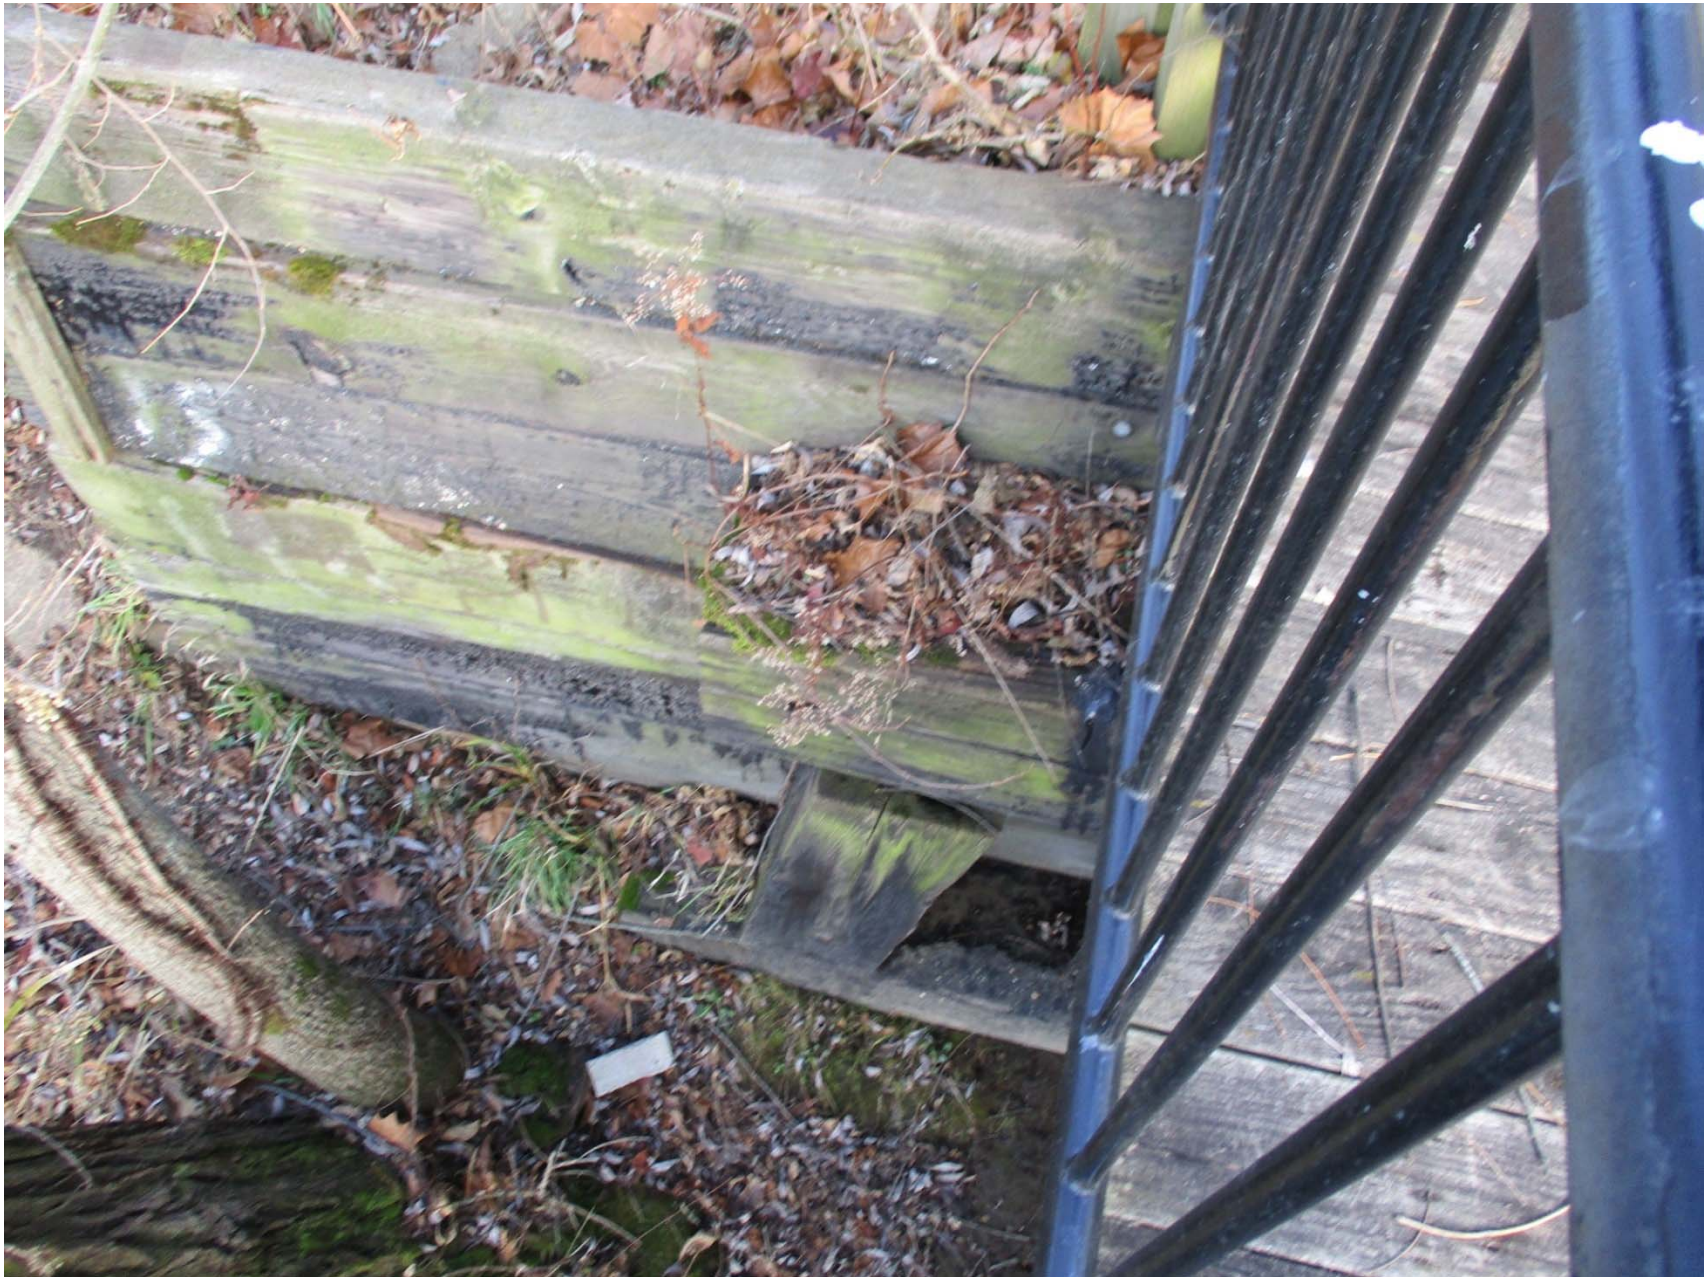
North abutment west end vegetation growth on cap

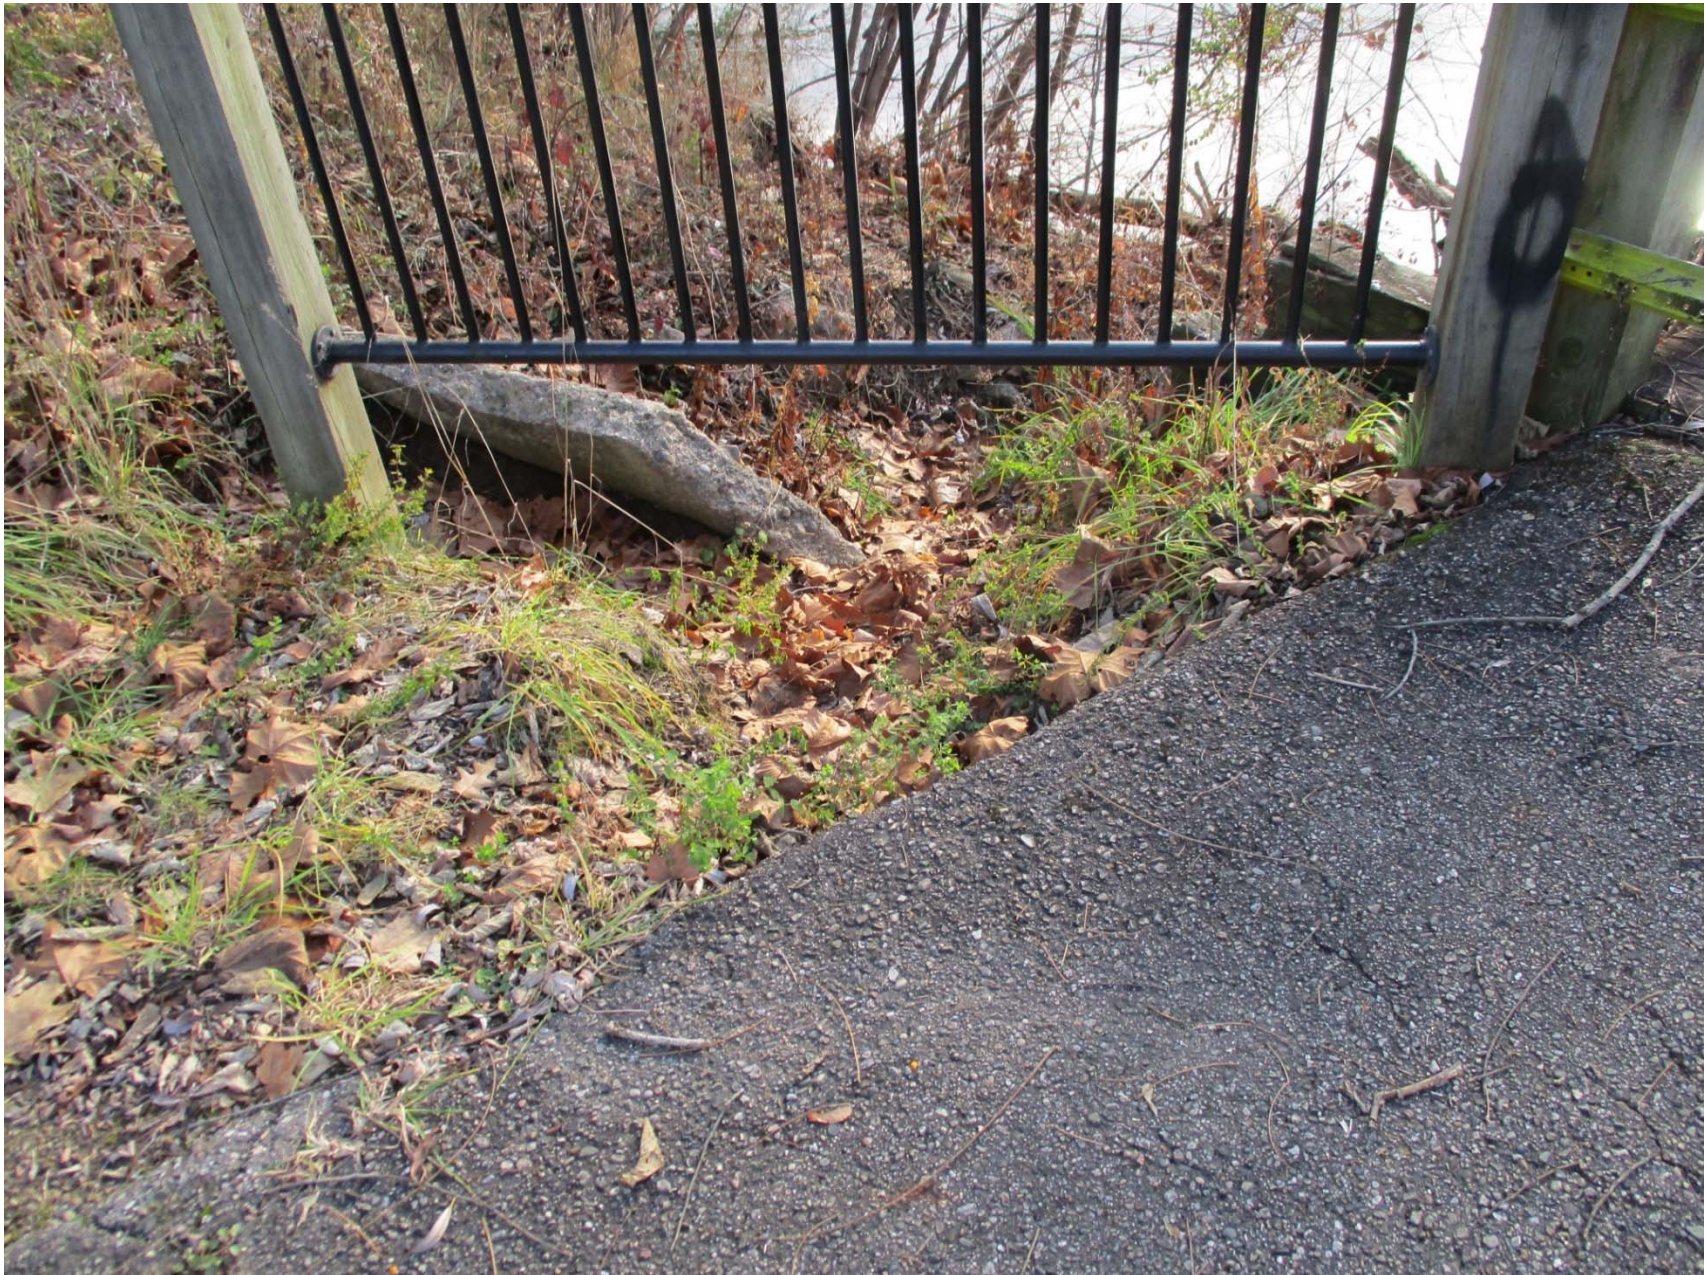
Erosion beginning to undermining approach path along east side

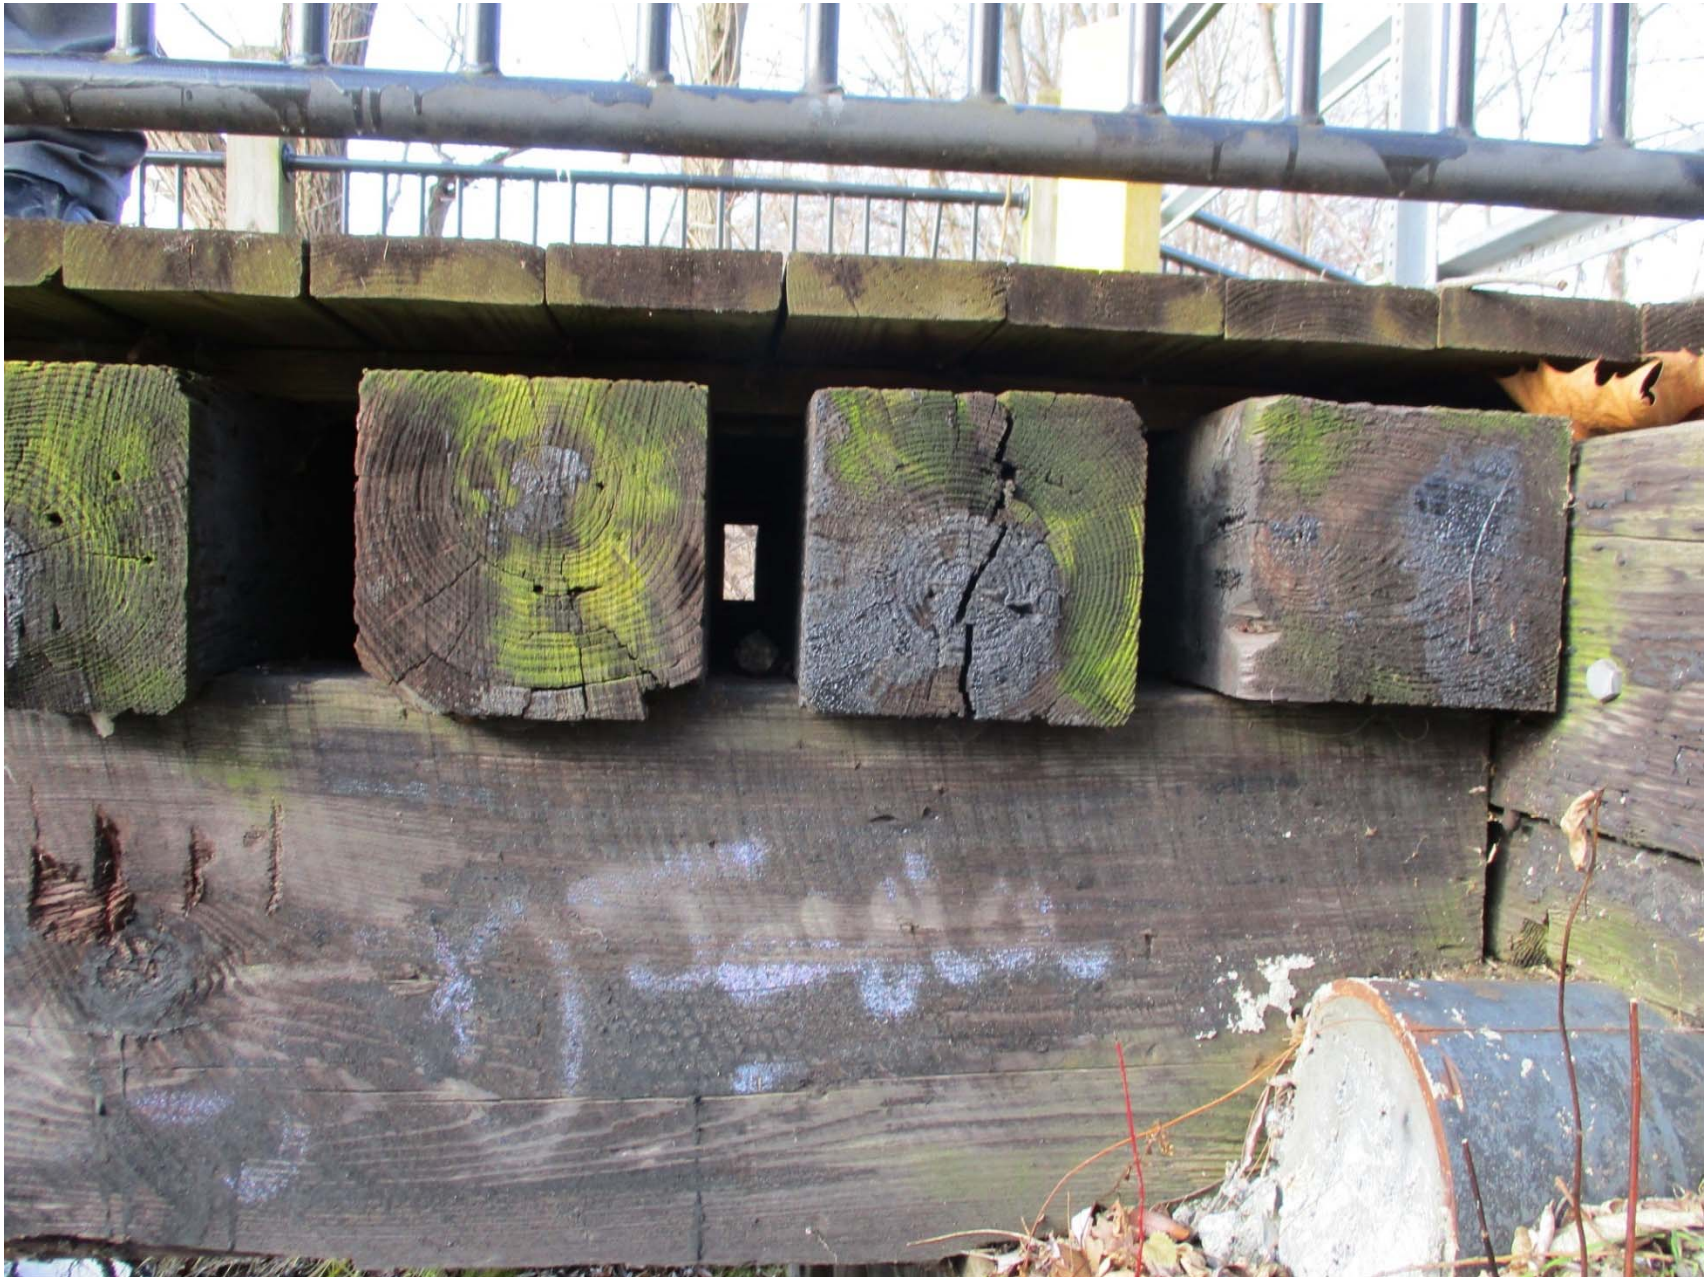
Scattered end split ties with some rot

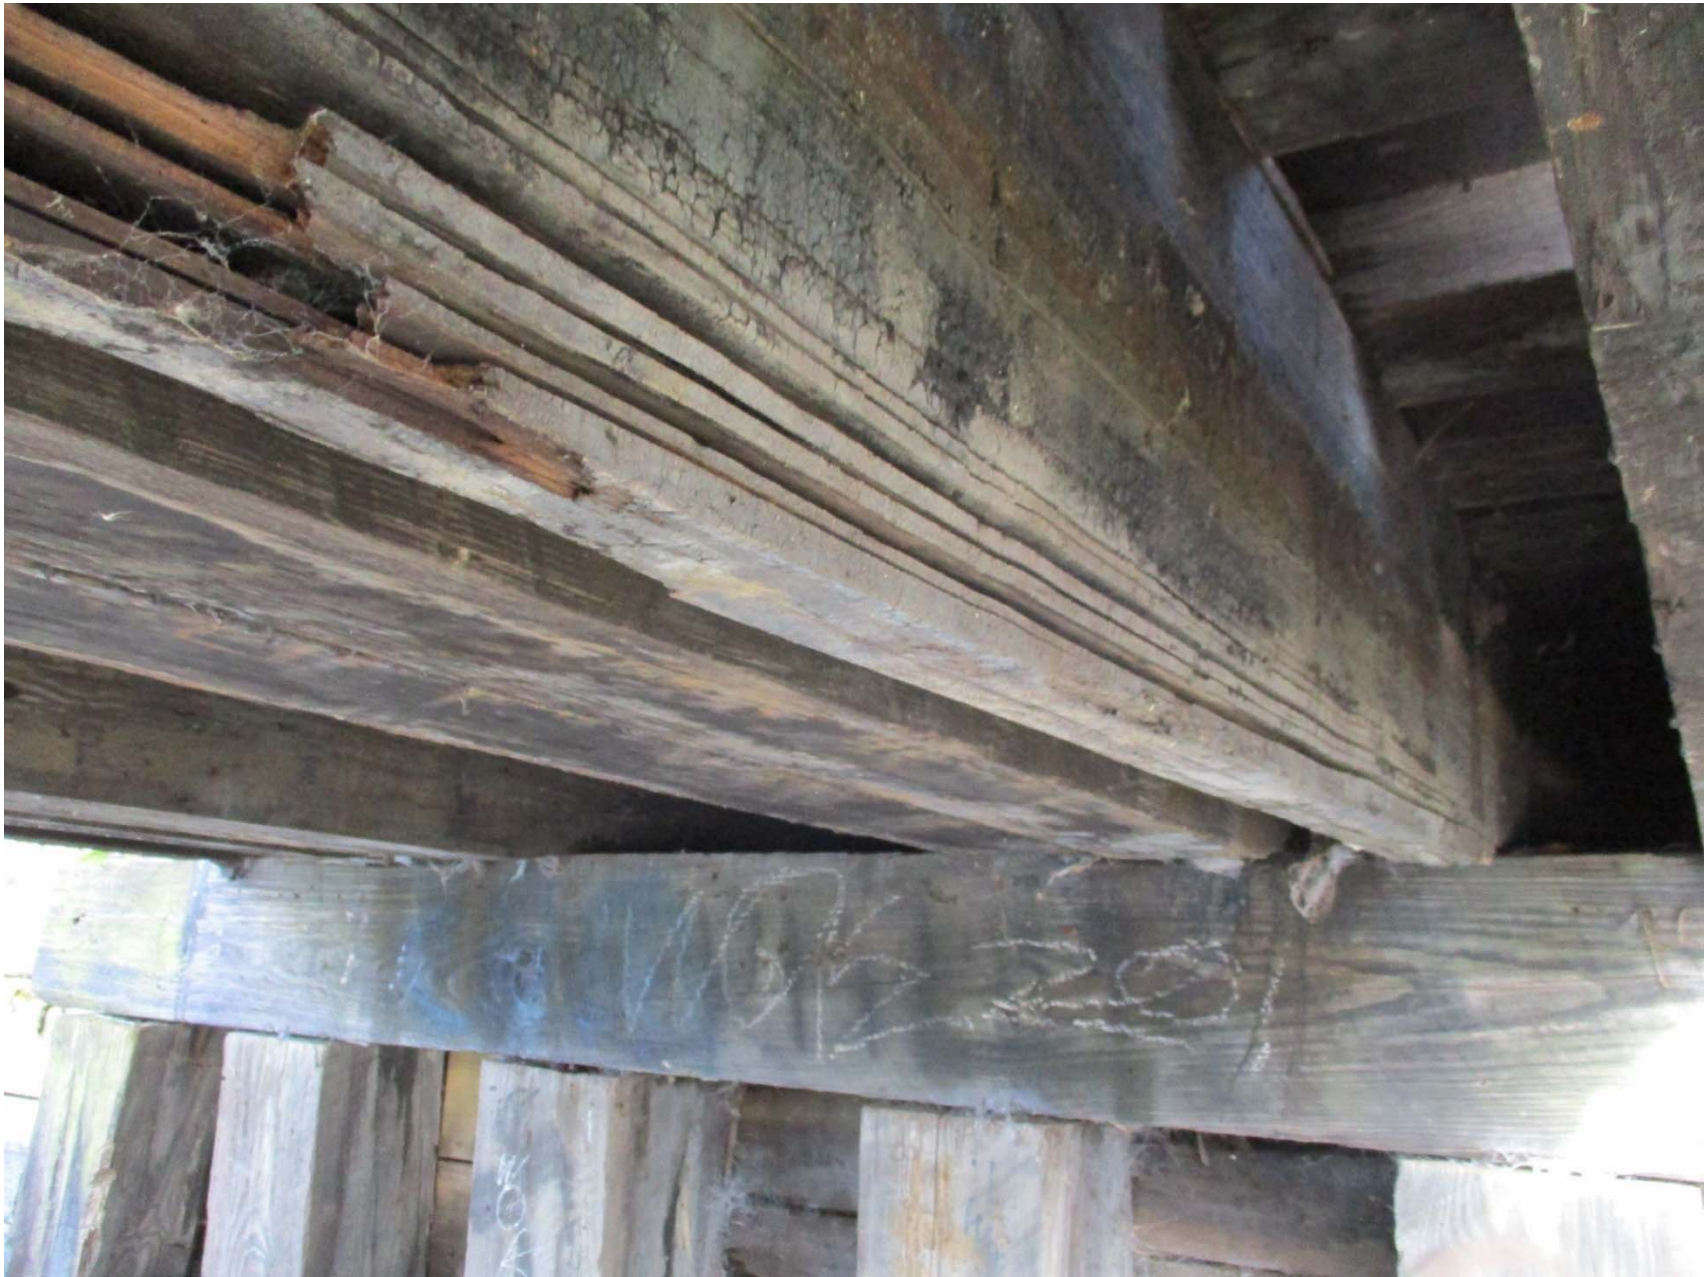
Timber beams support the deck. Three – 8"x16" timbers are located under each rail location with one fascia beam to support each end of the ties. Only minor deficiencies were noted. At the far north span, beam 2E has splits along the bottom. West beams at pier are beginning to split due to beam wedging against the steel end cross frame. Steel girders in spans 8S and 9S remain in good condition, with light rust and little to no section loss.

Splitting along bottom of beam 2E at north abutment

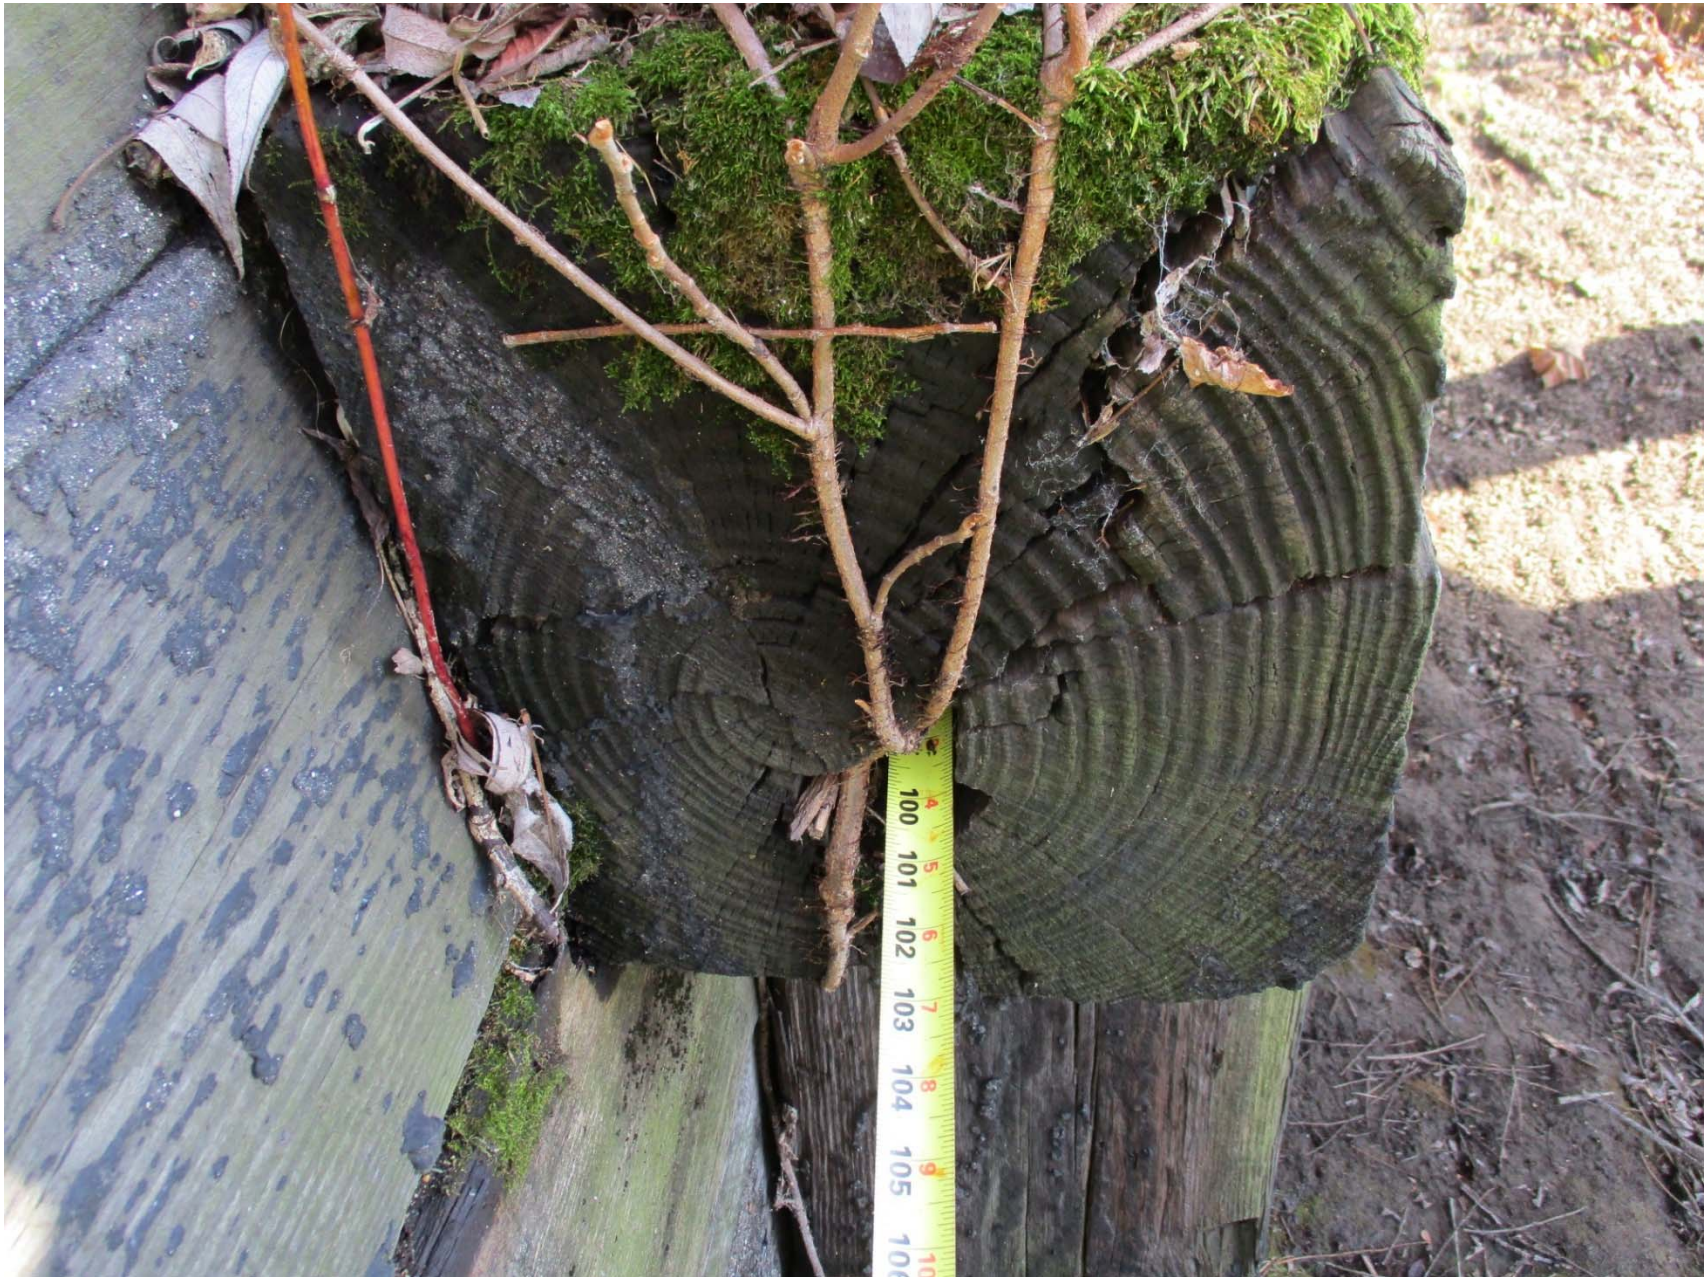
North abutment cap internal rot extends at least 100 inches from west end

North abutment: Rot to pile 1E at the groundline. The cap has internal rot, at least 100" deep from the west end. Vegetation is growing on each end of the cap.

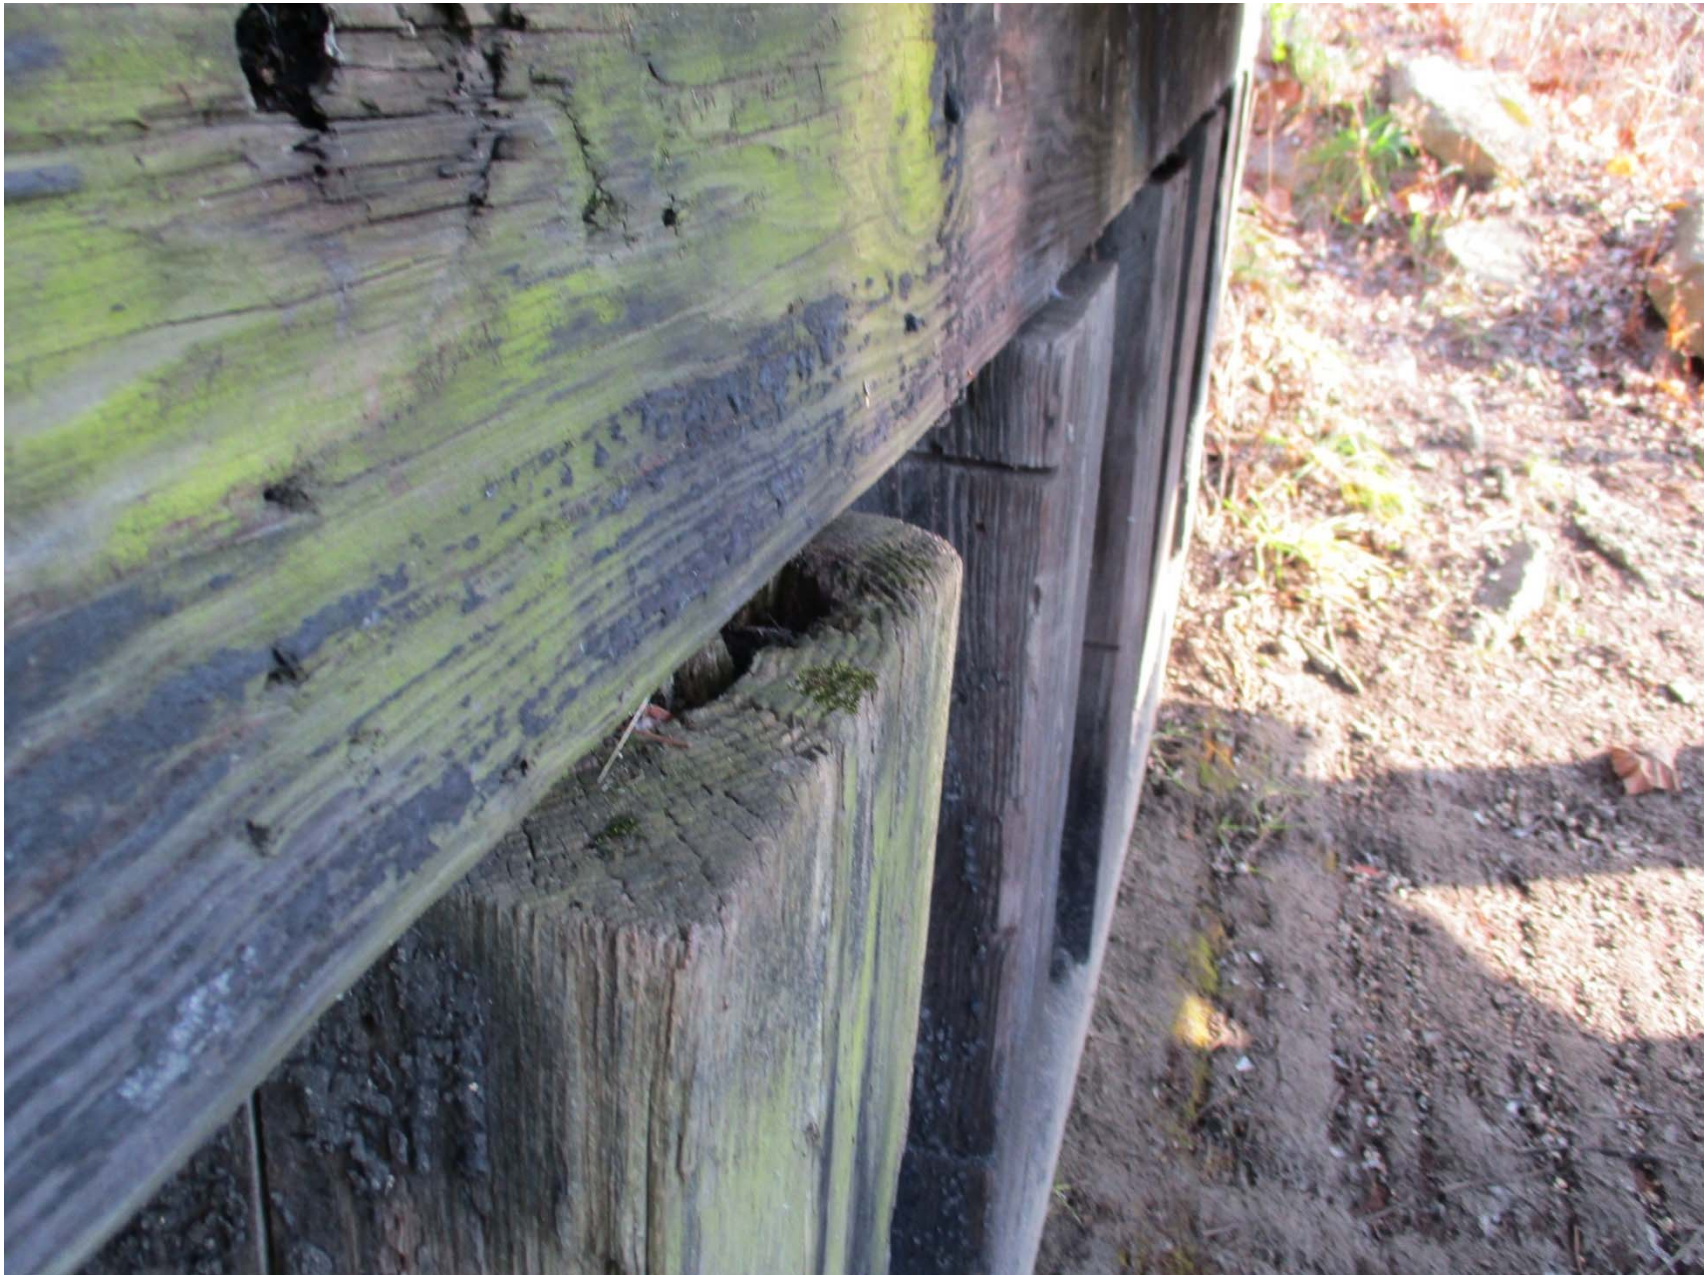
Internal rot to vertical supports at north abutment

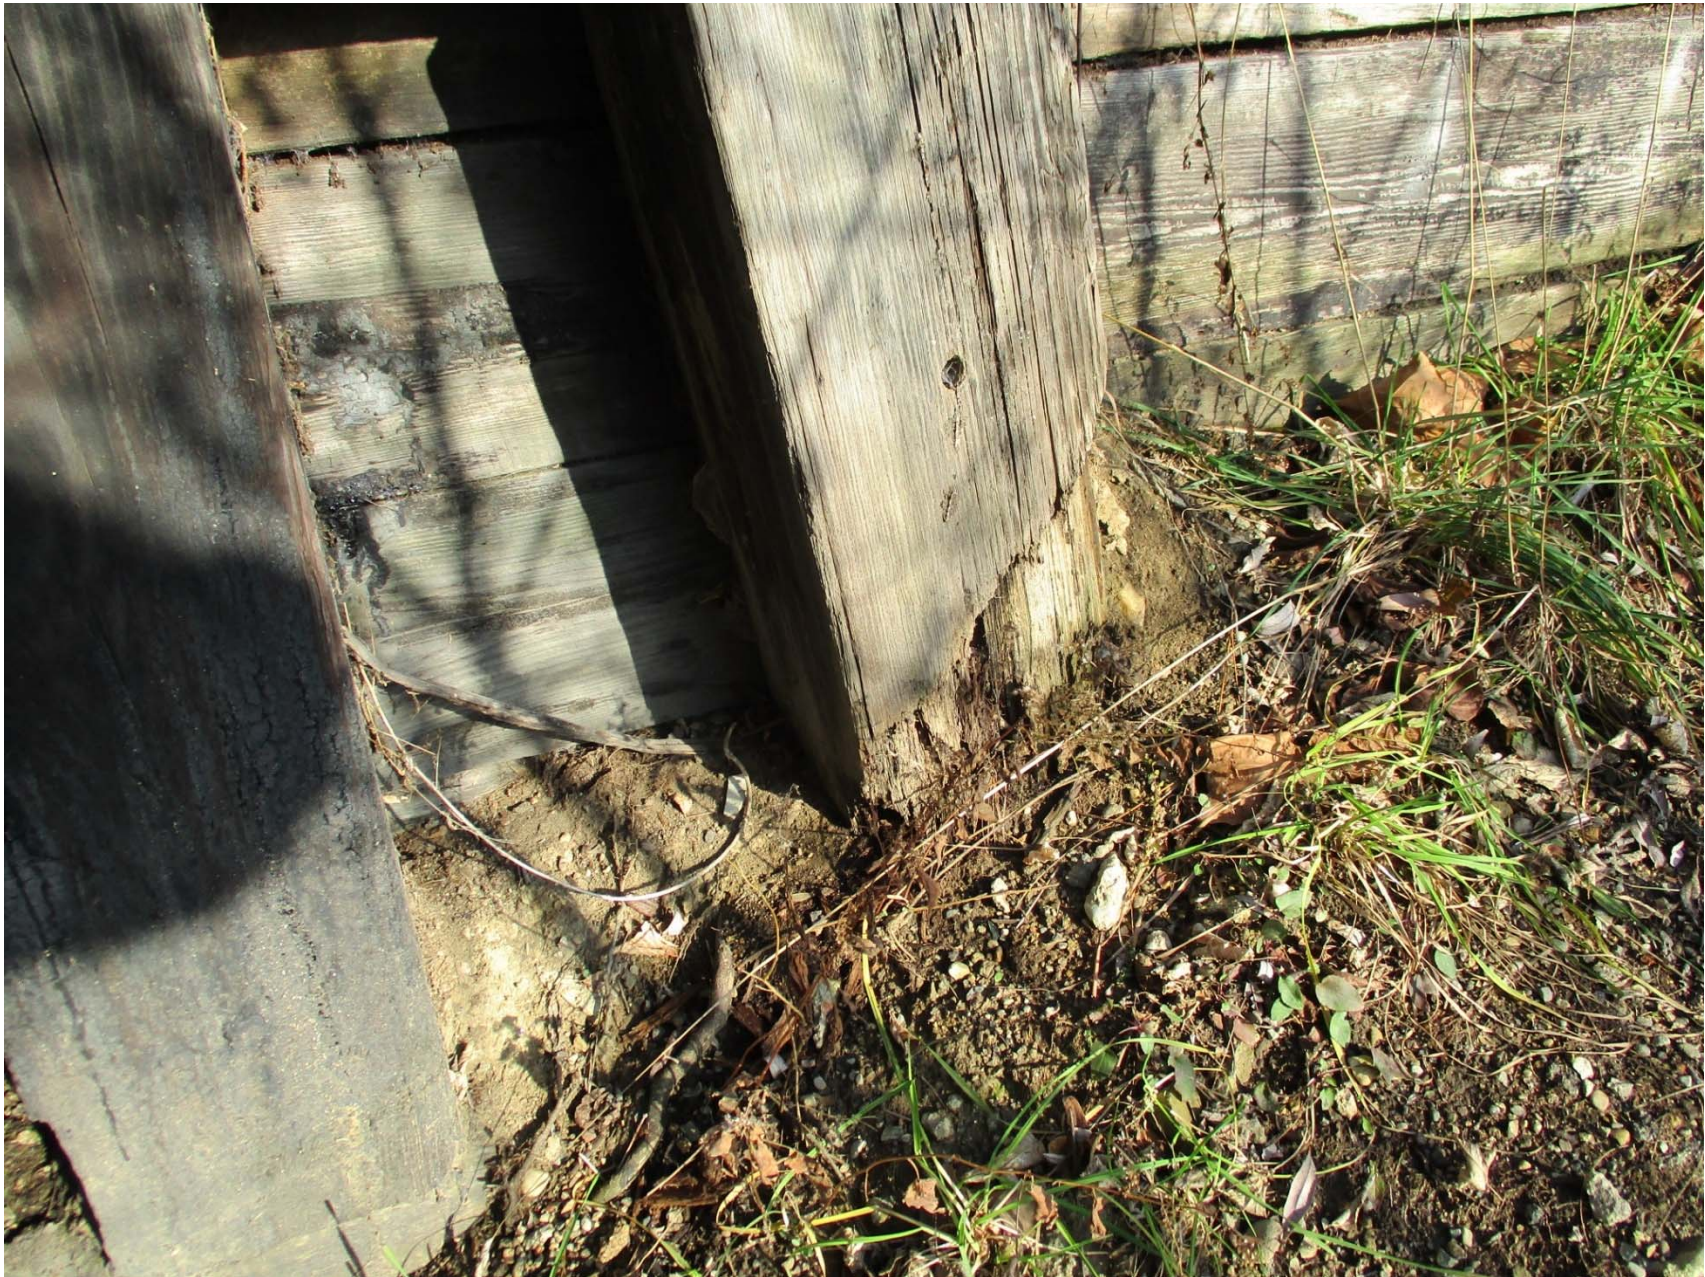
North abutment east pile rot at ground line

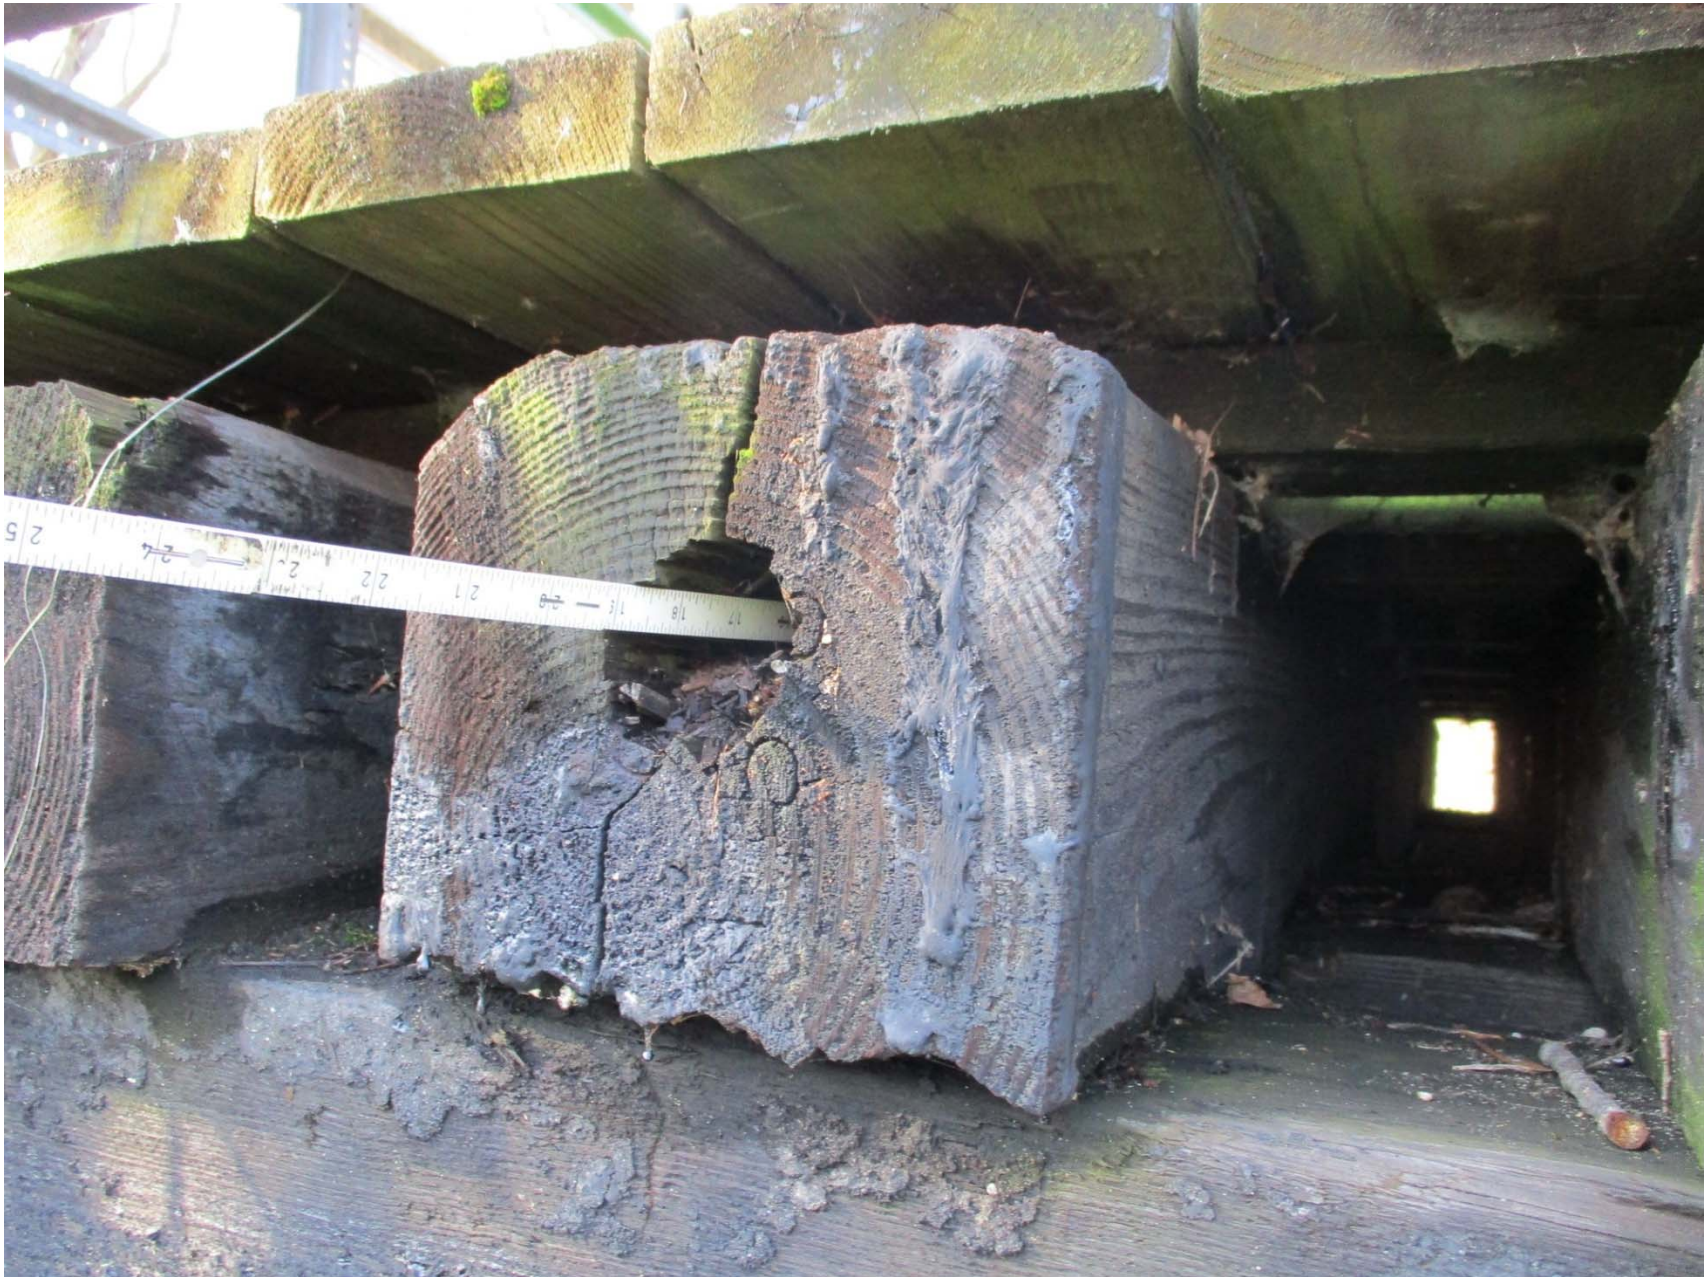
Tie end rot at south abutment
