SUBJECT: Jaycee Park Pedestrian Bridge Inspection

A detailed inspection of the old railroad trestle in Jaycee Park over the Kalamazoo River in the City of Allegan was completed on December 8, 2023. Enclosed is a copy of the report and pictures for your bridge files, supplemented with the comments below.

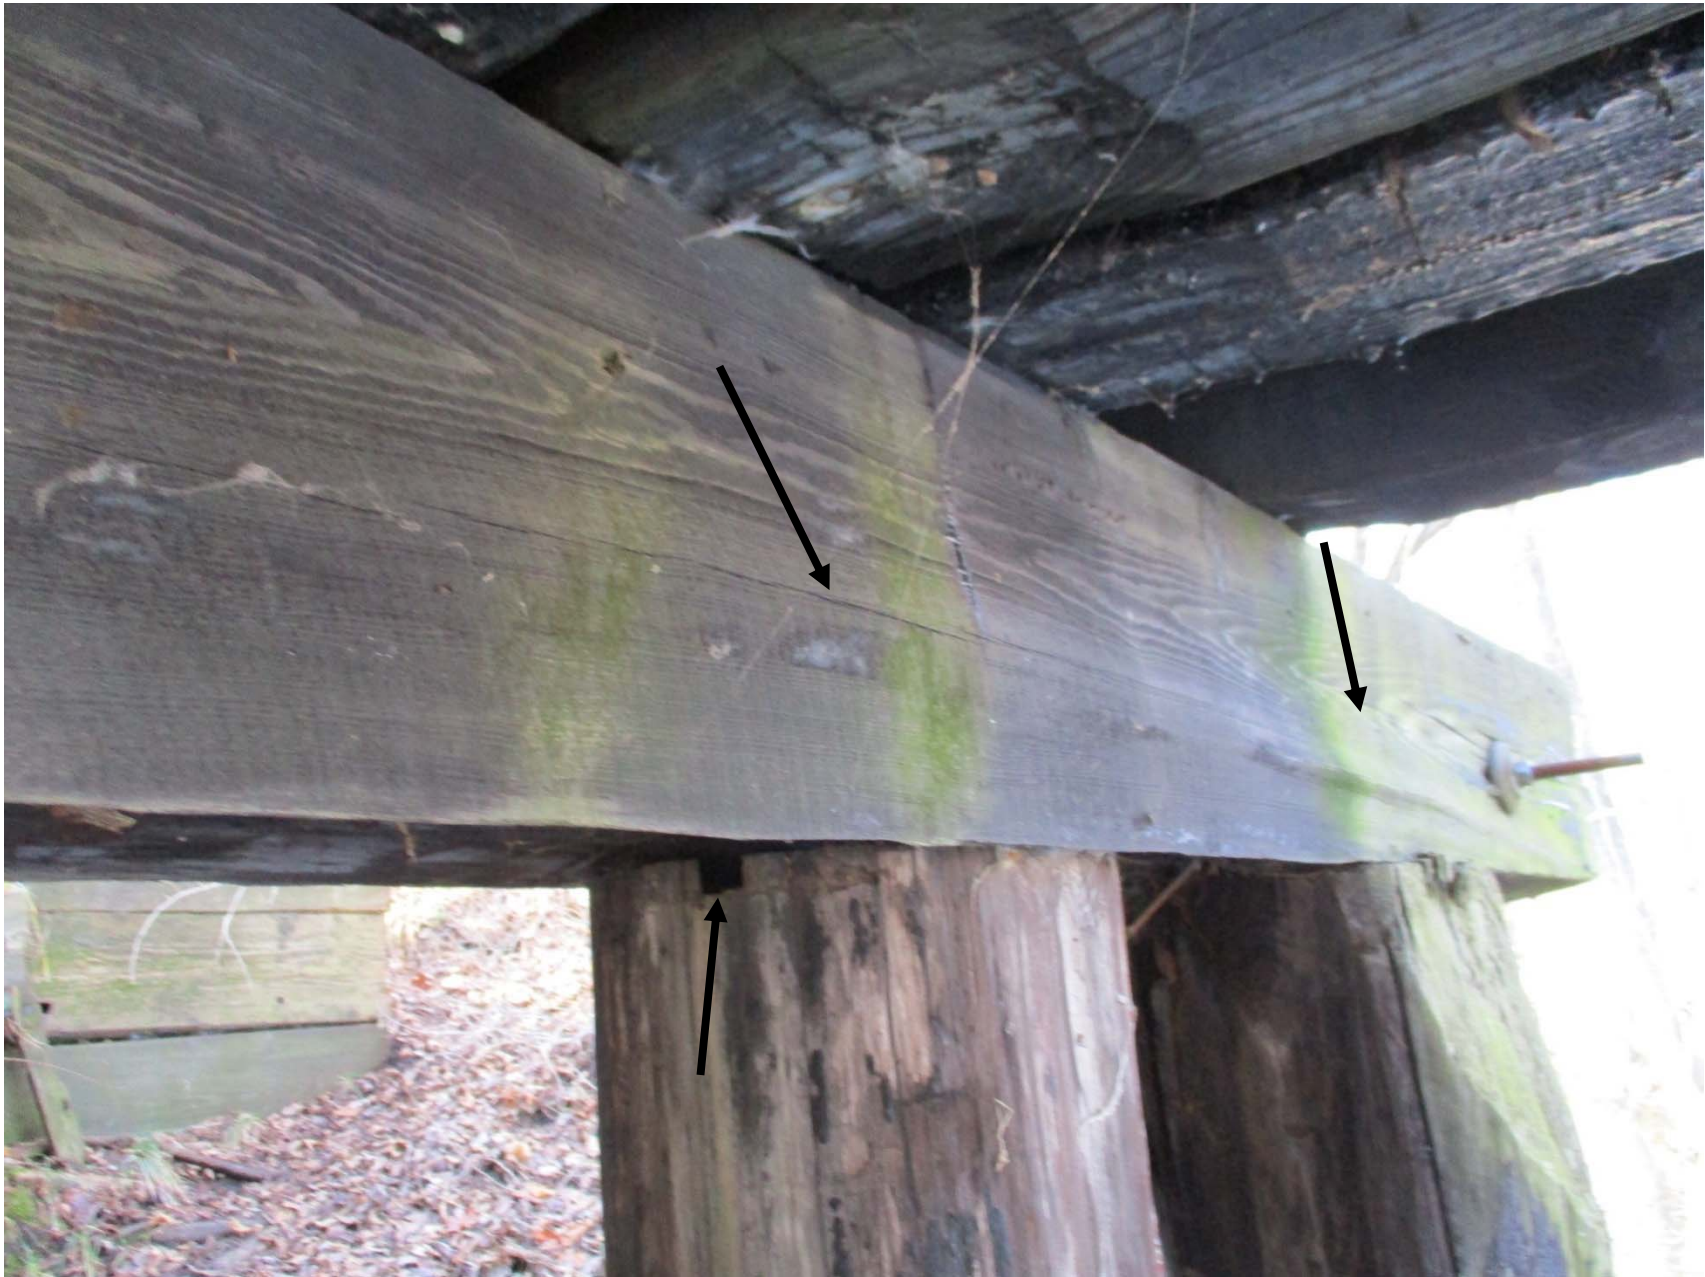
Pier 1S west end of remaining cap is crushing, rot inside top of piles

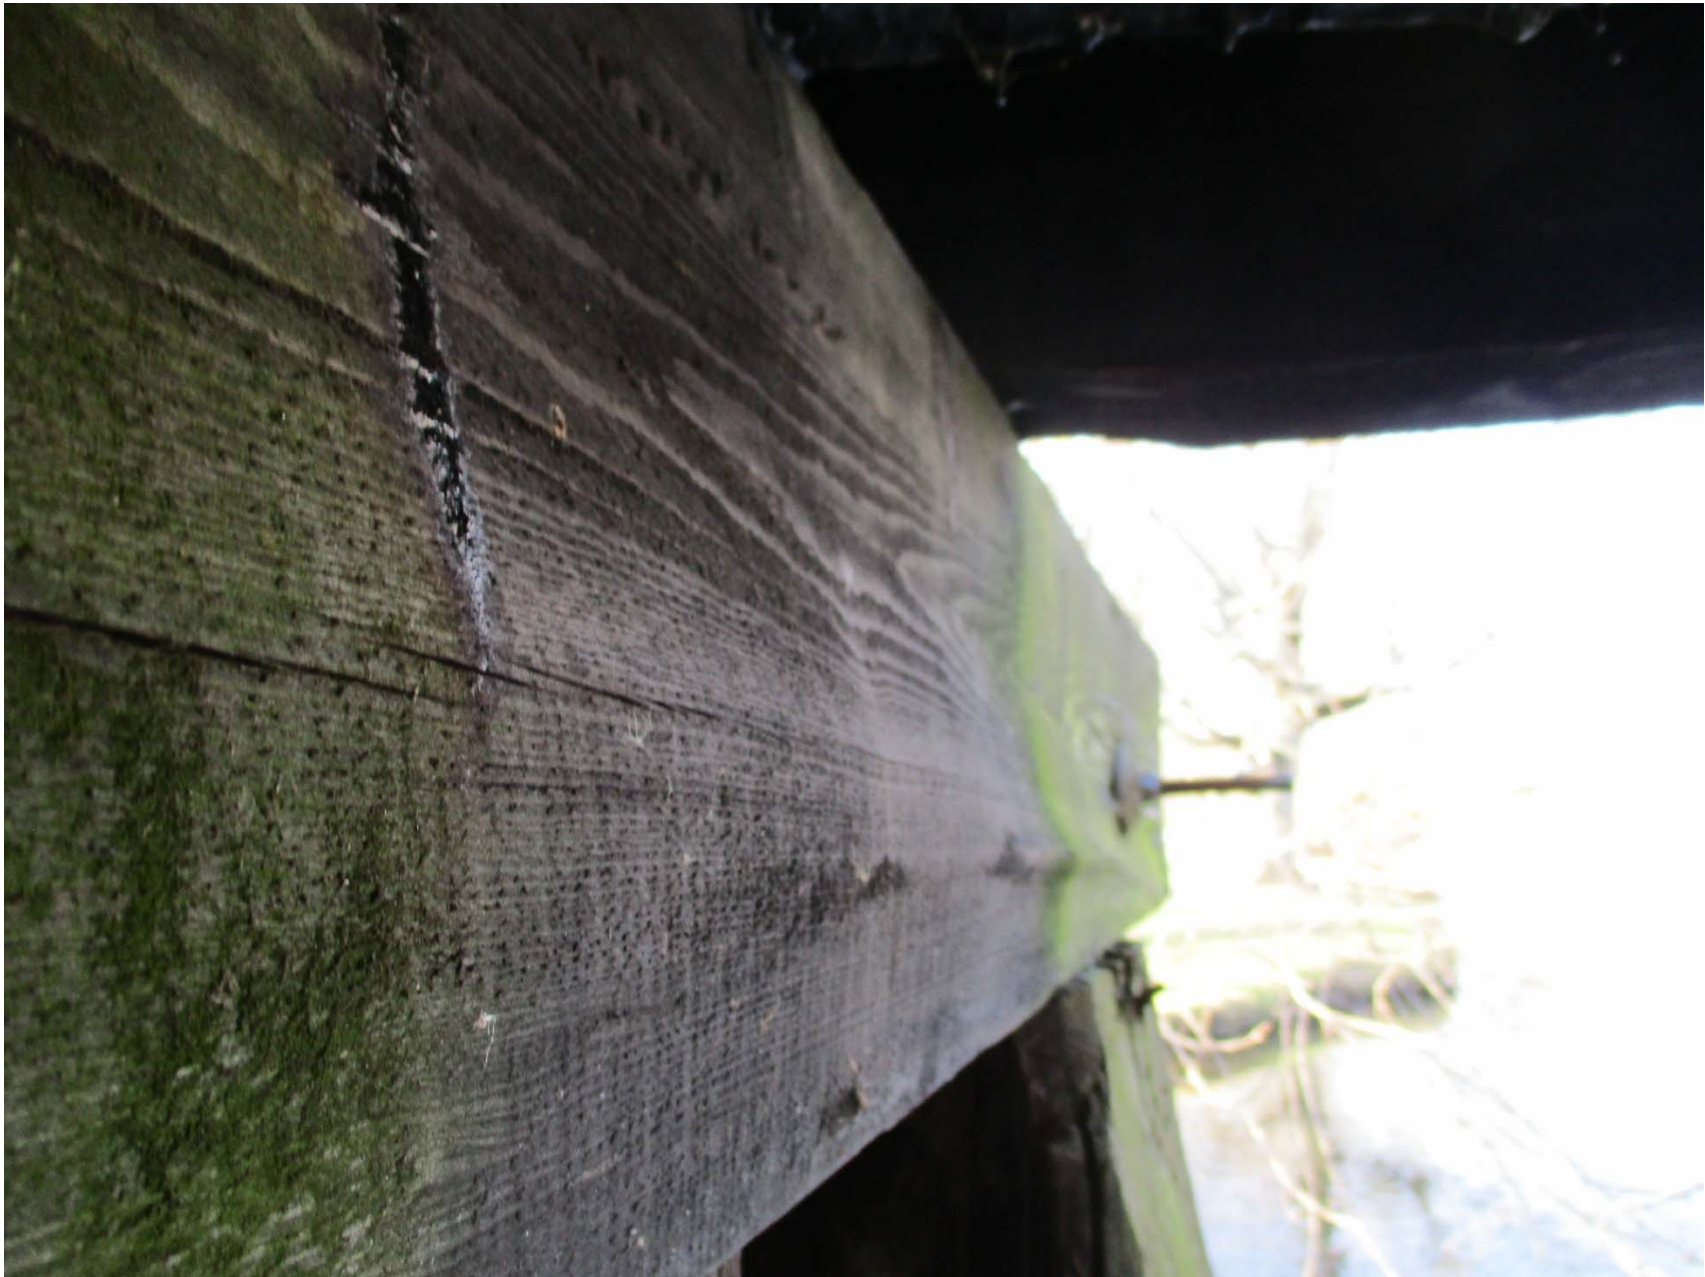
Pier 1S west end crushing/buckling

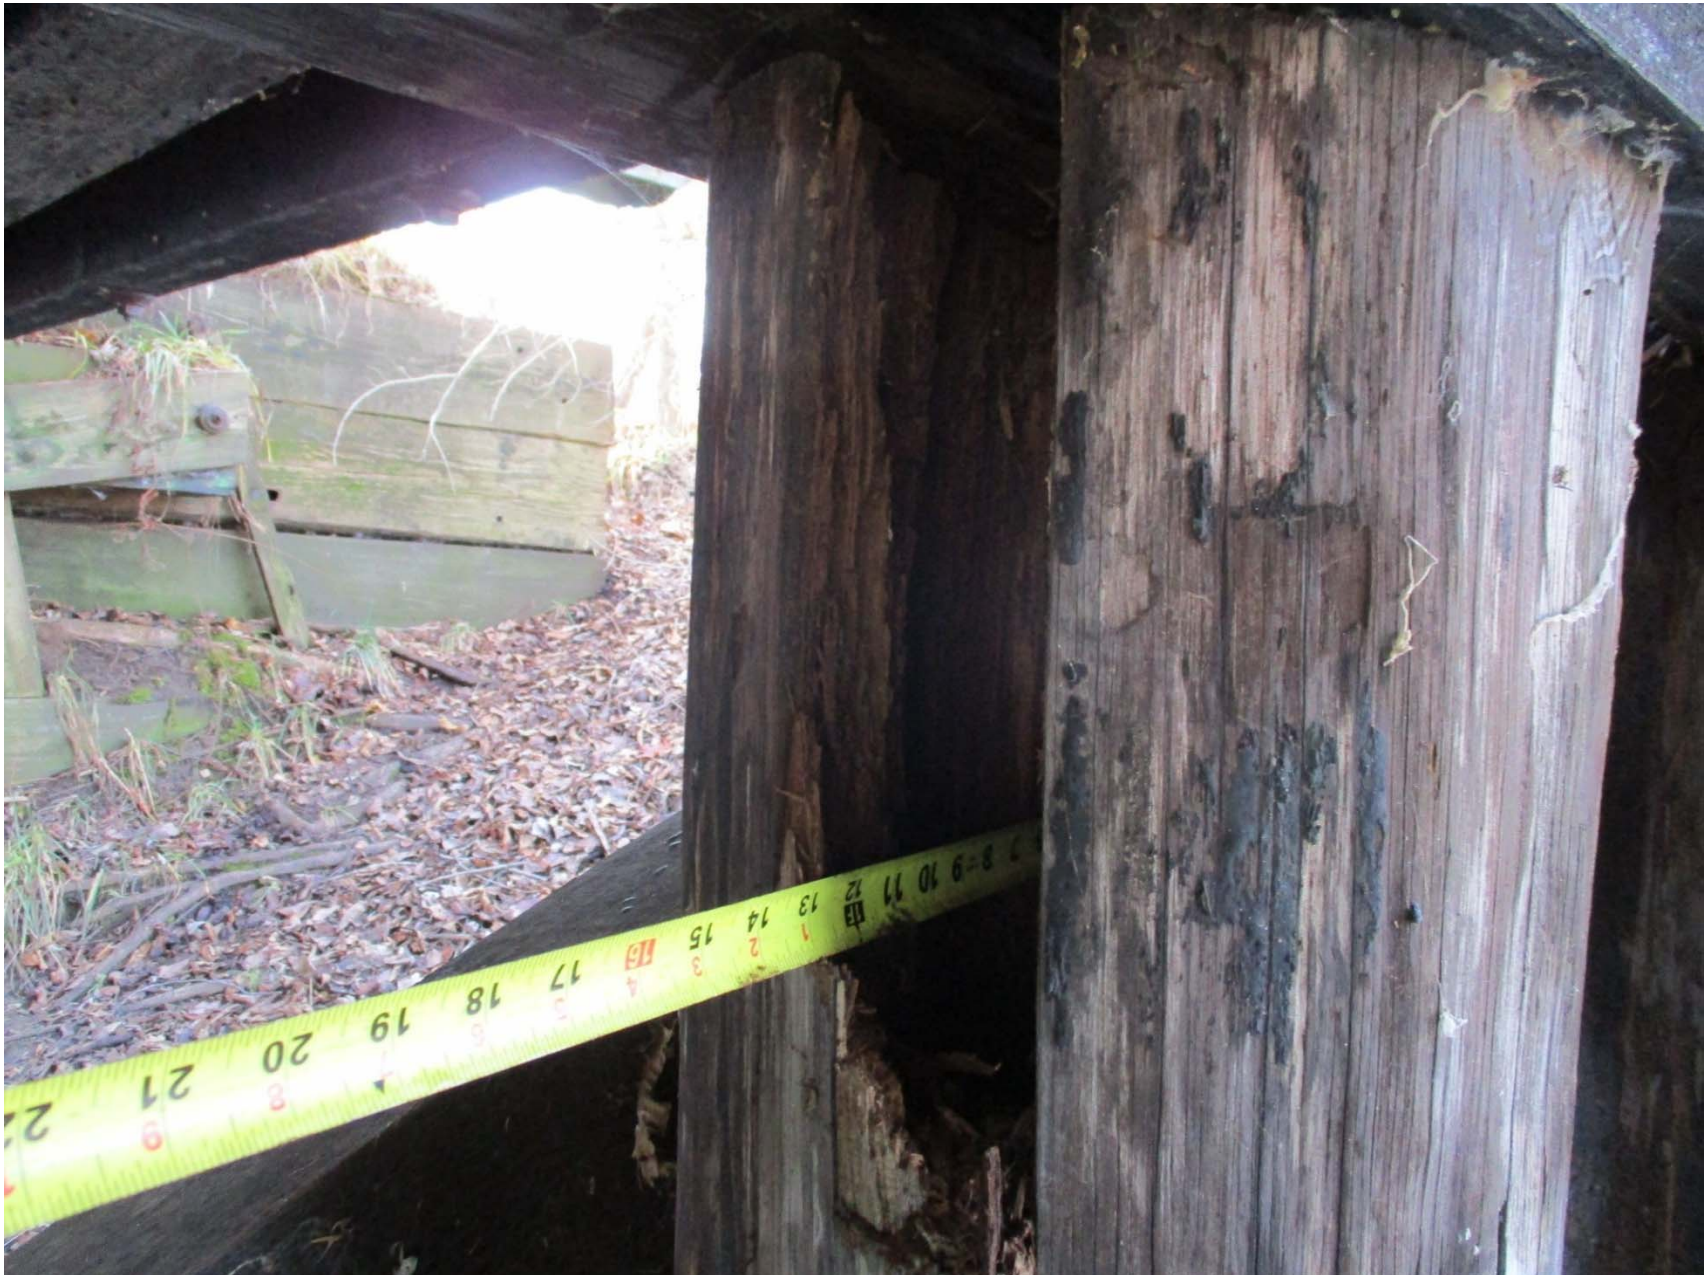
Internal rot in pile 2W exposed, only outer shell remains

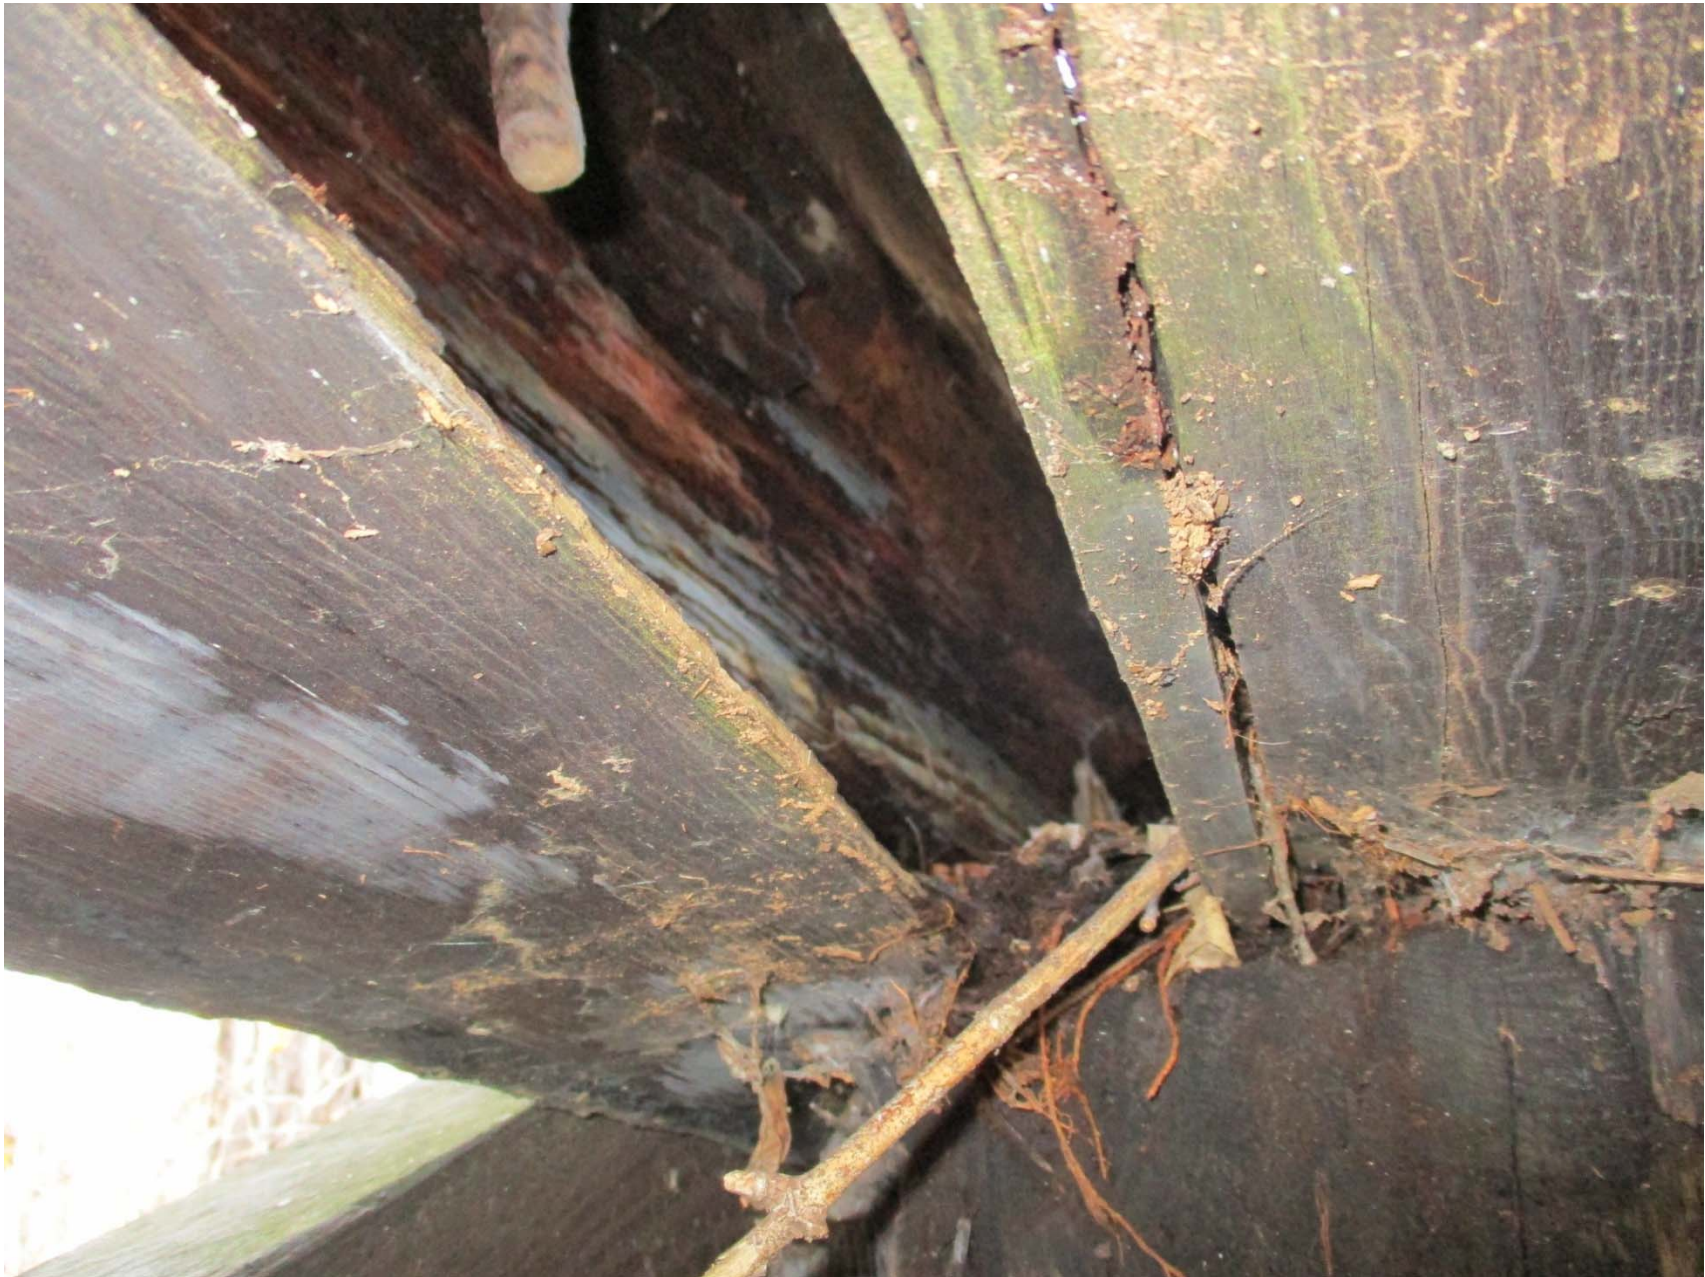
Pier 1S east half rotted

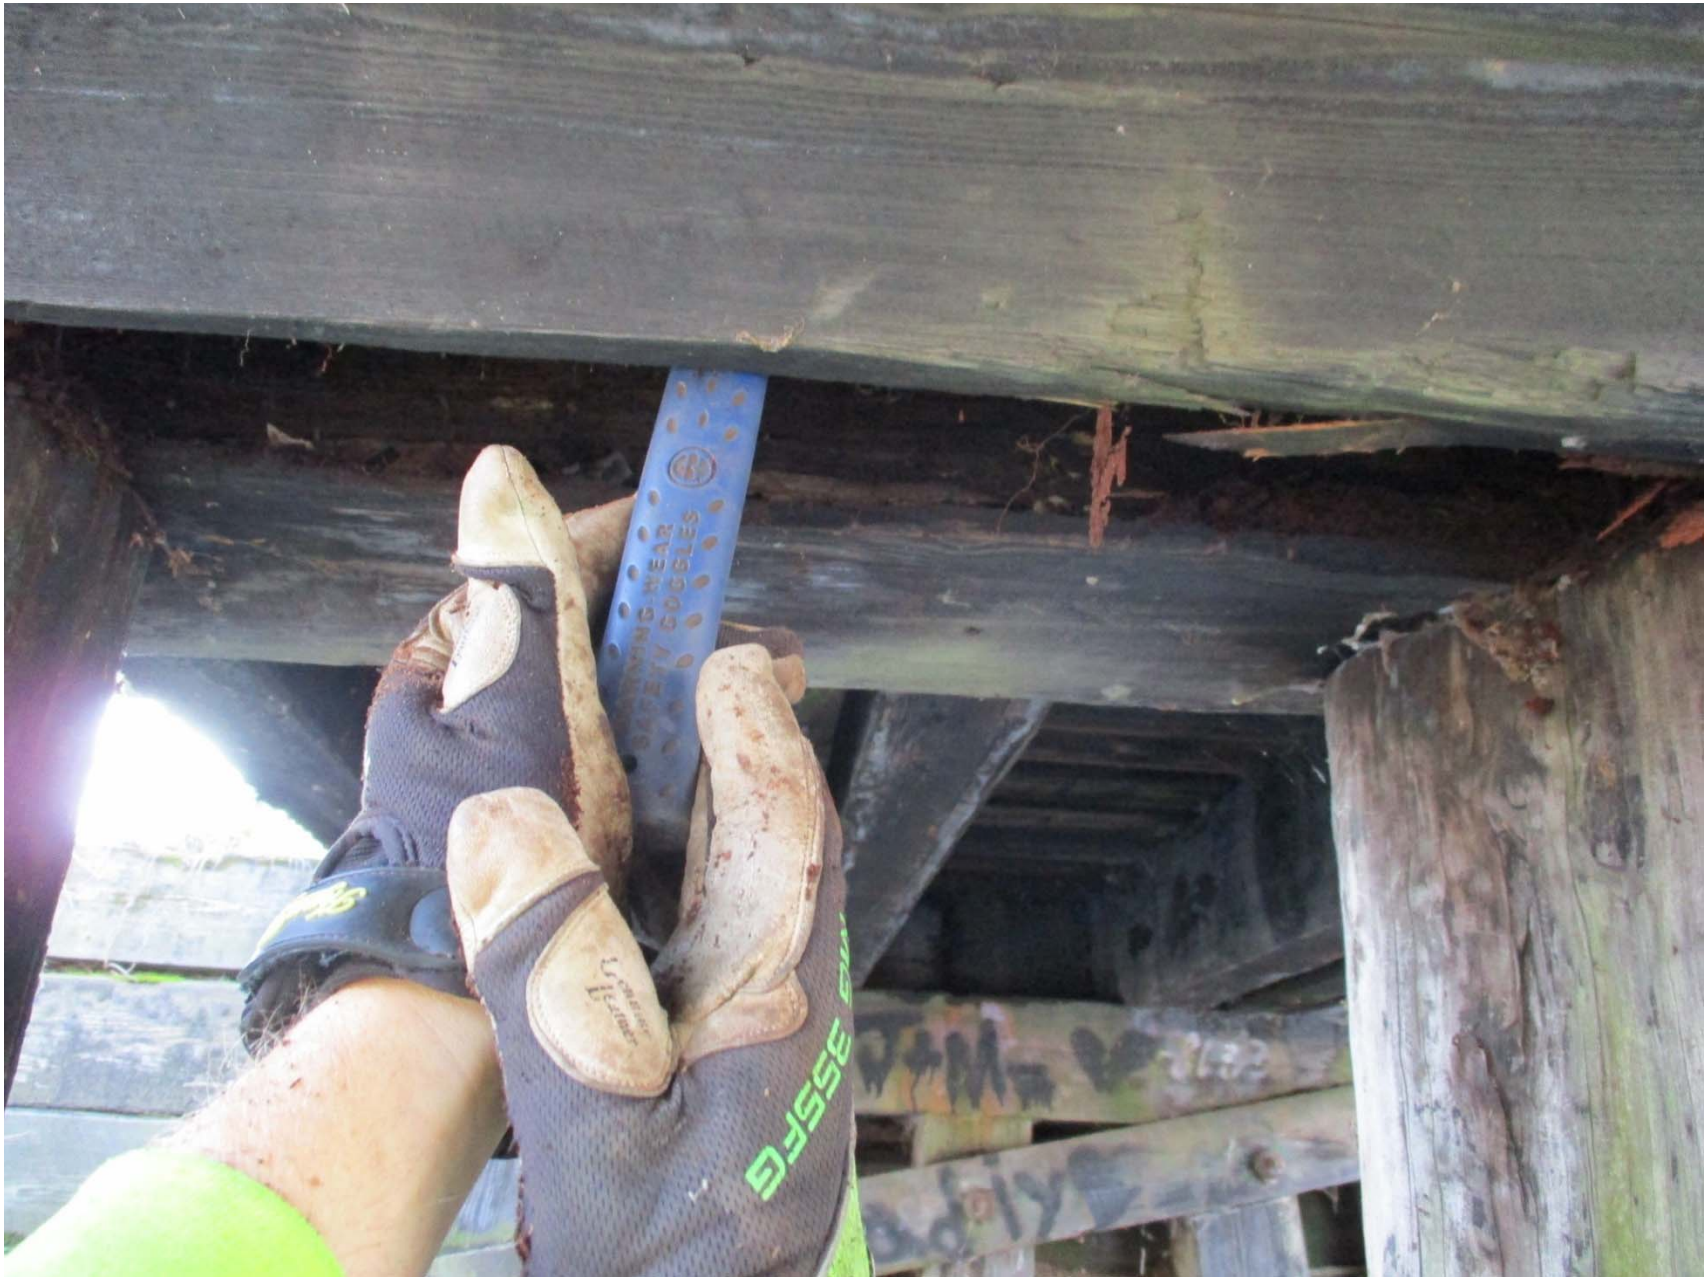
Pier 1S internal rot in east half

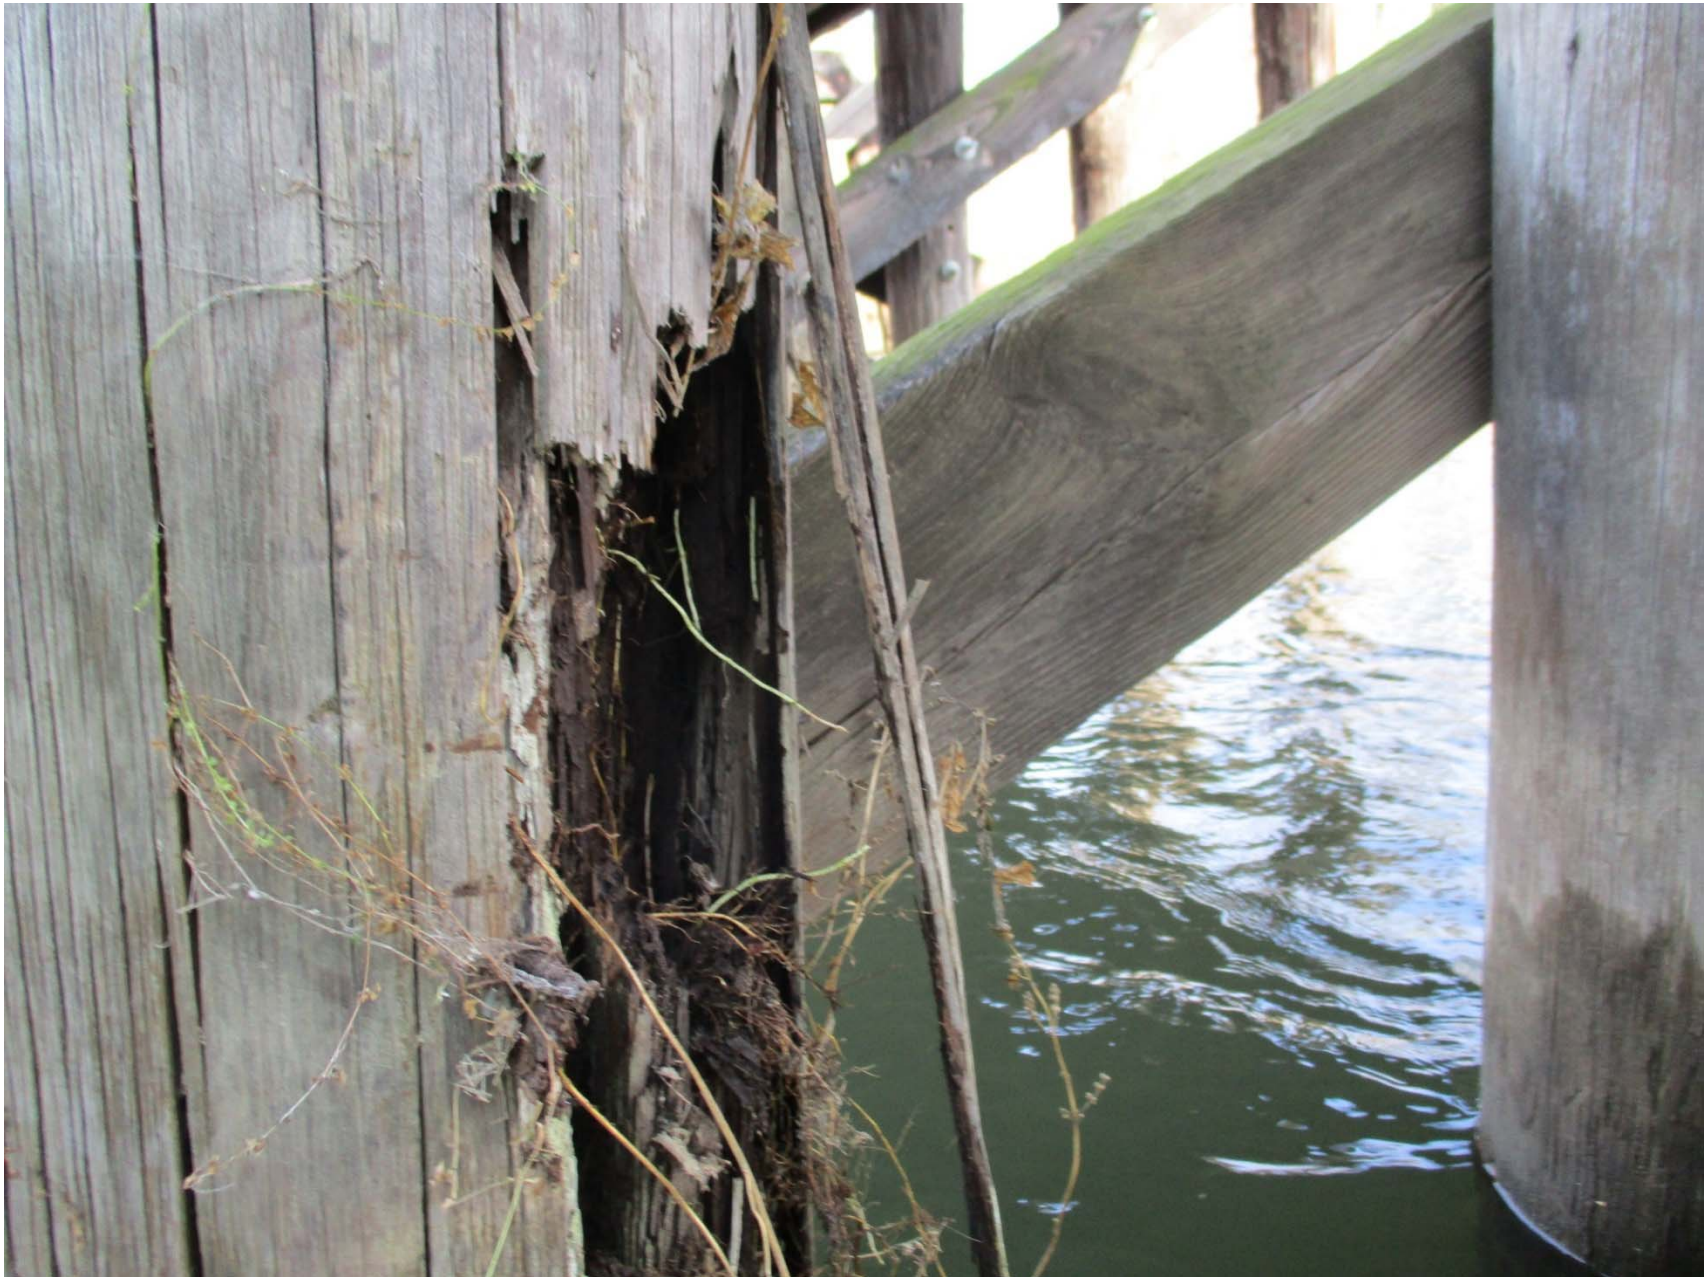
Pier 2S pile 1W rot

Pier 2S: Cap is in fair condition, no rot found. Each end pile is rotted with vegetation growing out of the timber. The estimated section loss to pile 1W is 20%, outer 1-2" at pile 2E is rotting.

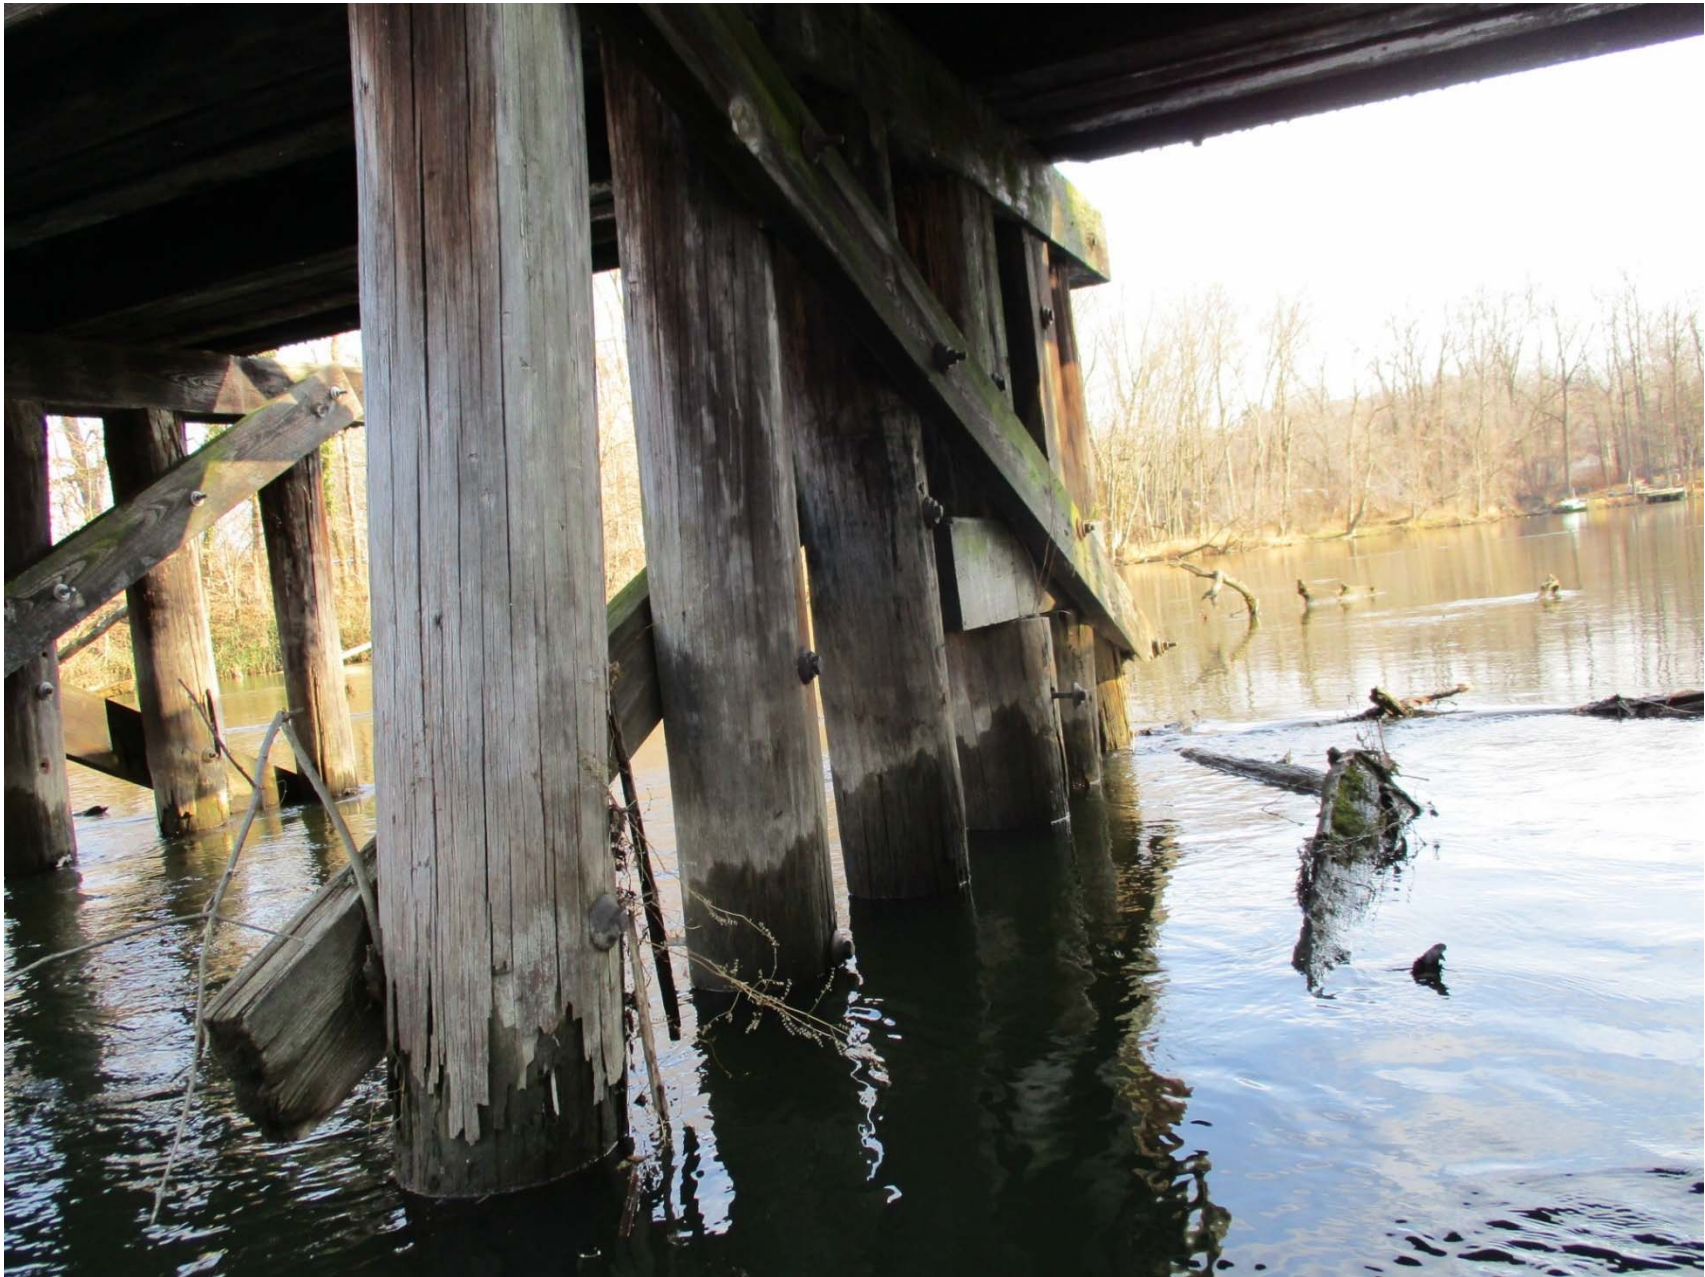
Pier 2S surface rot to pile 1W

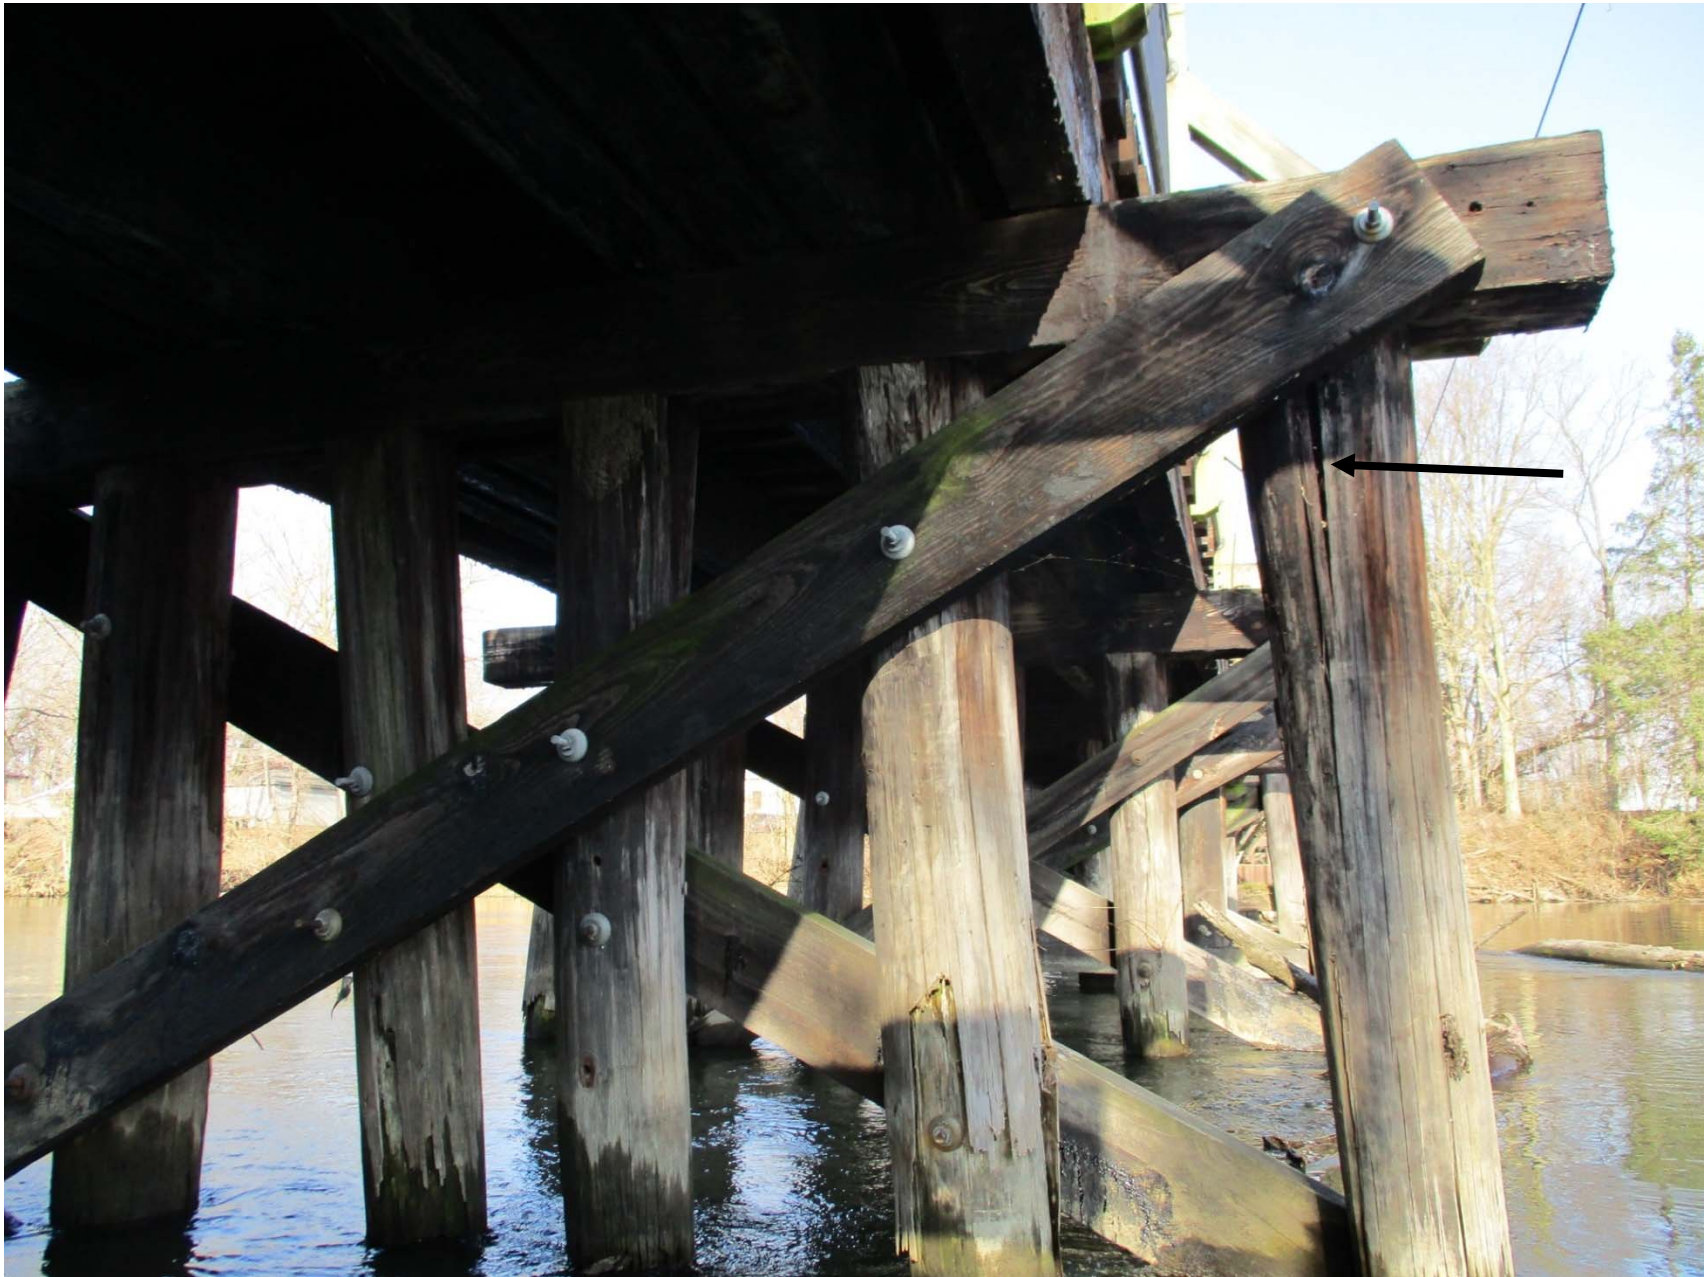
Pier 3S pile 1E split at cap

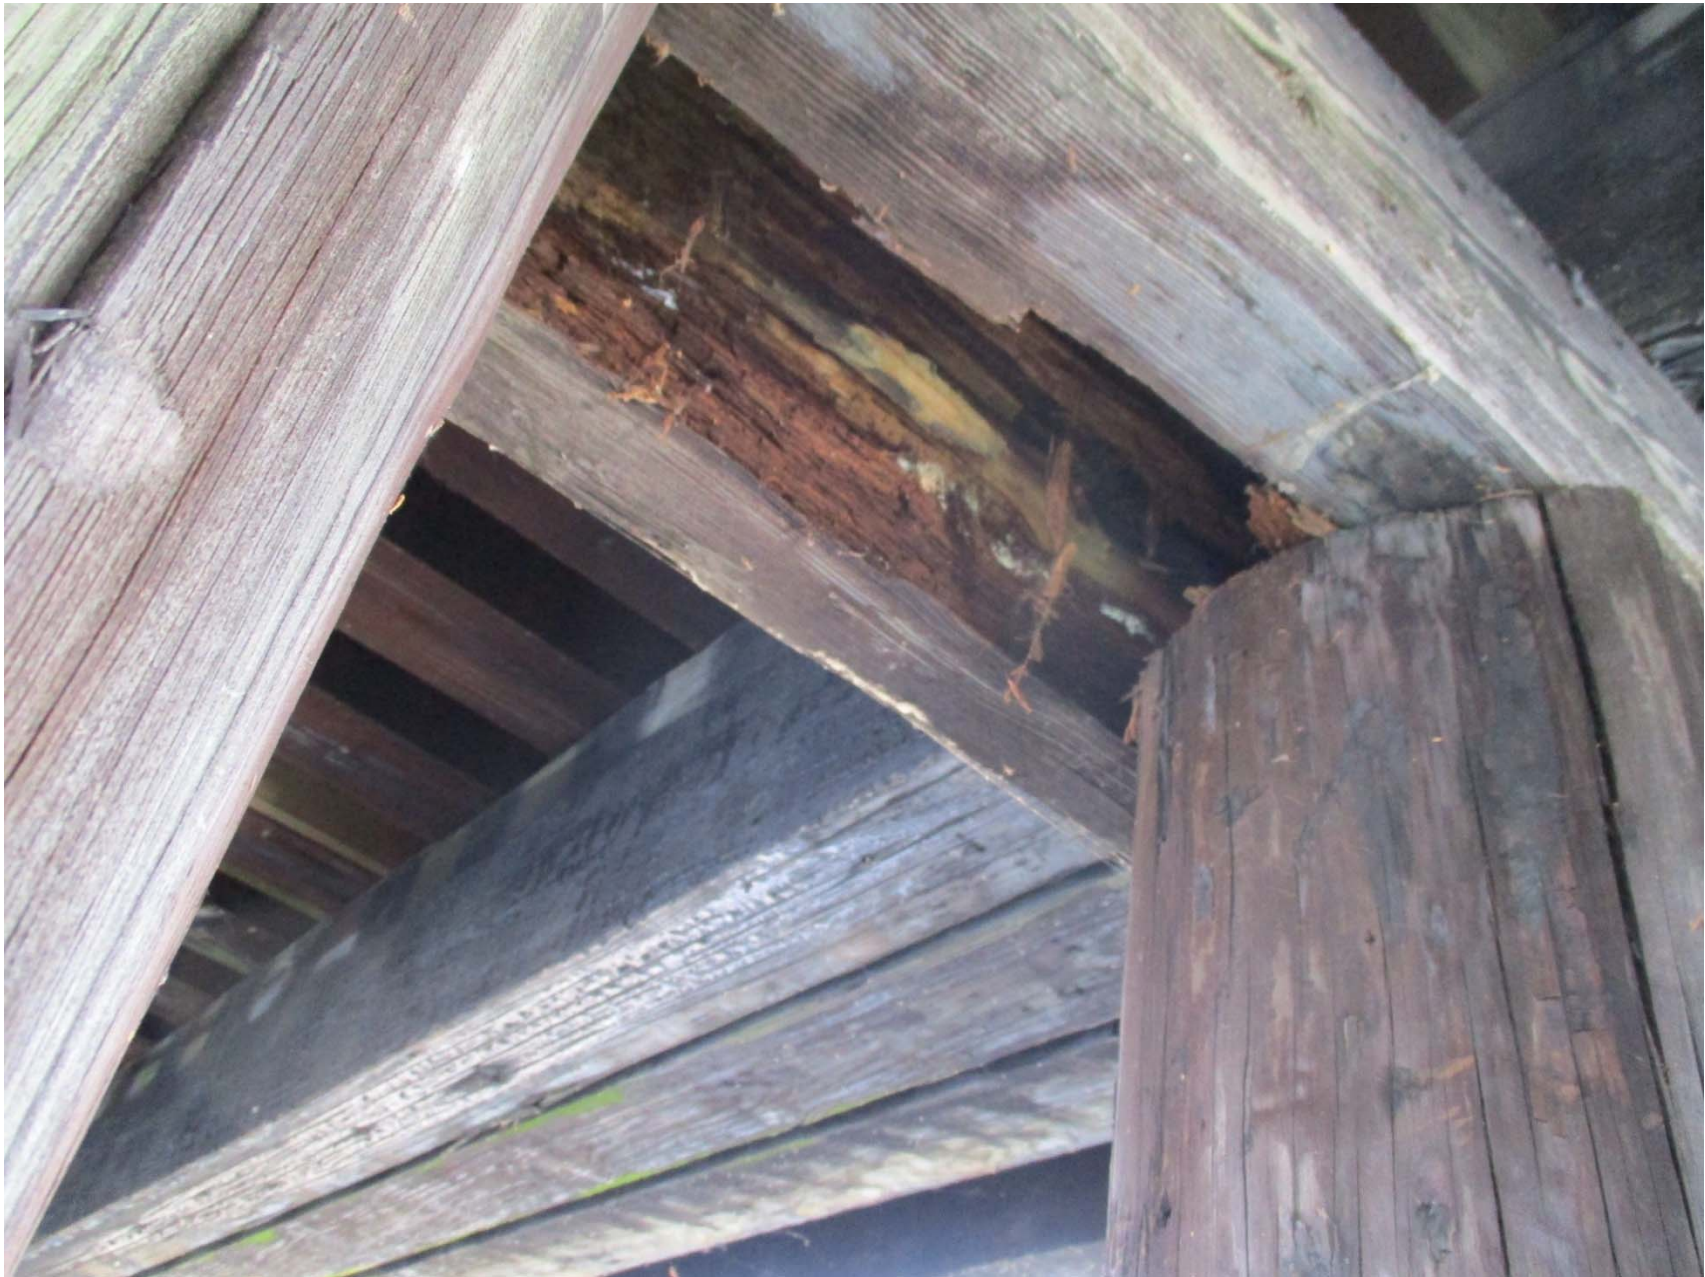
Pier 3S cap internal rot with fungus growth

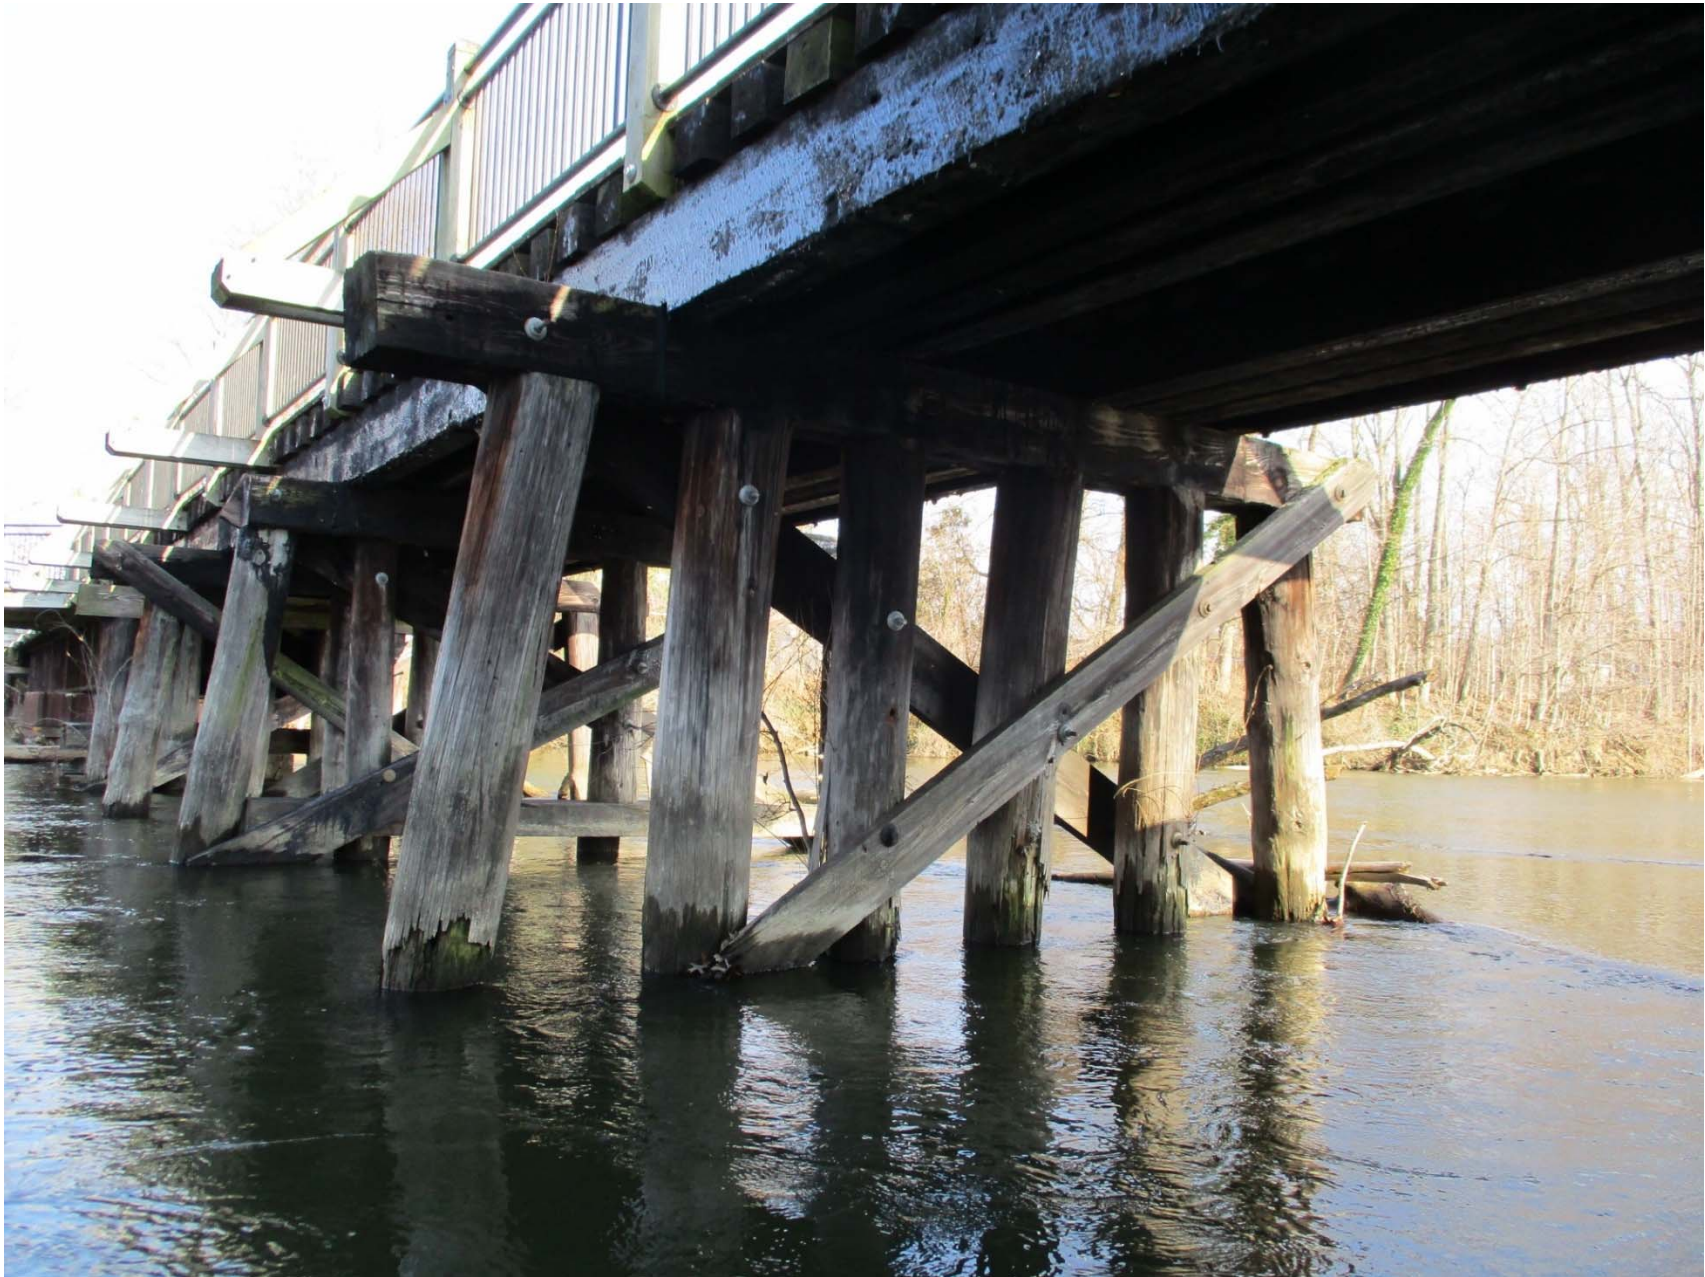
Pier 4S surface to piles at waterline
