SUBJECT: Jaycee Park Pedestrian Bridge Inspection

A detailed inspection of the old railroad trestle in Jaycee Park over the Kalamazoo River in the City of Allegan was completed on December 8, 2023. Enclosed is a copy of the report and pictures for your bridge files, supplemented with the comments below.

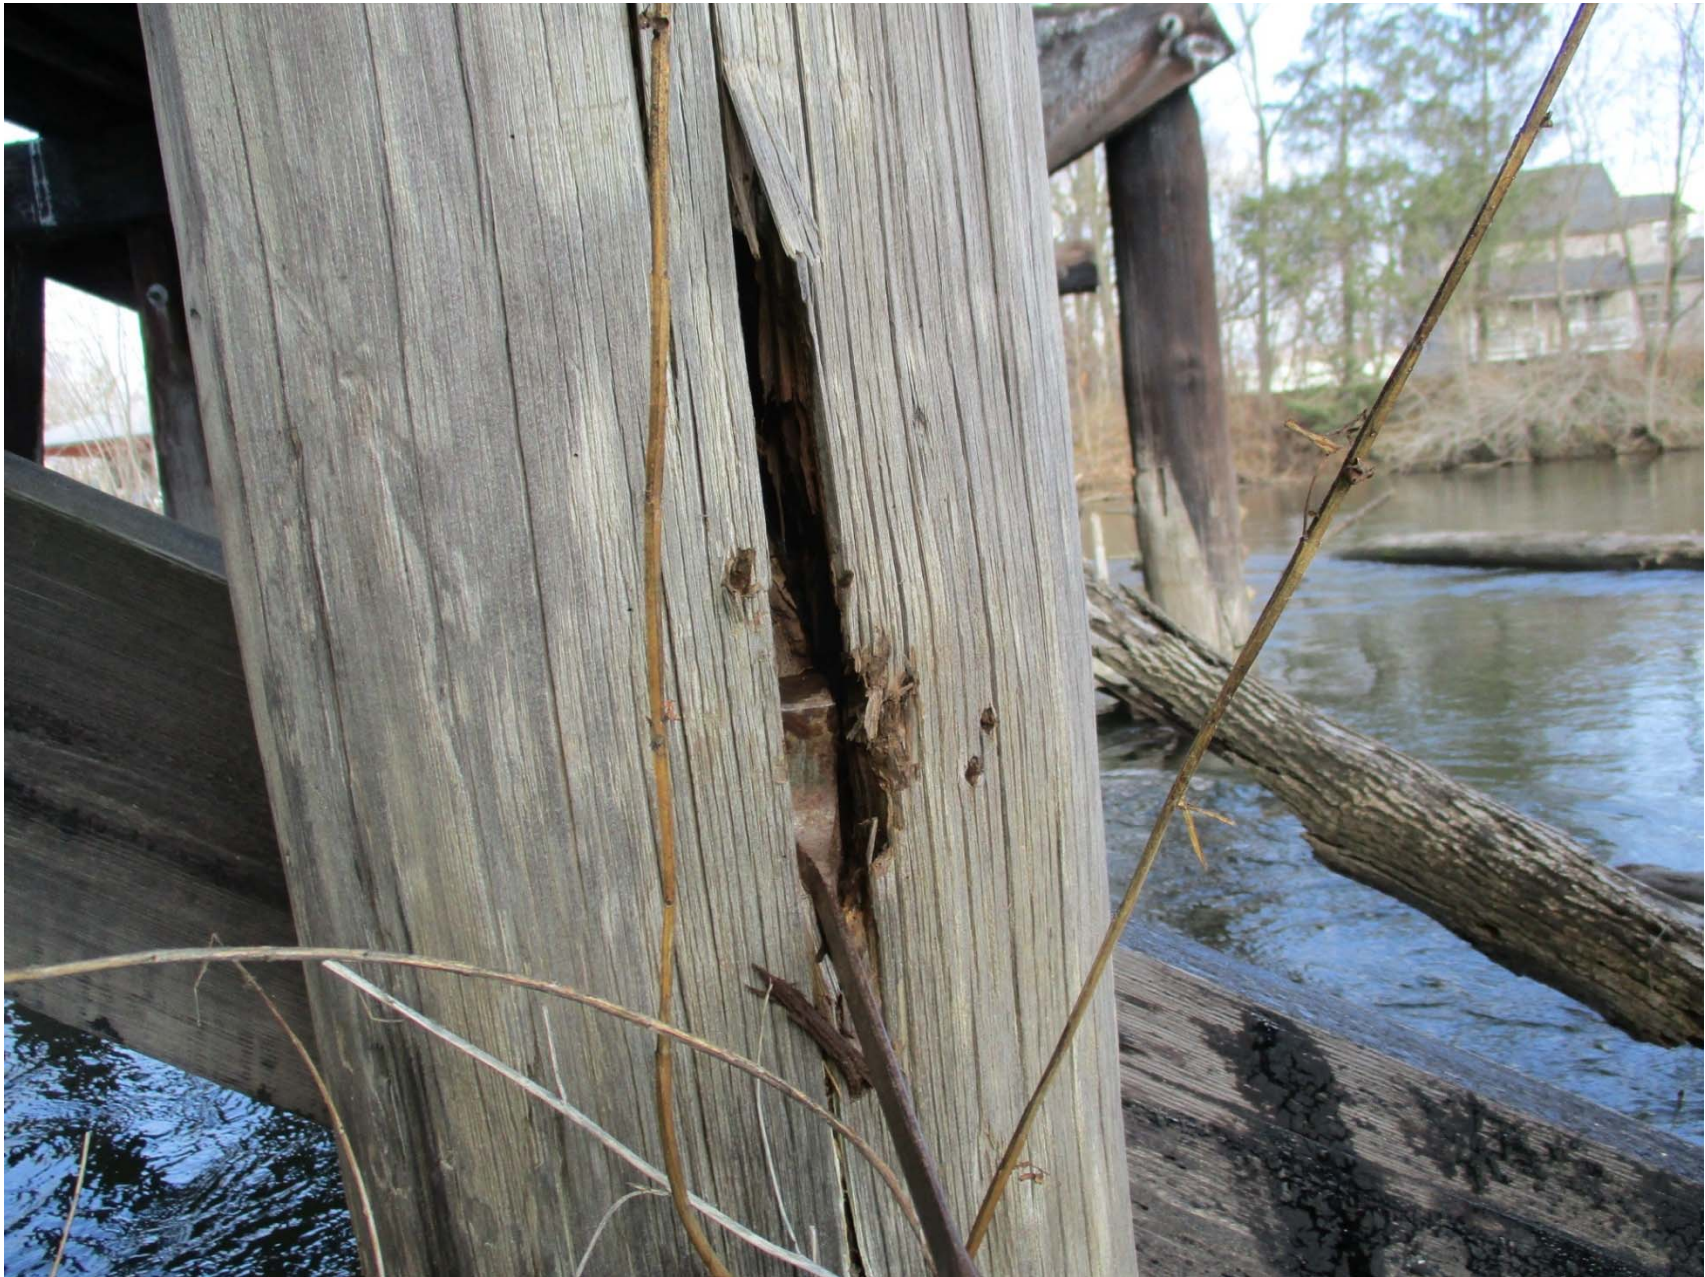
Pier 4S pile 3W internal rot

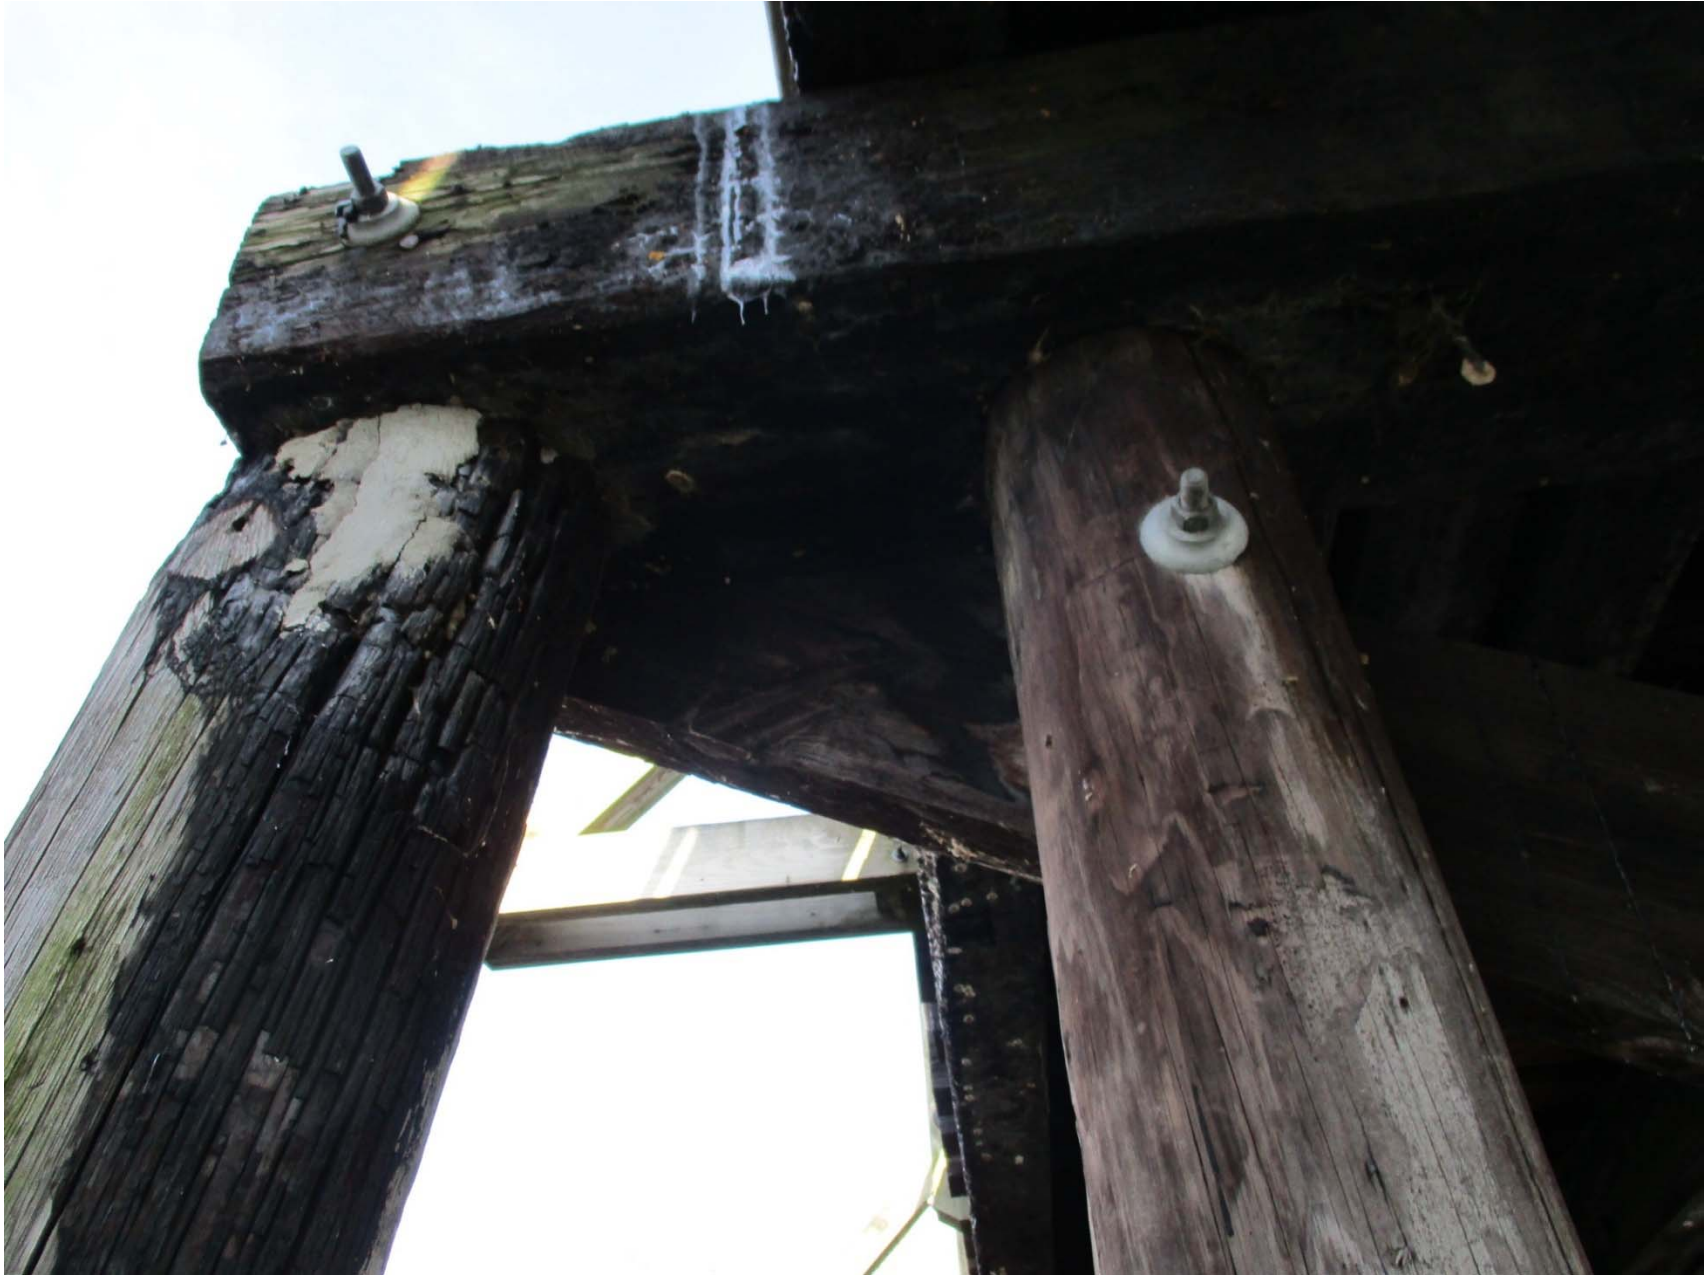
Pier 5S pile 1W has fire damage

Pier 5S: Cap appears in good condition with the presence of creosote remaining. Previous fire damage was noted on Pile 1W with some grout patching at the cap, and internal rot at the water line. Pile 1E has a bolted splice, the lower west side portion is nearly rotted through. The main support for piles 2 & 3E are underwater and not visible.

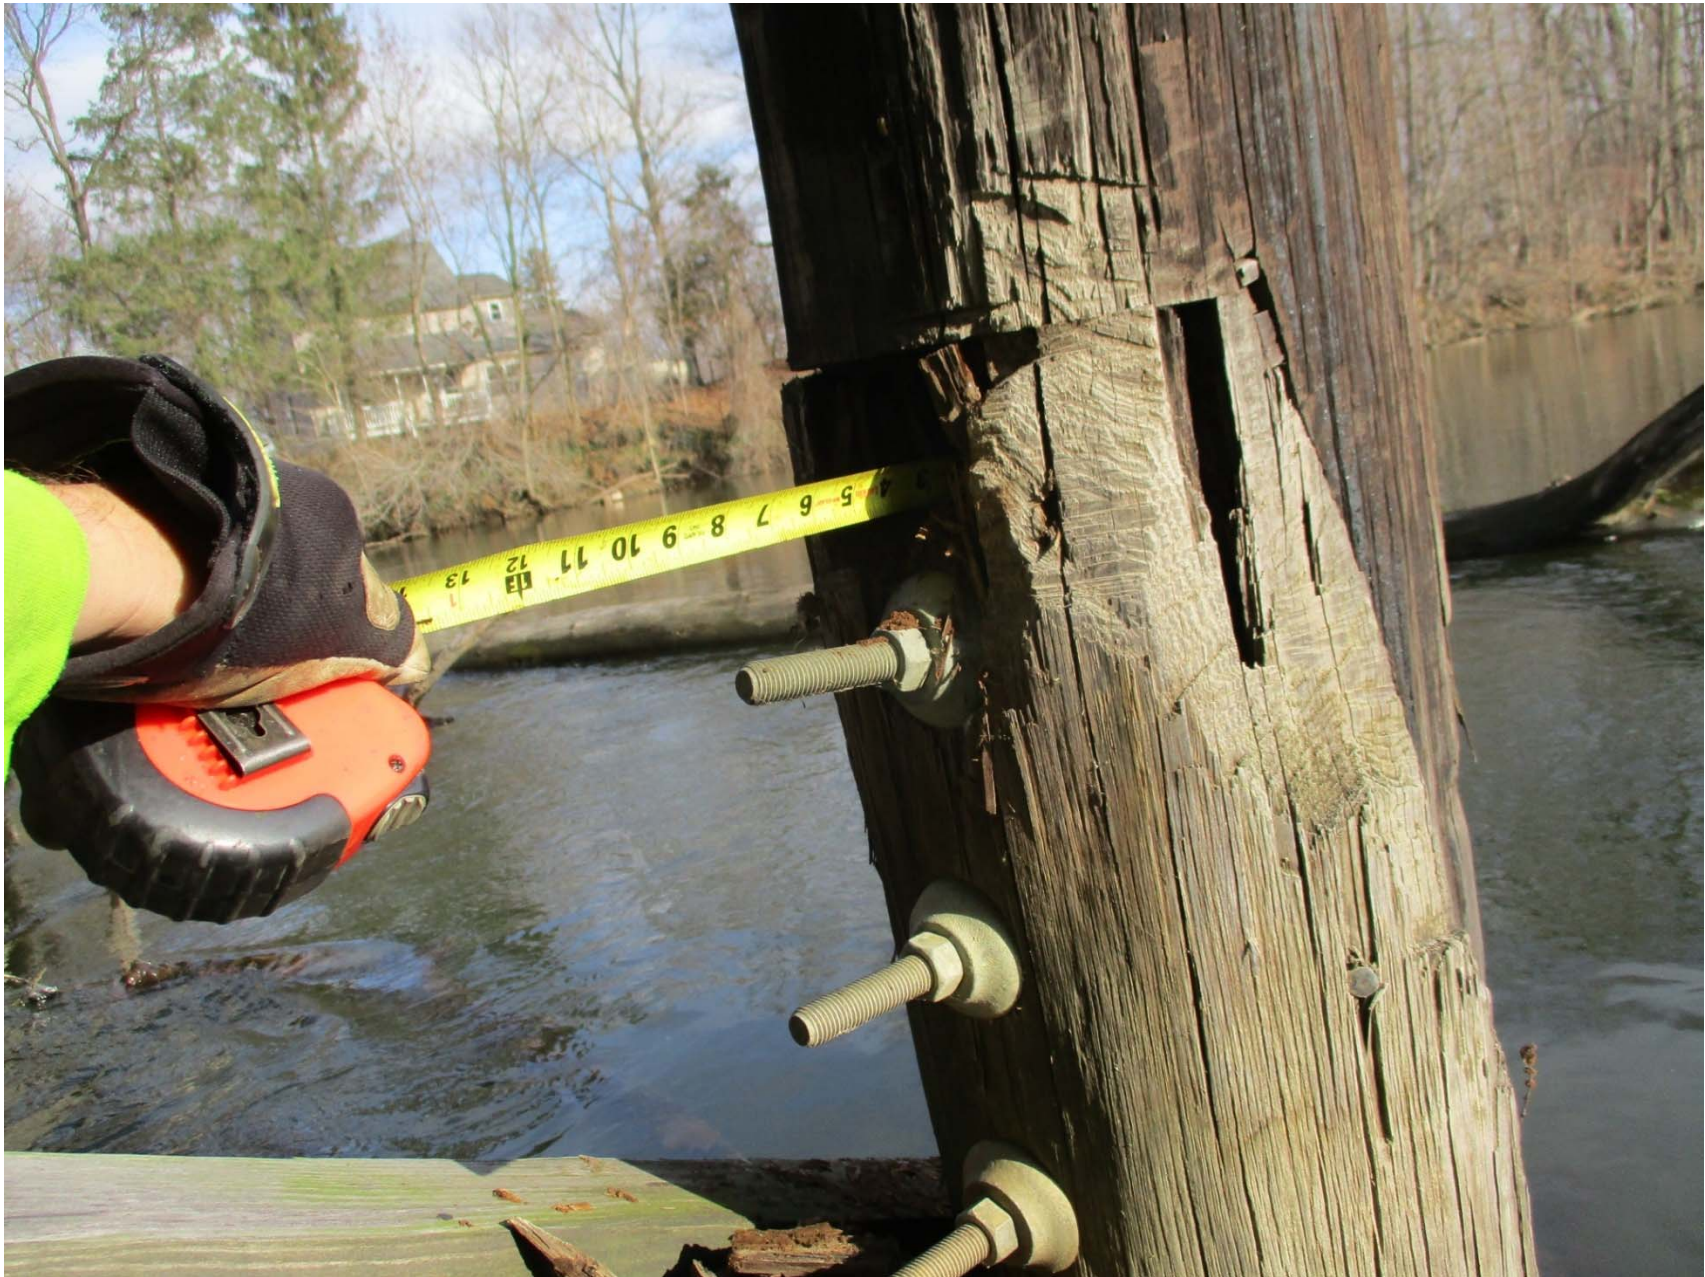
Pier 5S pile 1E lower west half rotted

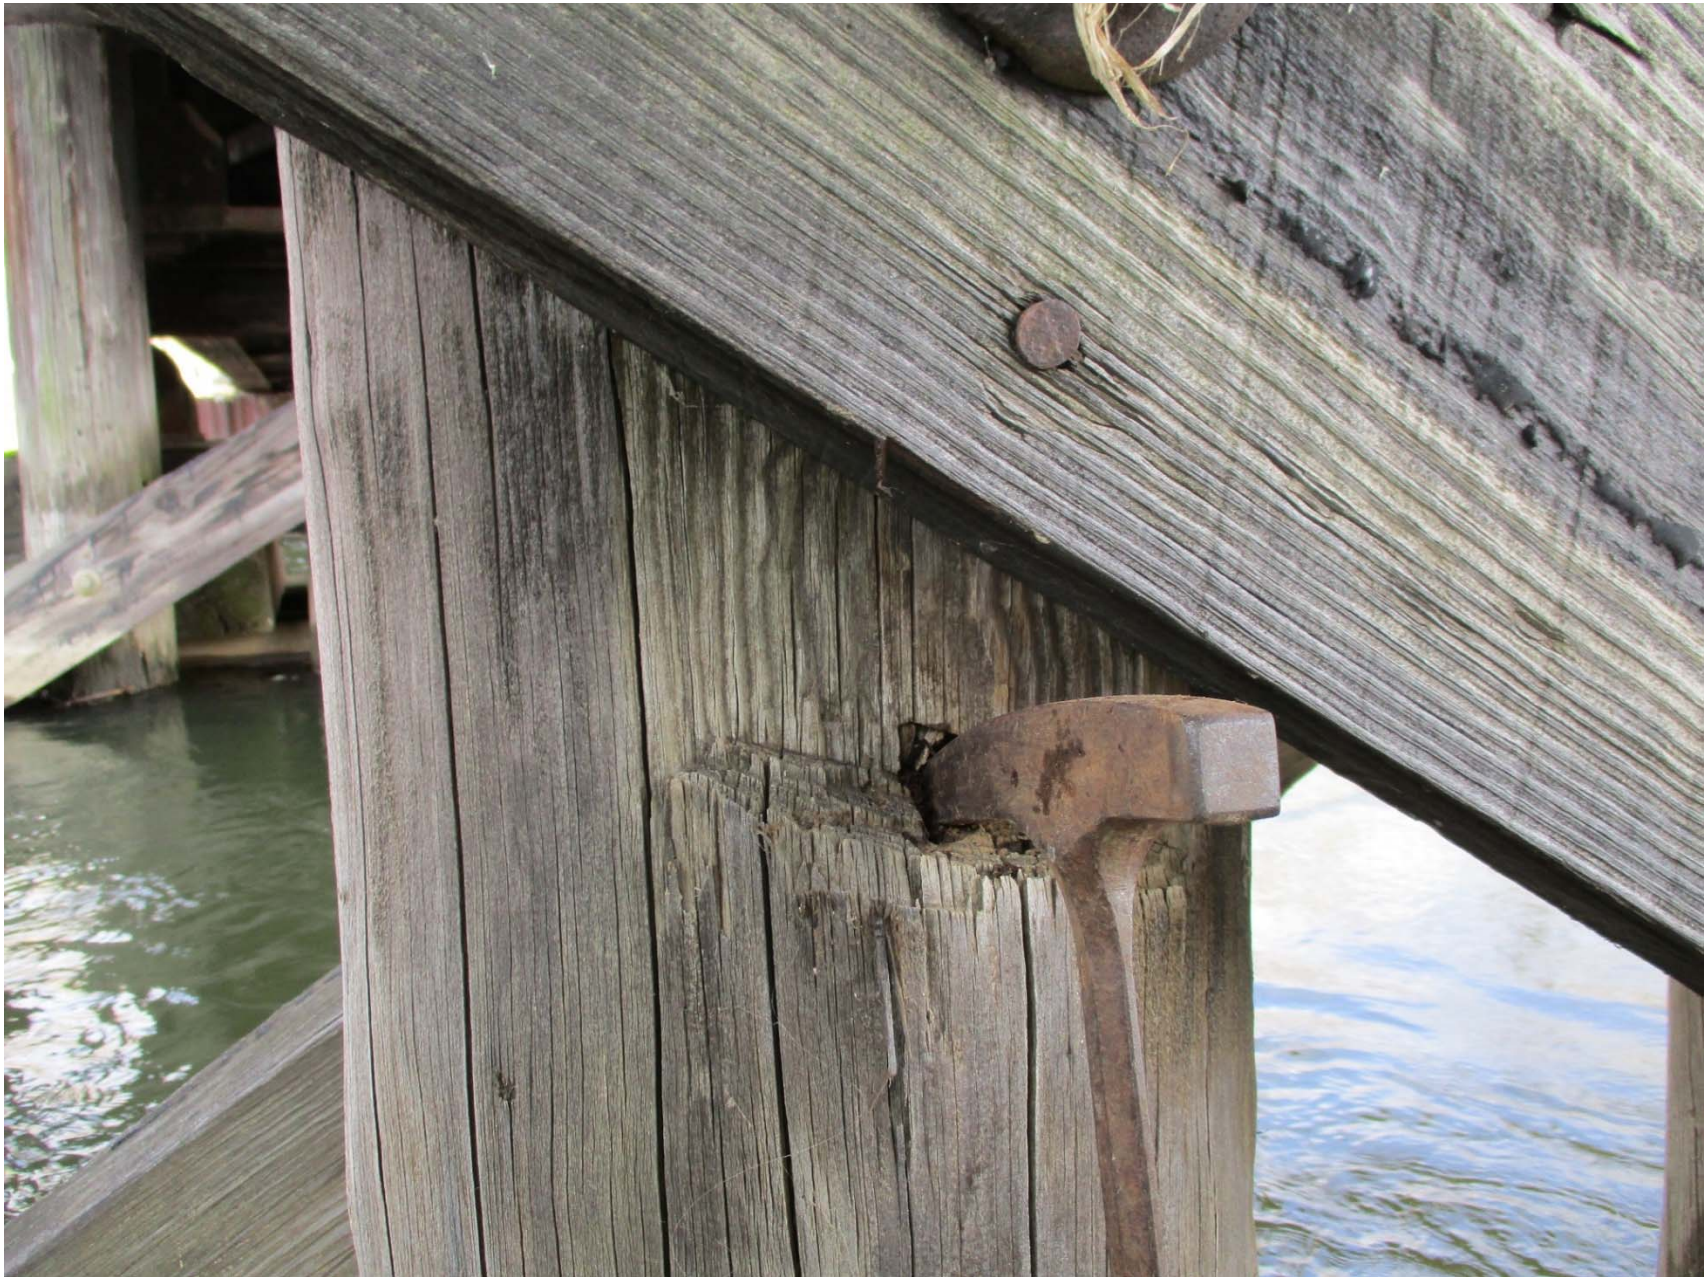
Pier 6S pile 3W has some internal rot

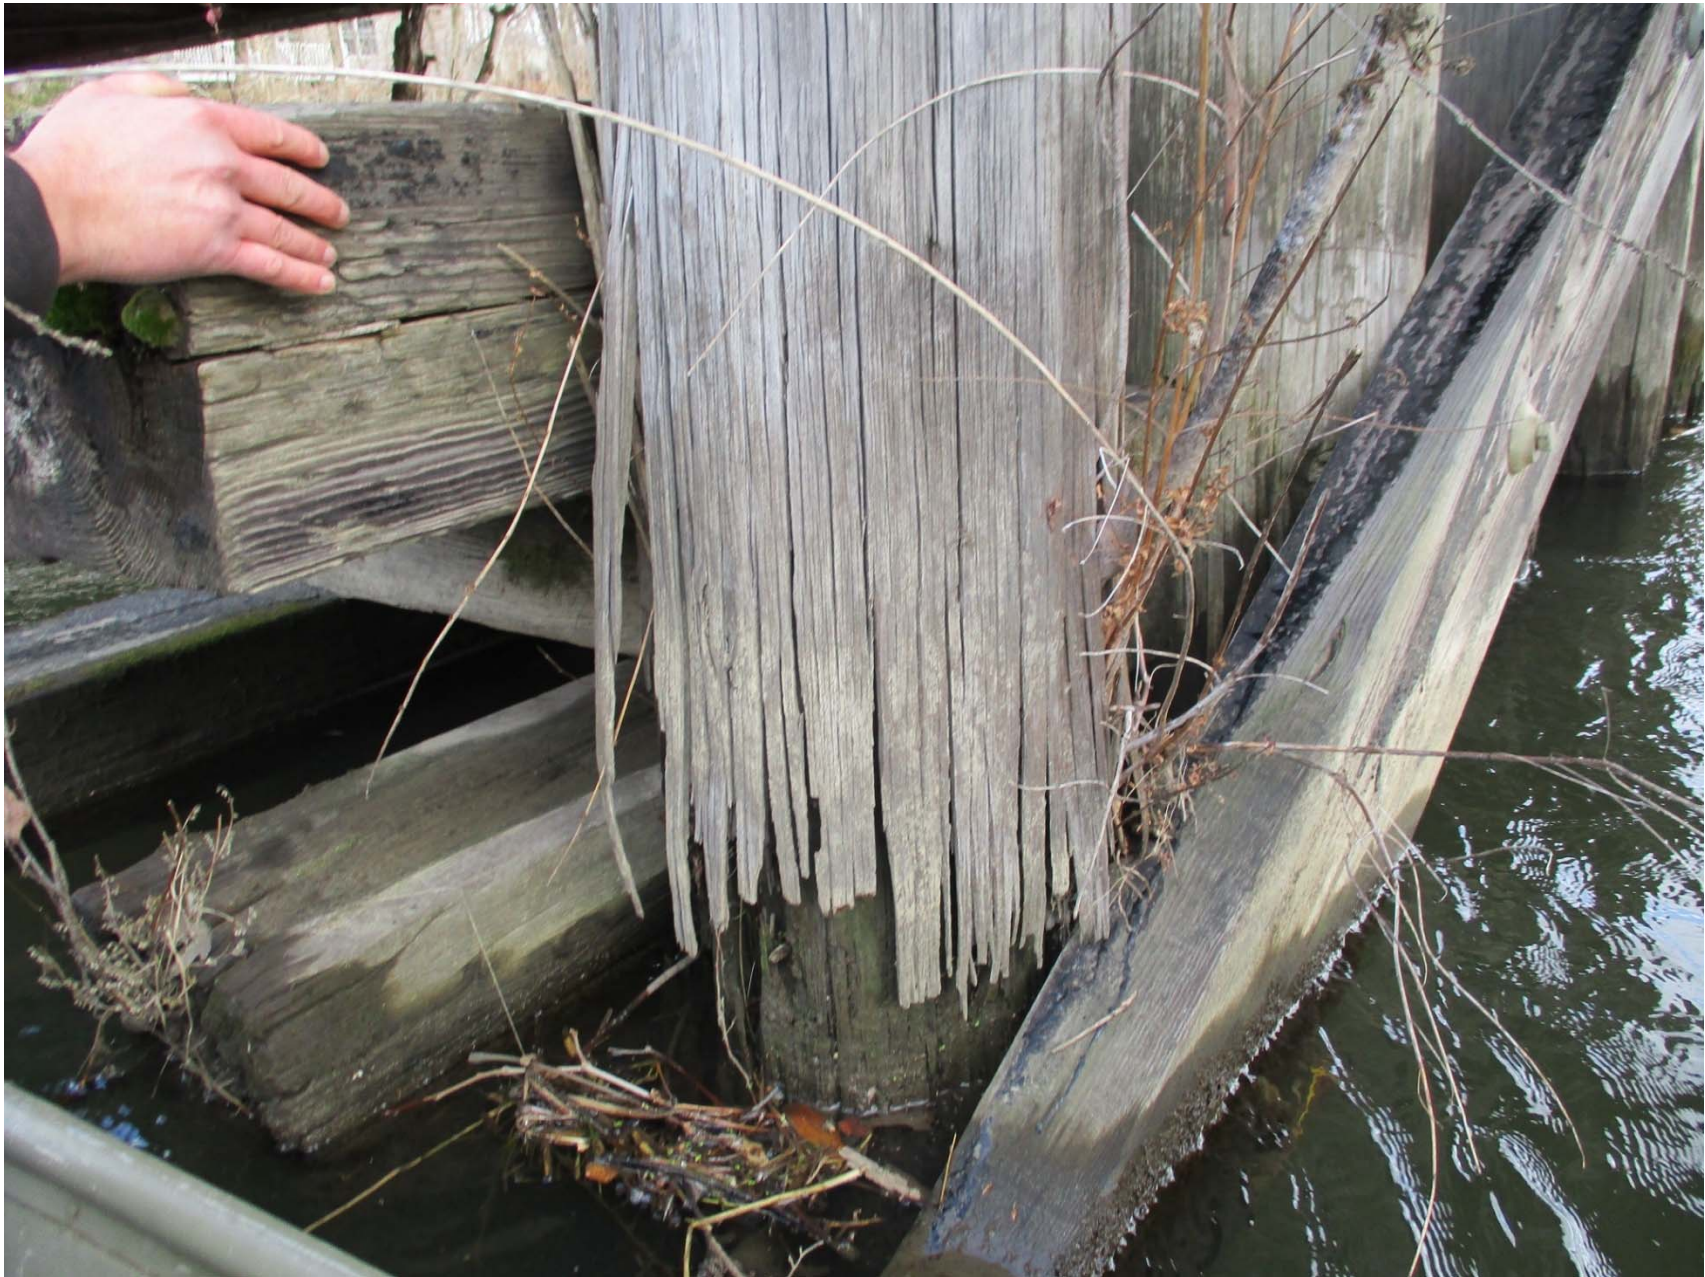
Pier 7S pile rot at water line

Pier 7S: Top portion of the cap is rotted along east half, about 3" deep. Pile 1E has 90% section loss to top portion with vegetation growing in the rotted section. Outer 2" or more loss to Piles 1W and 2E at the water surface, 1" to remaining piles. Adjacent timber cribbing holding the south end of the steel girders is rotting and split.

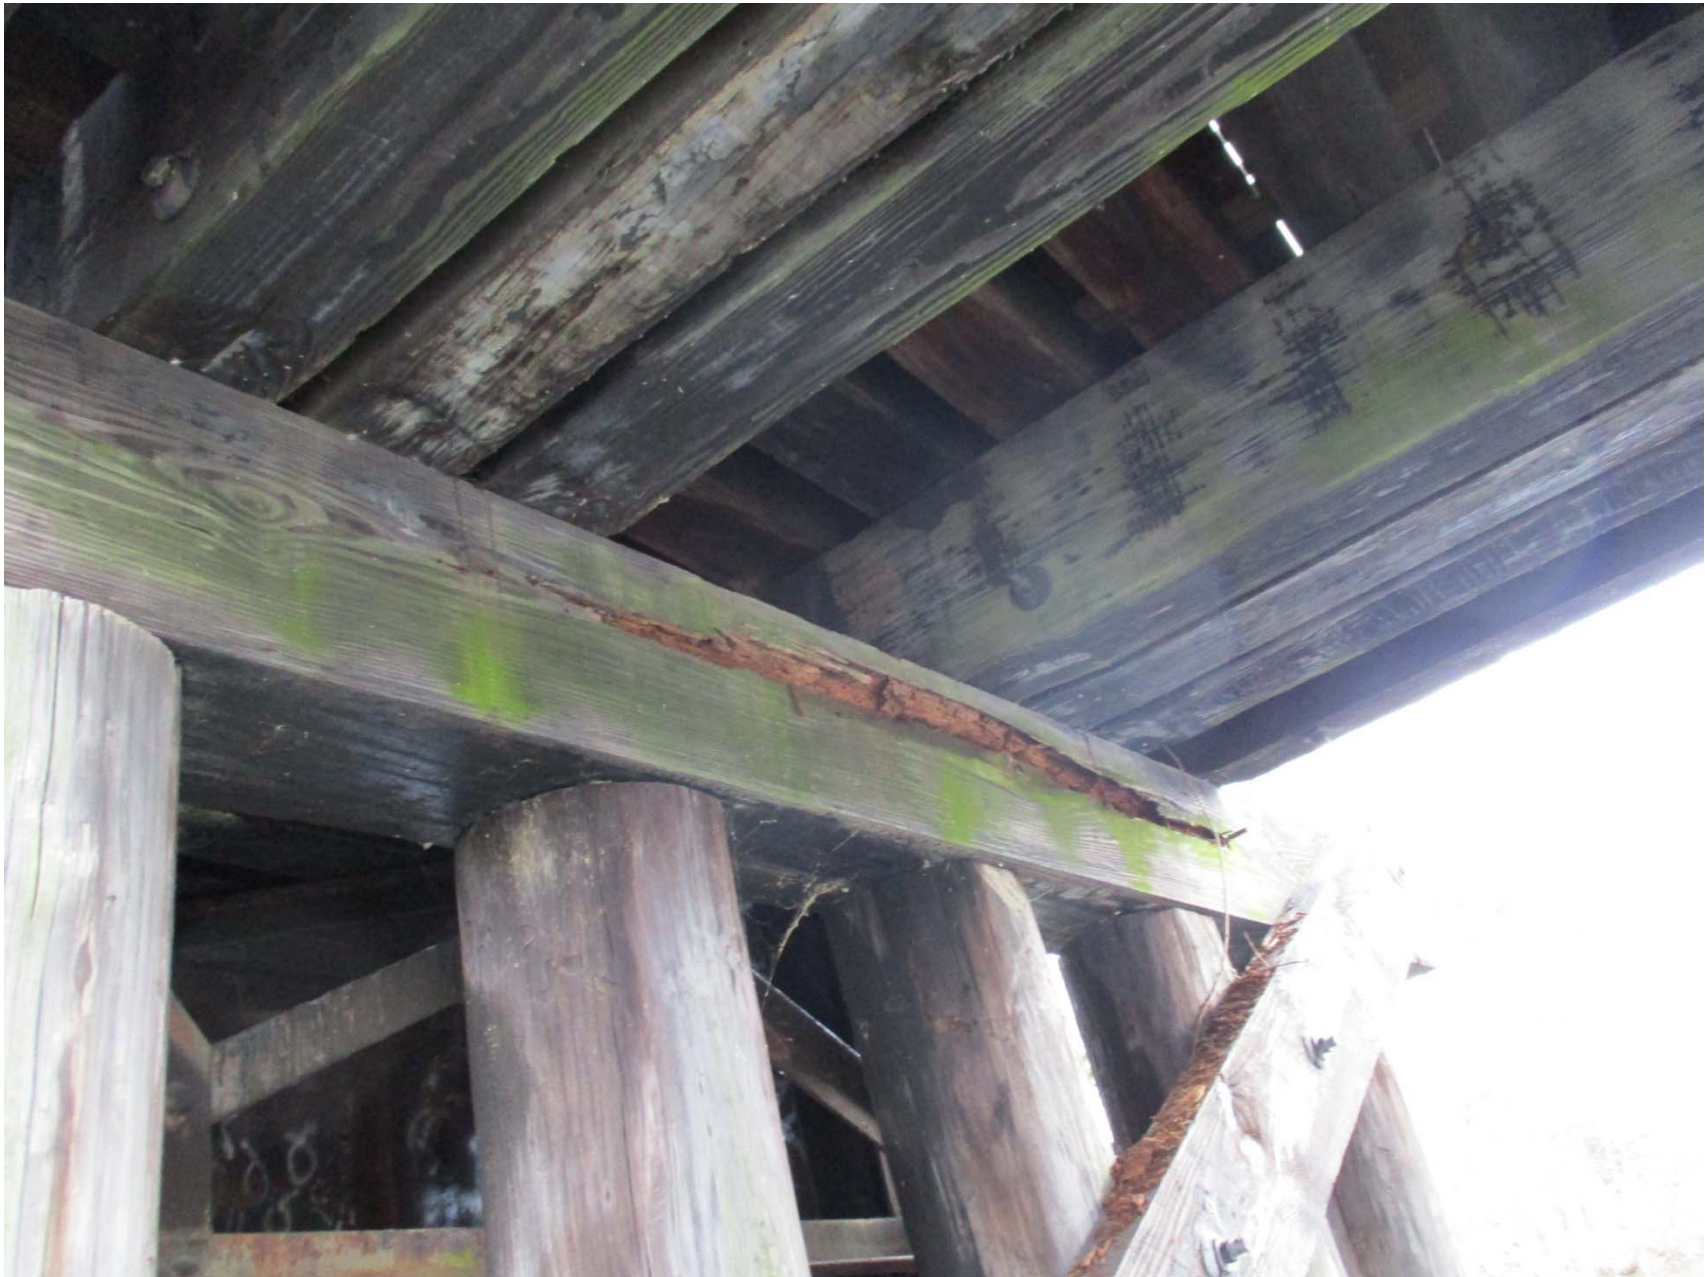
Pier 7S rot along the side 3" deep

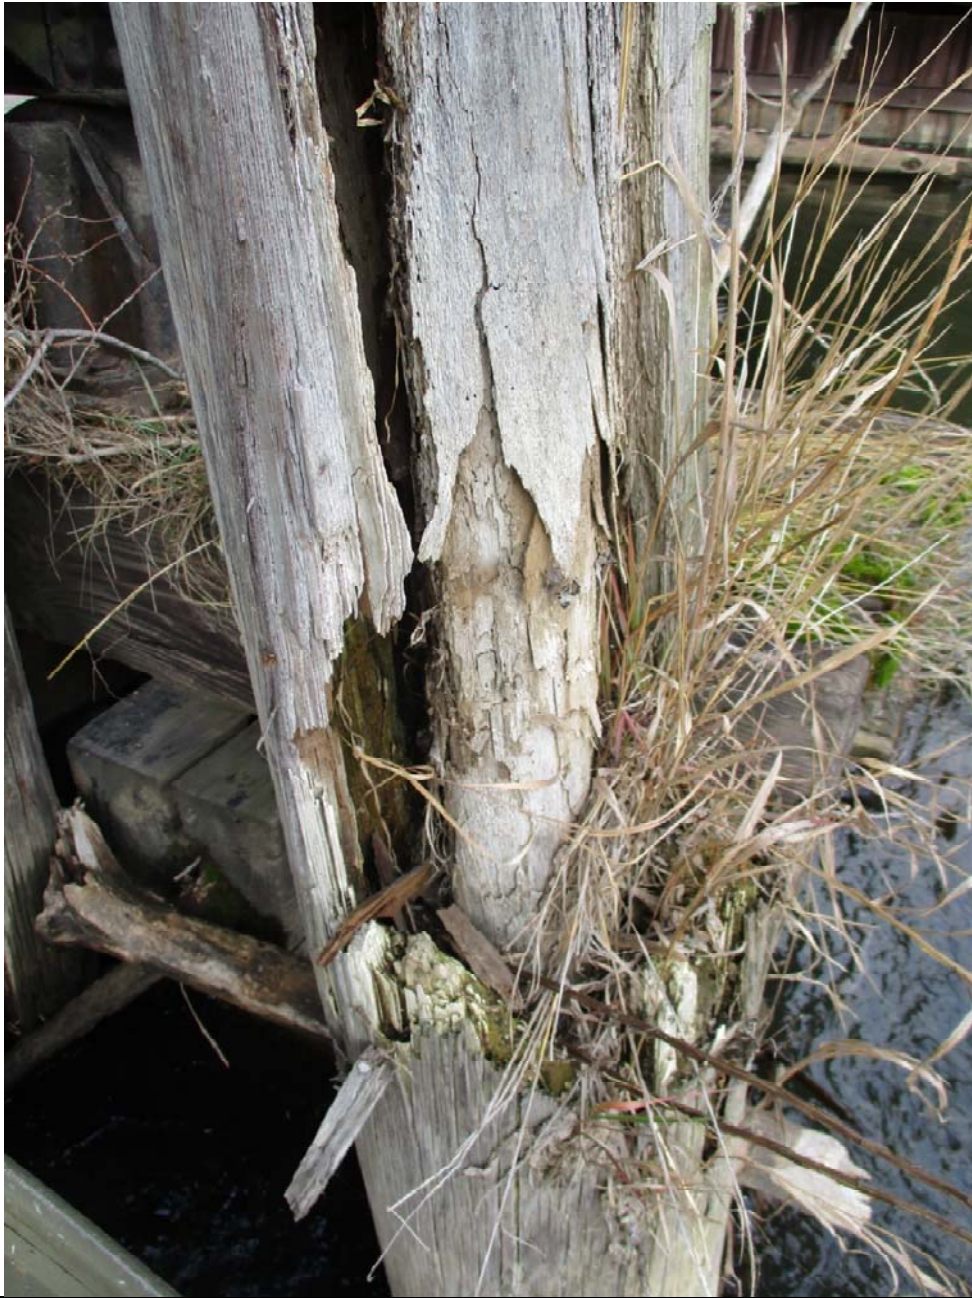
Pier 7S pile 1E nearly rotted through

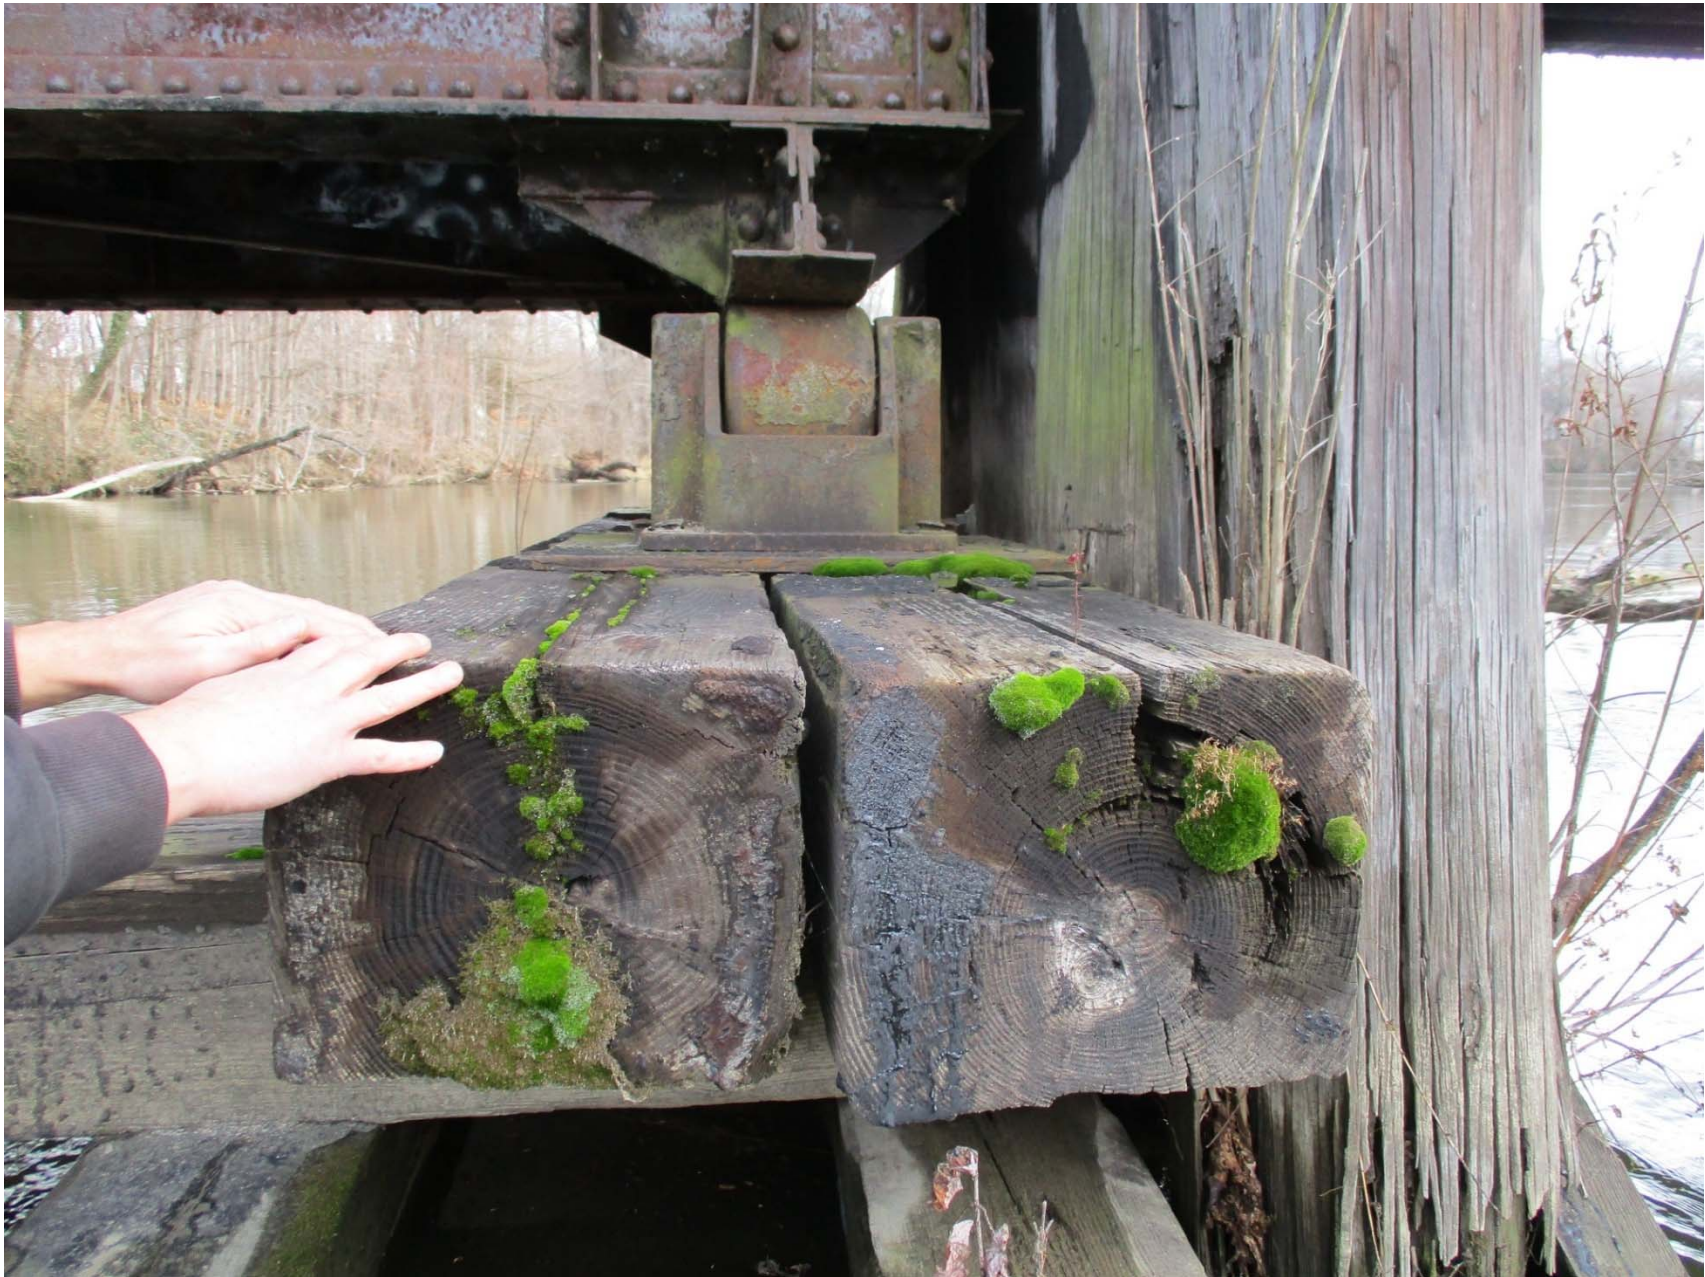
Pier 7S cribbing split with rot

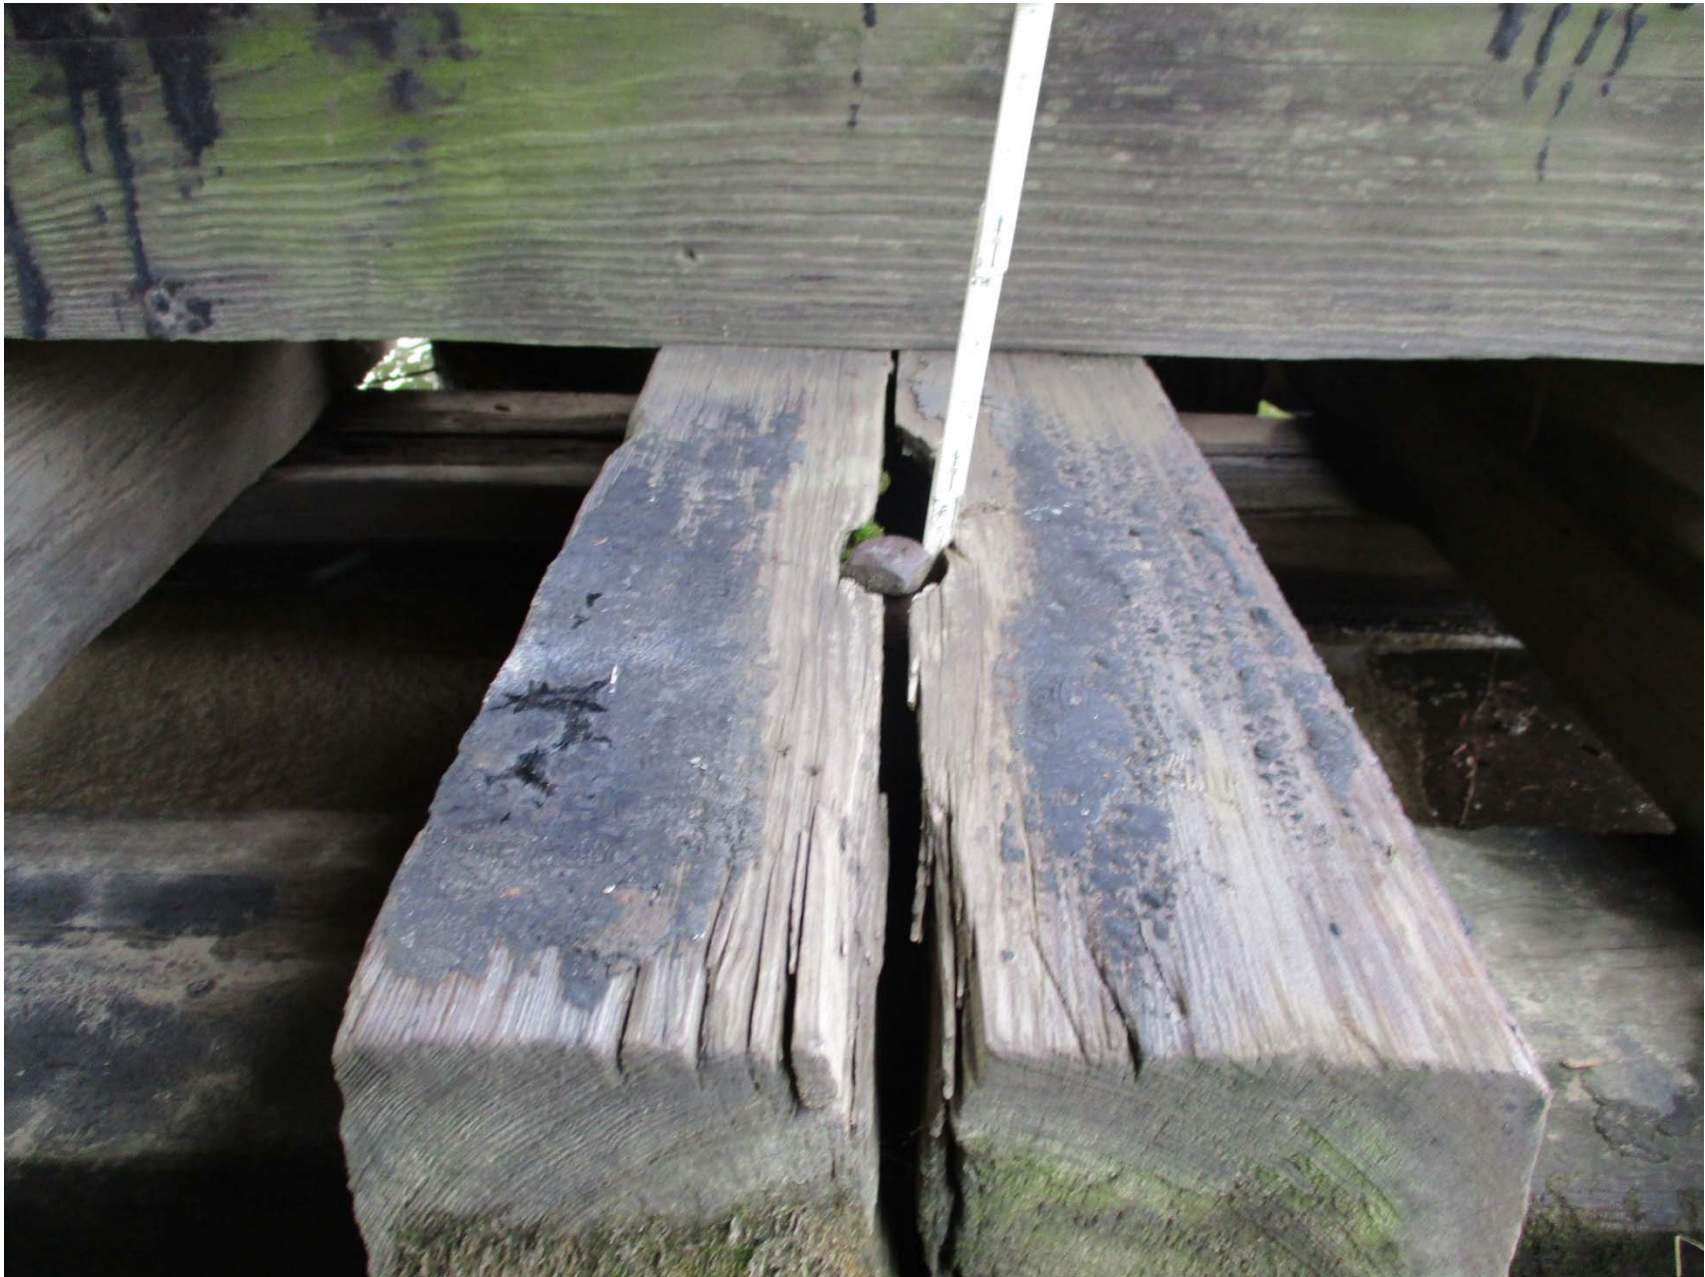
Pier 7S cribbing split with rot, west end

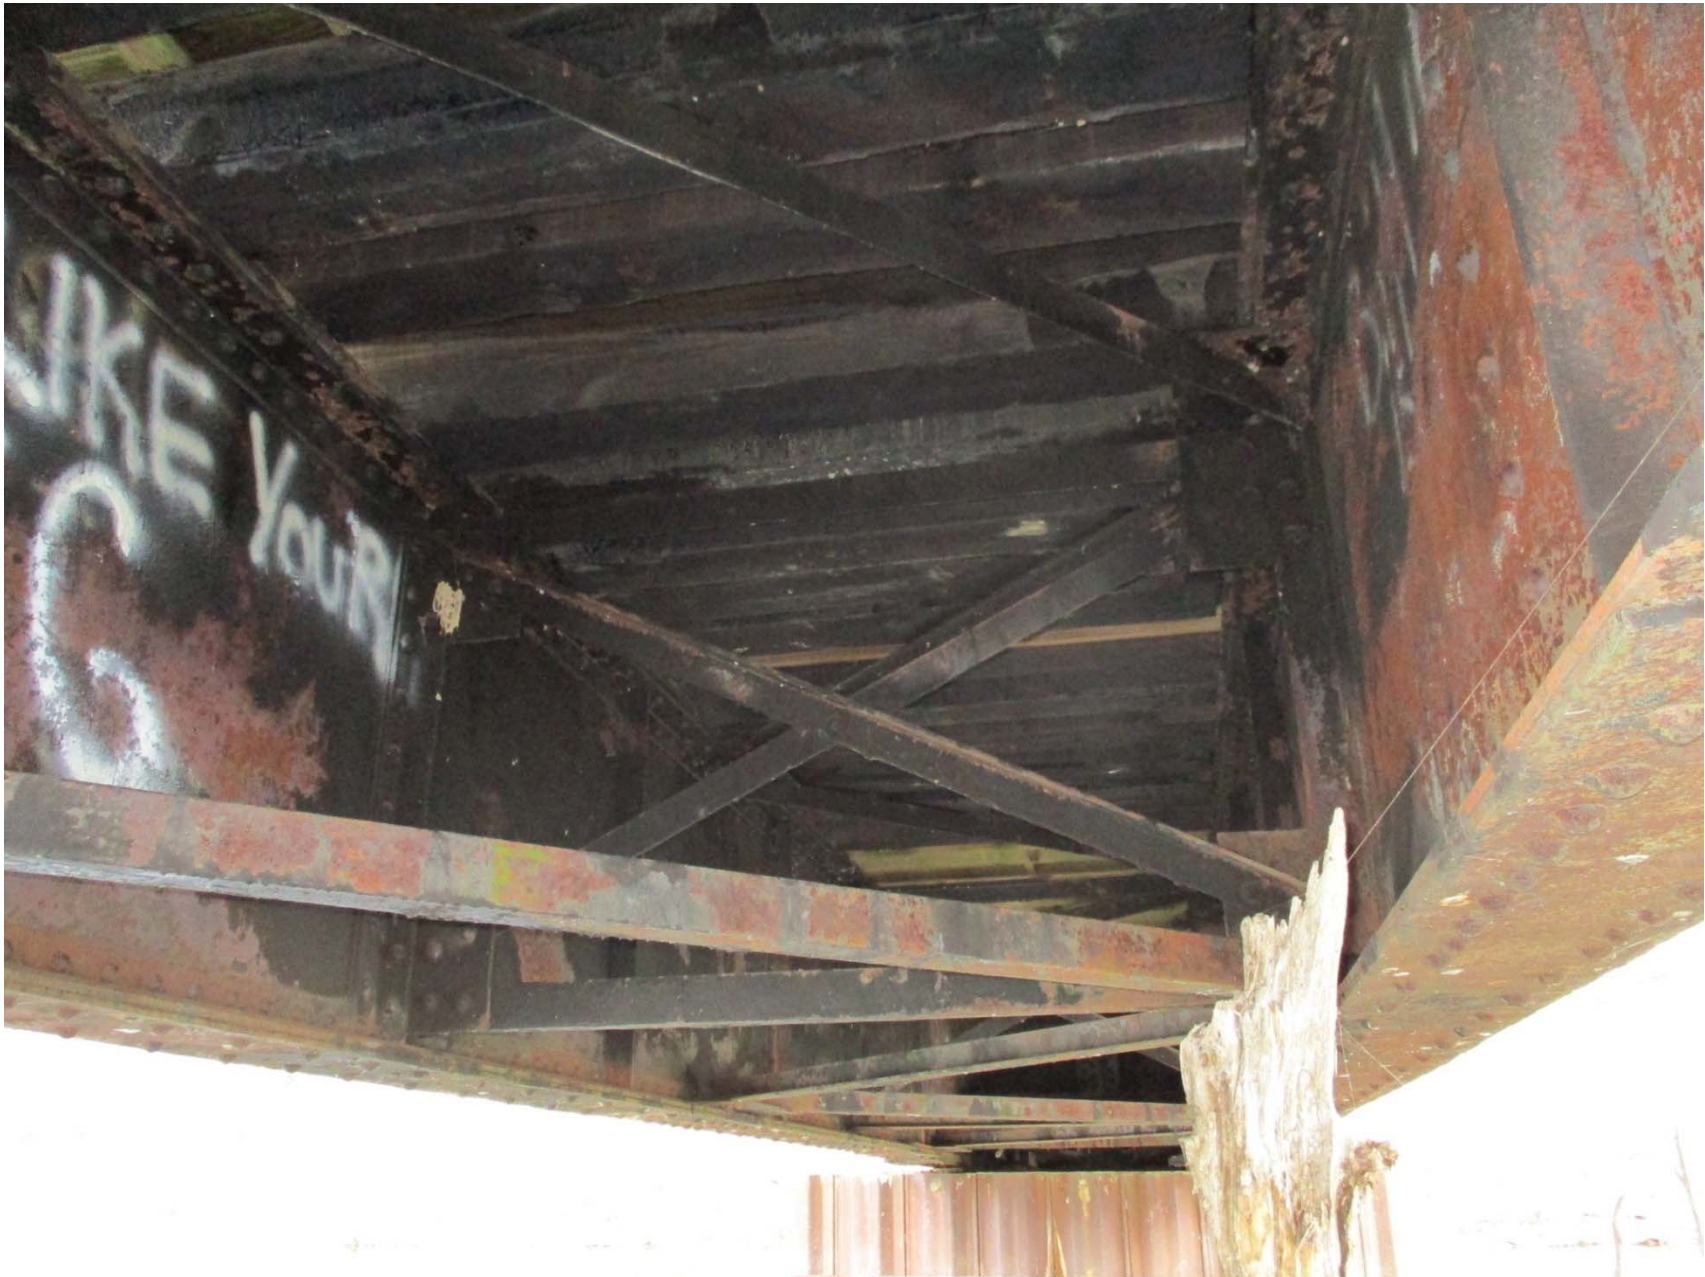
Light rust to steel beams and bracing

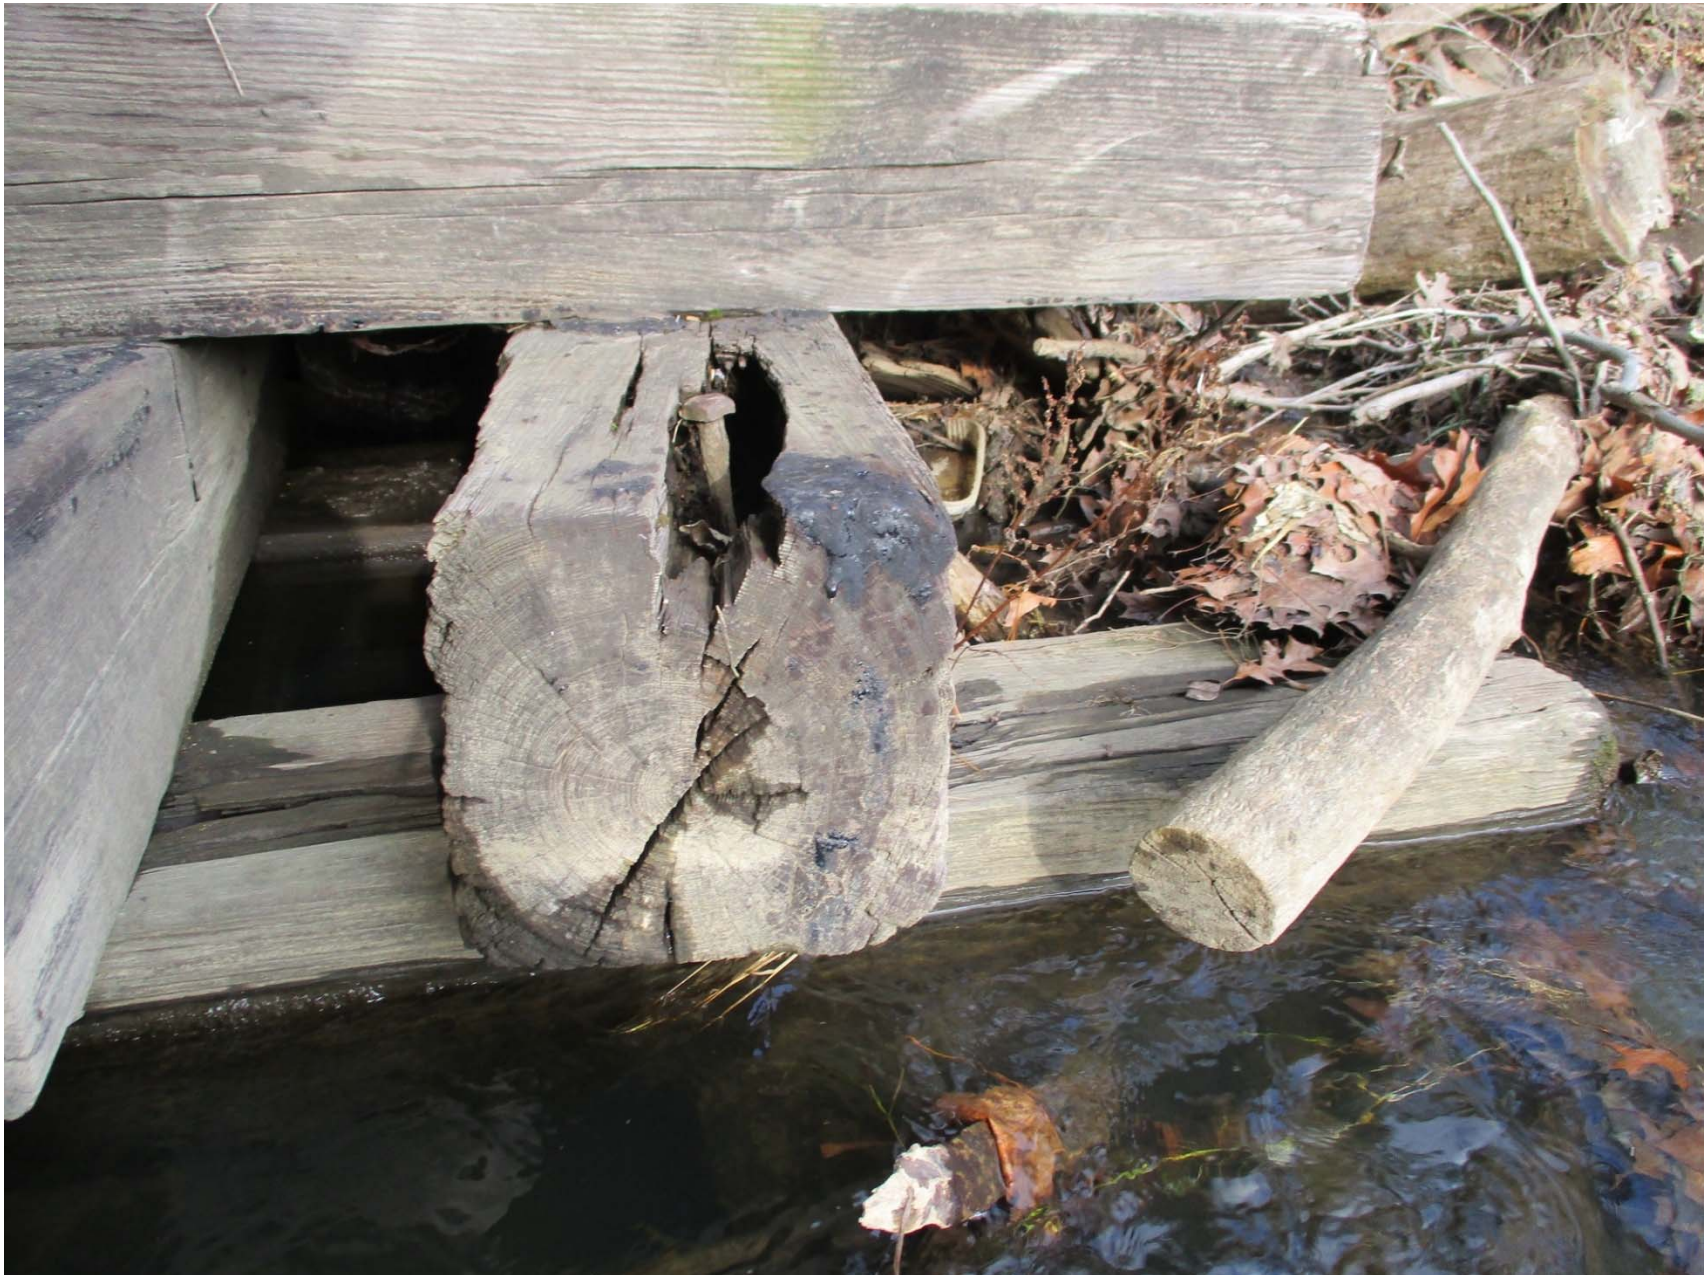
Pier 9S north end cribbing rotted
