SUBJECT: Jaycee Park Pedestrian Bridge Inspection

A detailed inspection of the old railroad trestle in Jaycee Park over the Kalamazoo River in the City of Allegan was completed on December 8, 2023. Enclosed is a copy of the report and pictures for your bridge files, supplemented with the comments below.

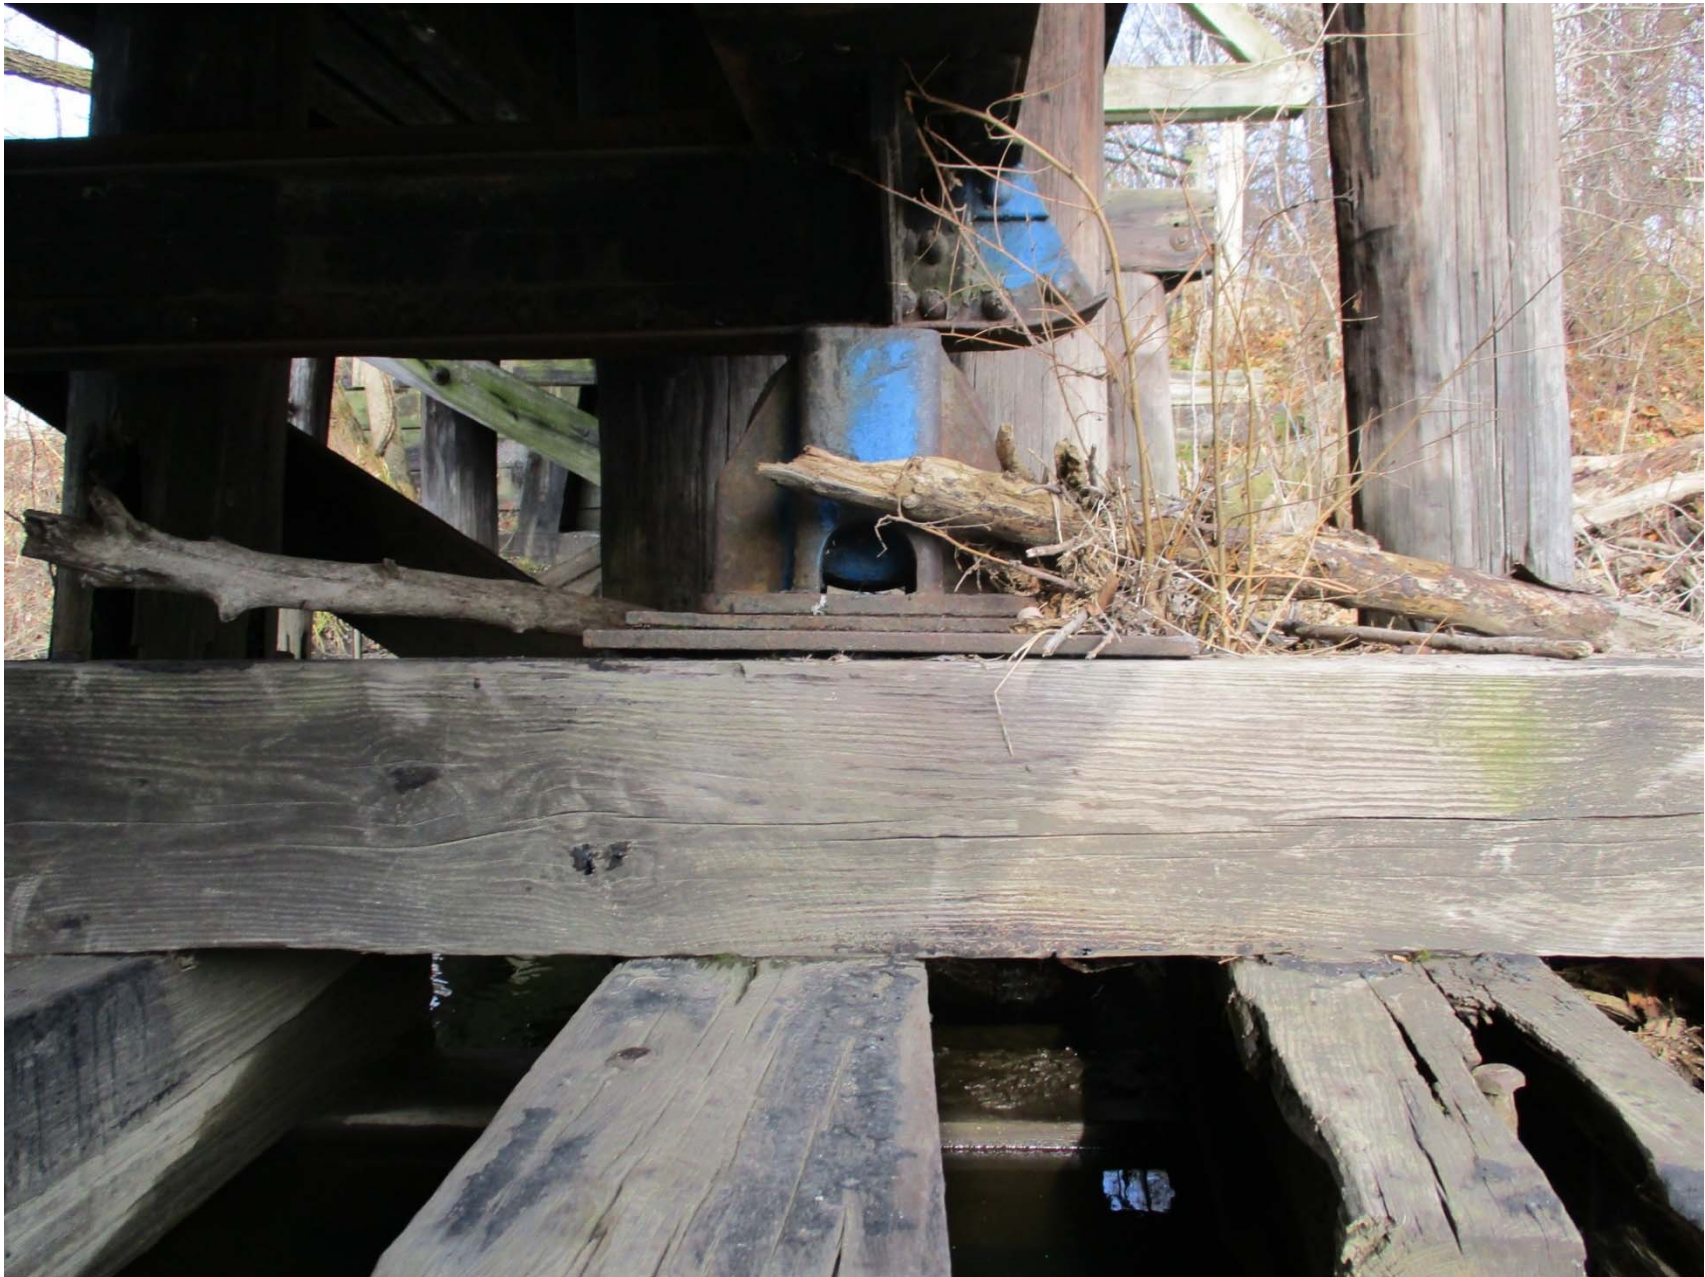
Gap between east bearing plates and cribbing at pier 9S

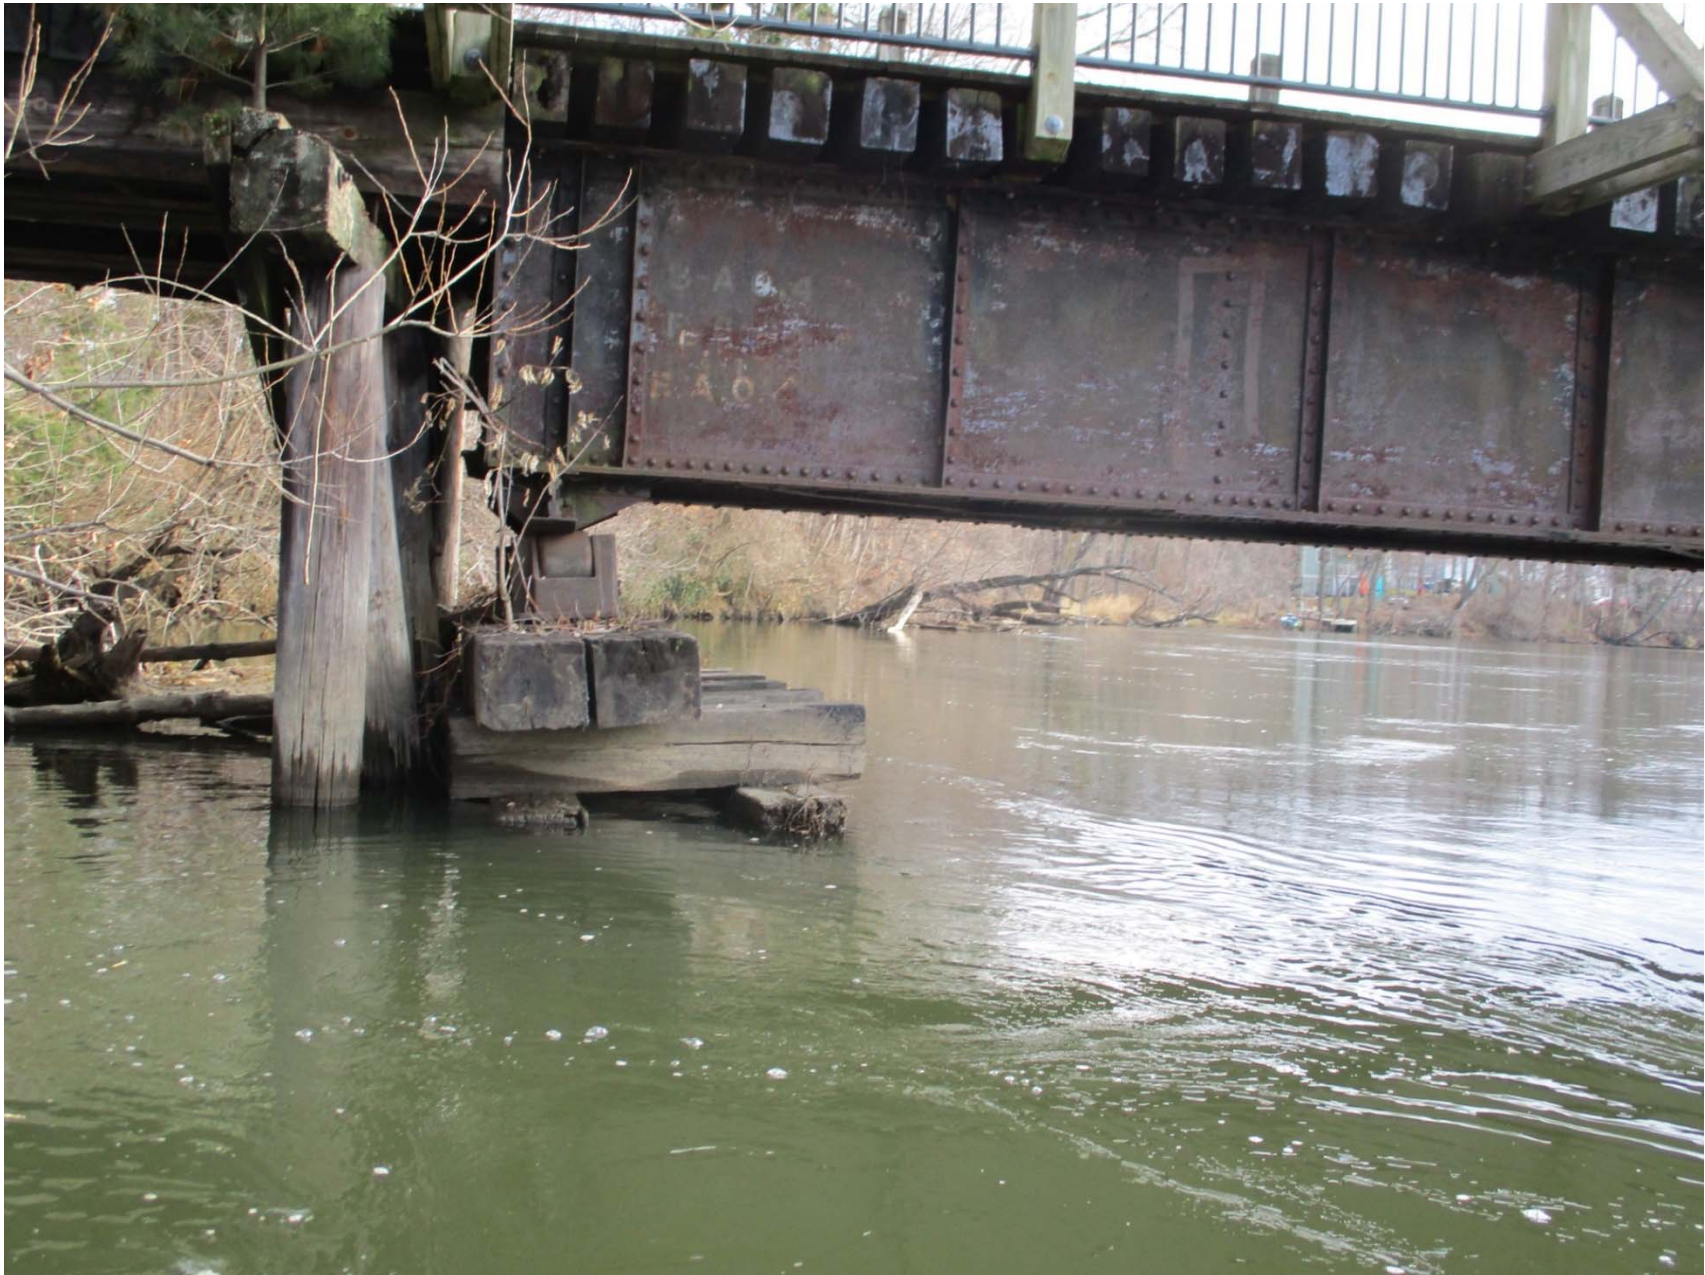
Pier 9S cribbing has settled and rotated north

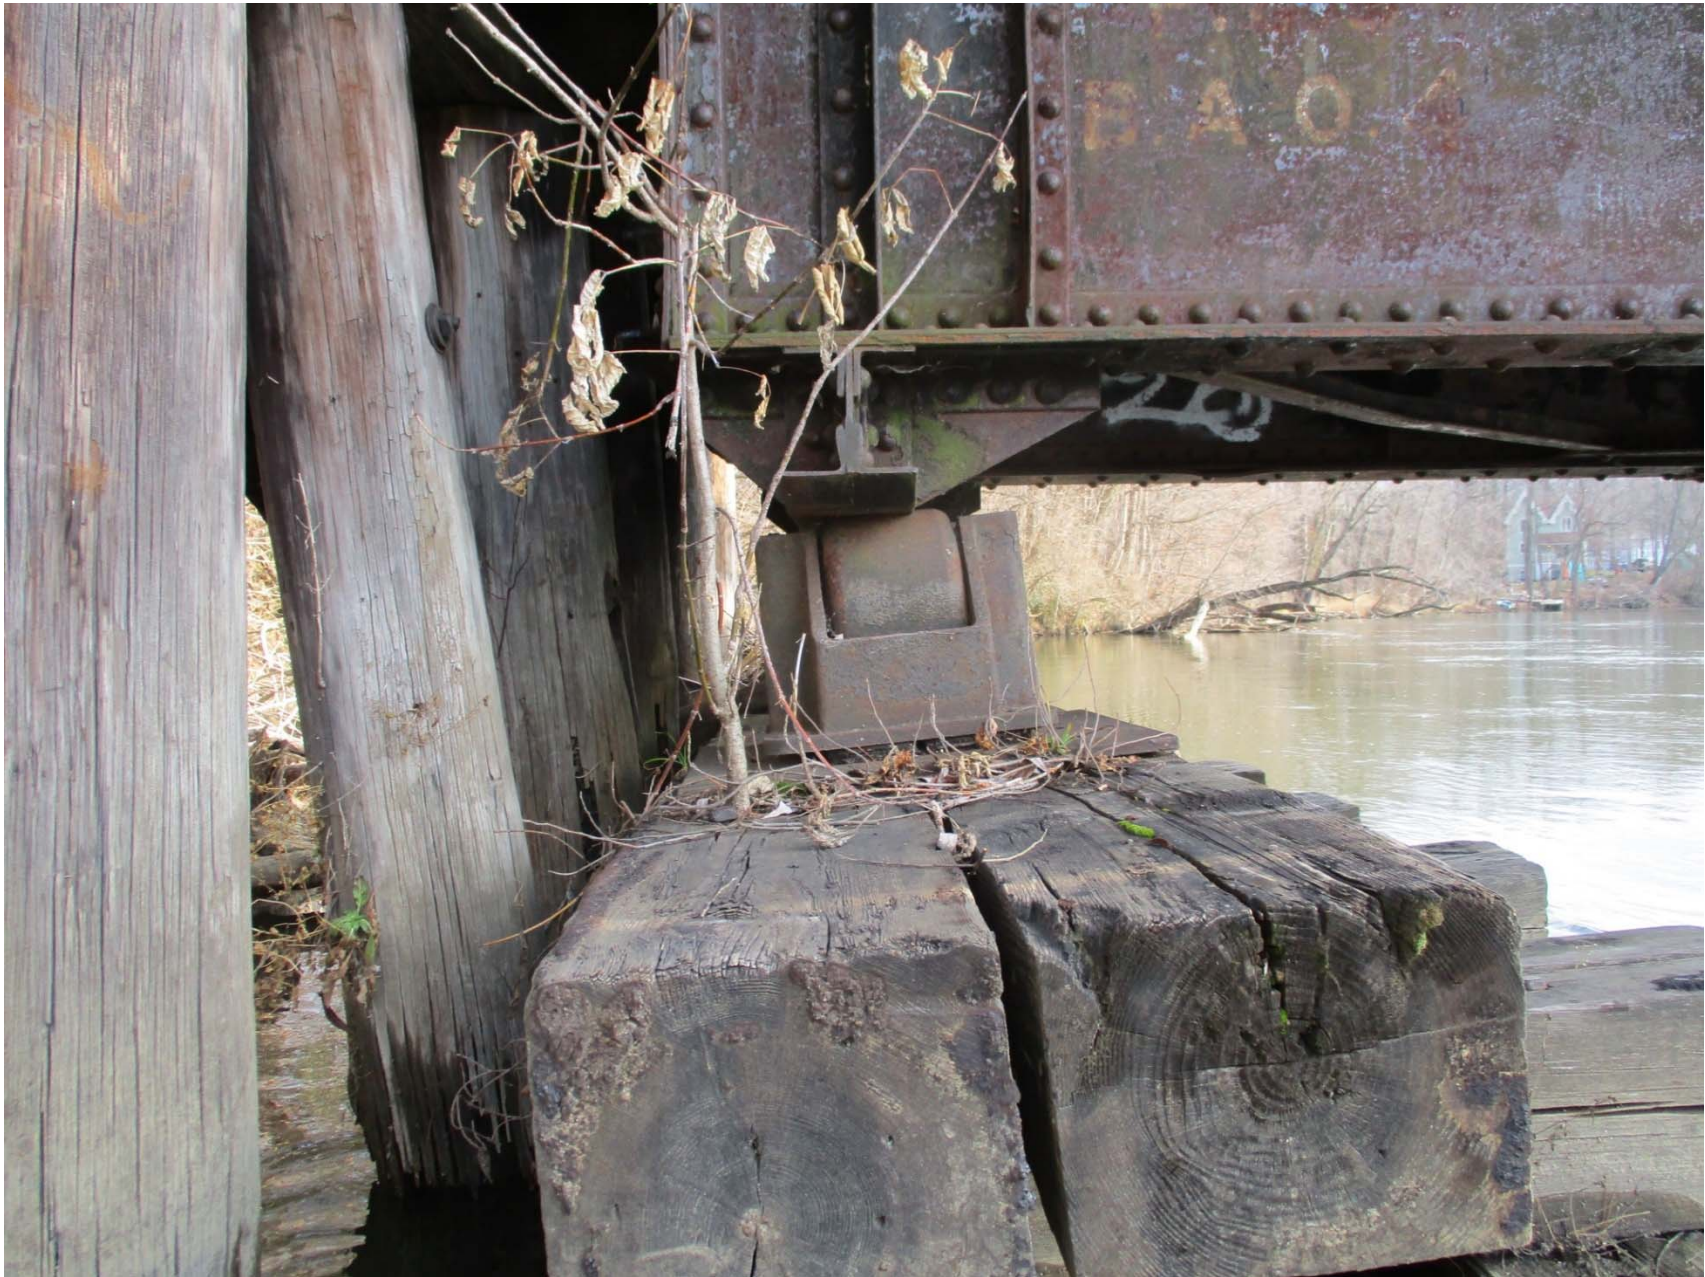
West bearing at pier 9S cribbing rotated

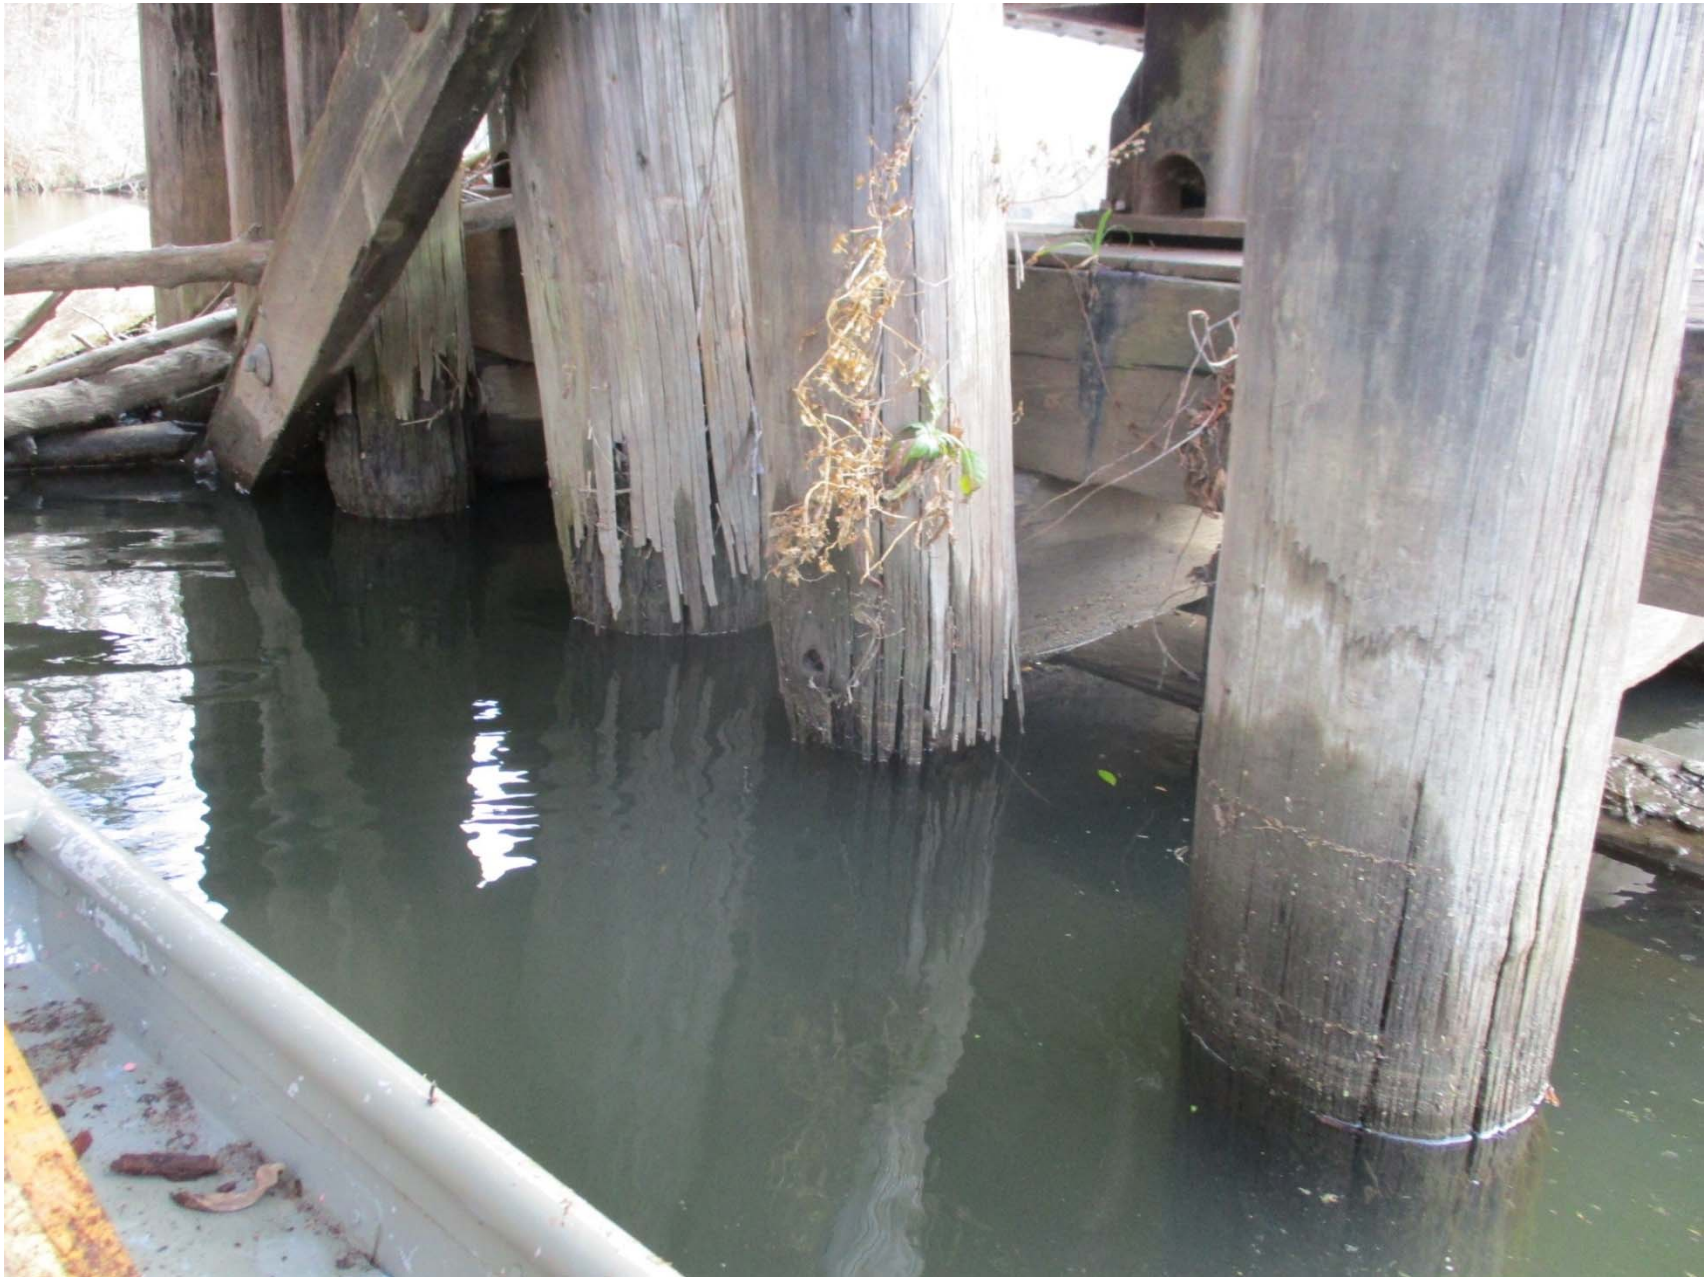
Pier 9S pile rot at water line

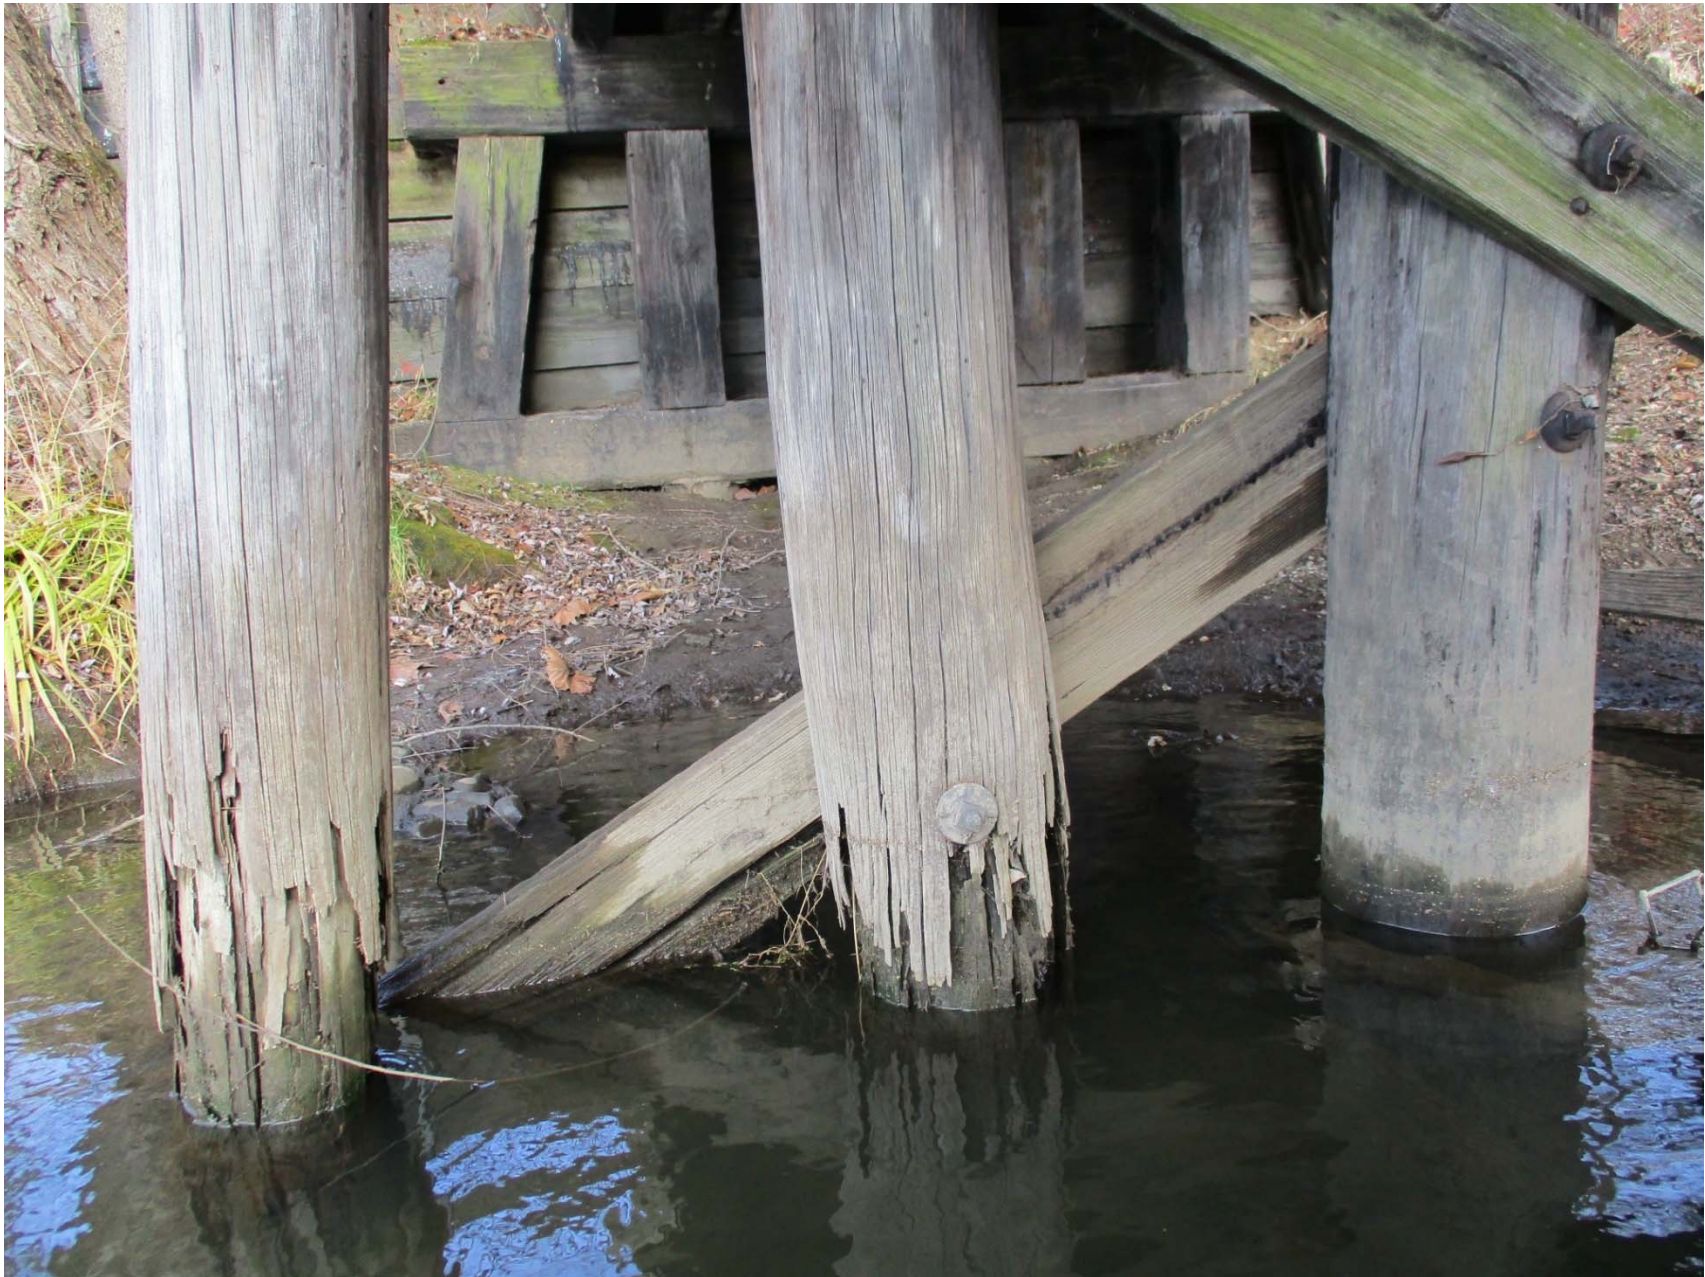
Pier 10S pile rot at water line

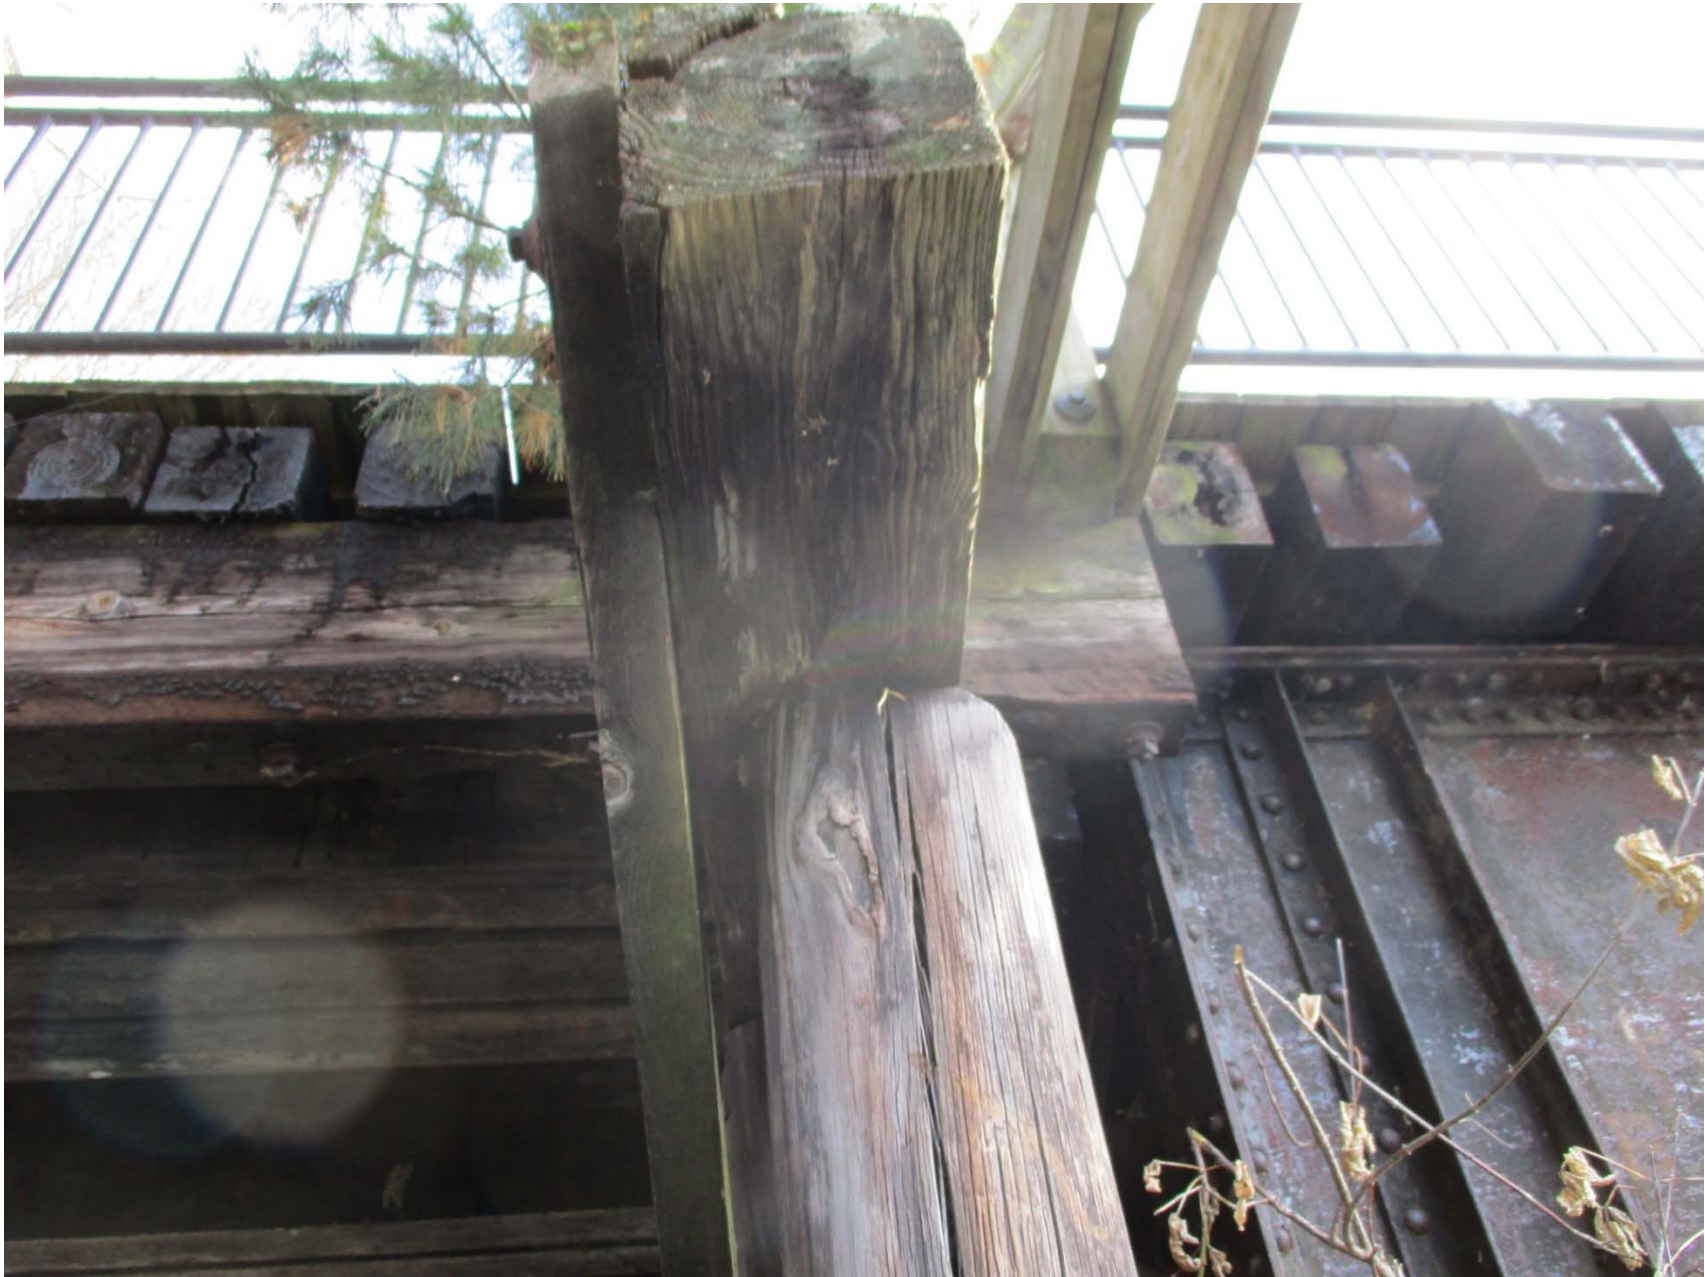
Pier 9S west end of cap offset

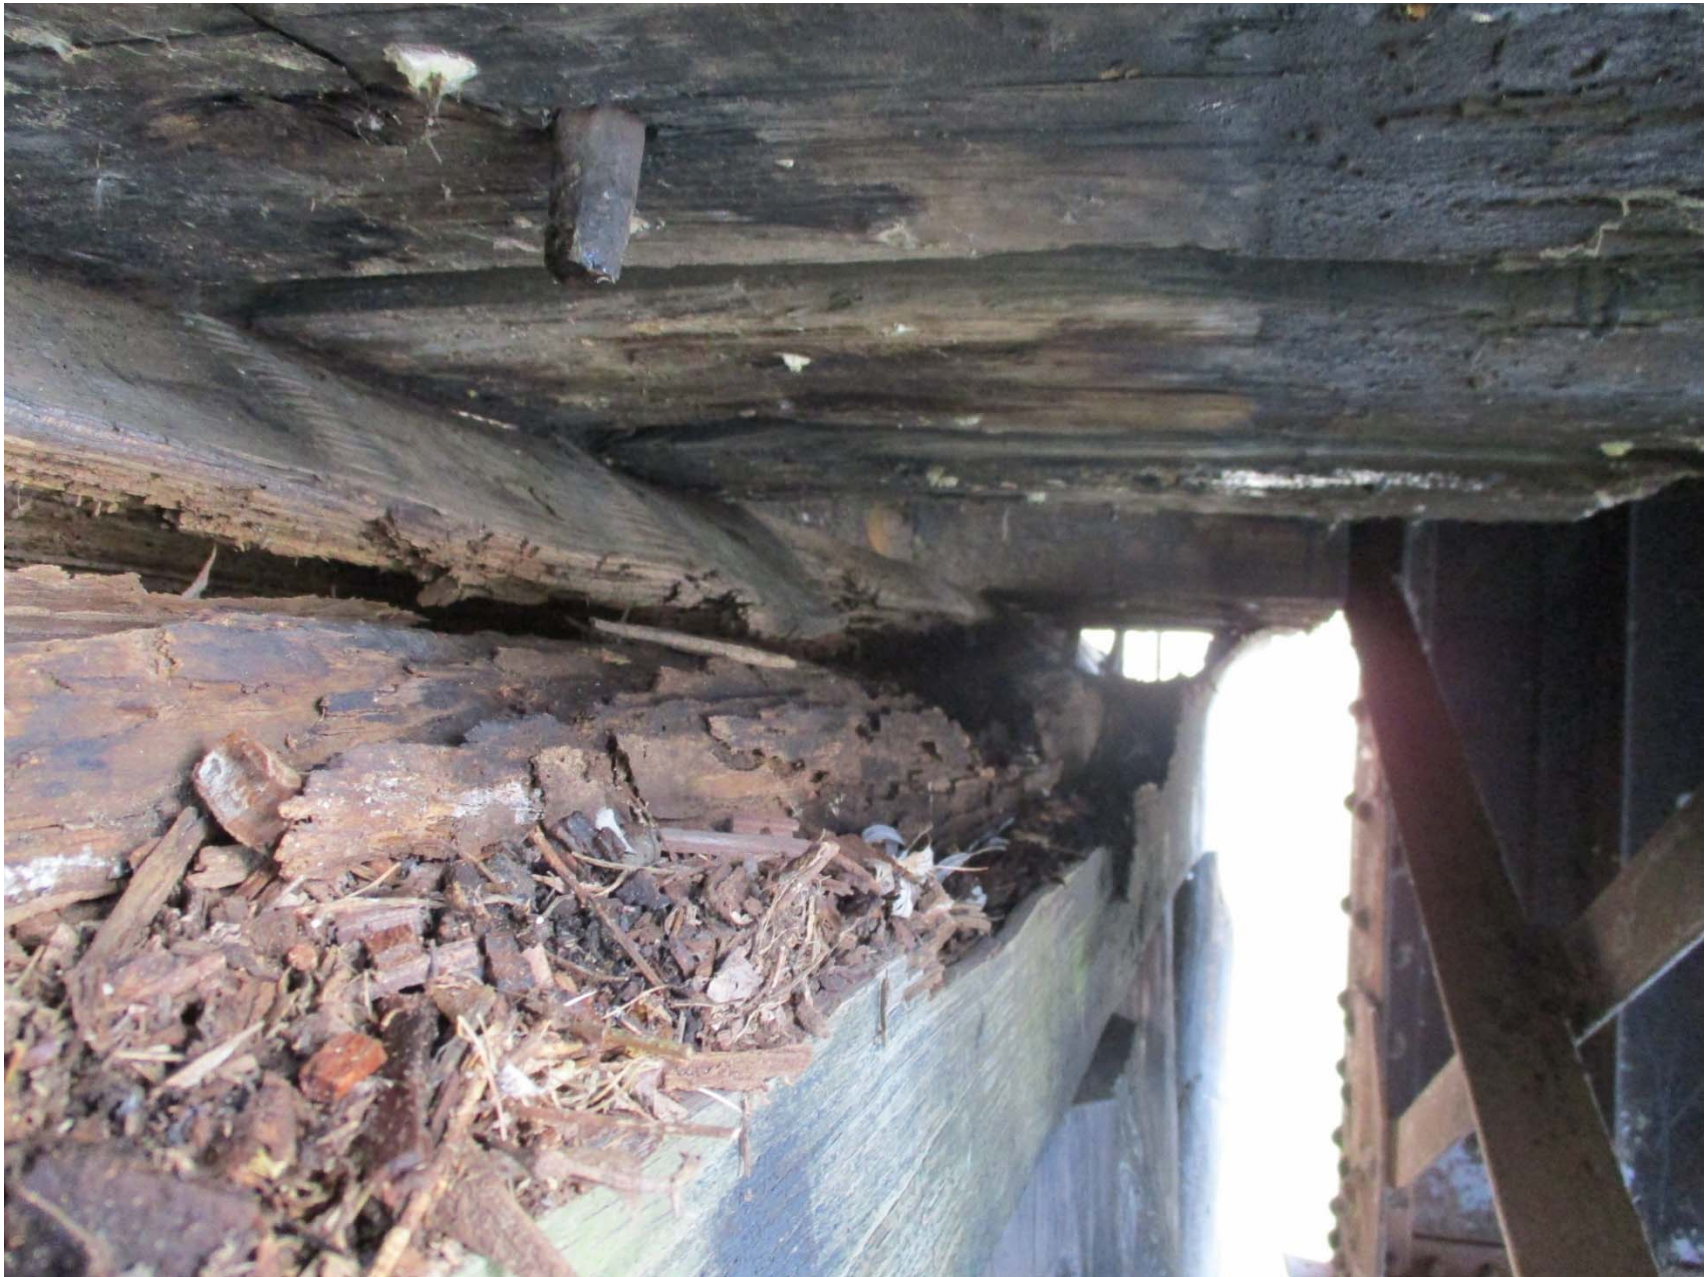
Top of pier 9S rotted full width for length of the cap, no beam support remains

With the imminent failure of the pier caps 1S, 3S, and 9S, the bridge needs to remain closed.

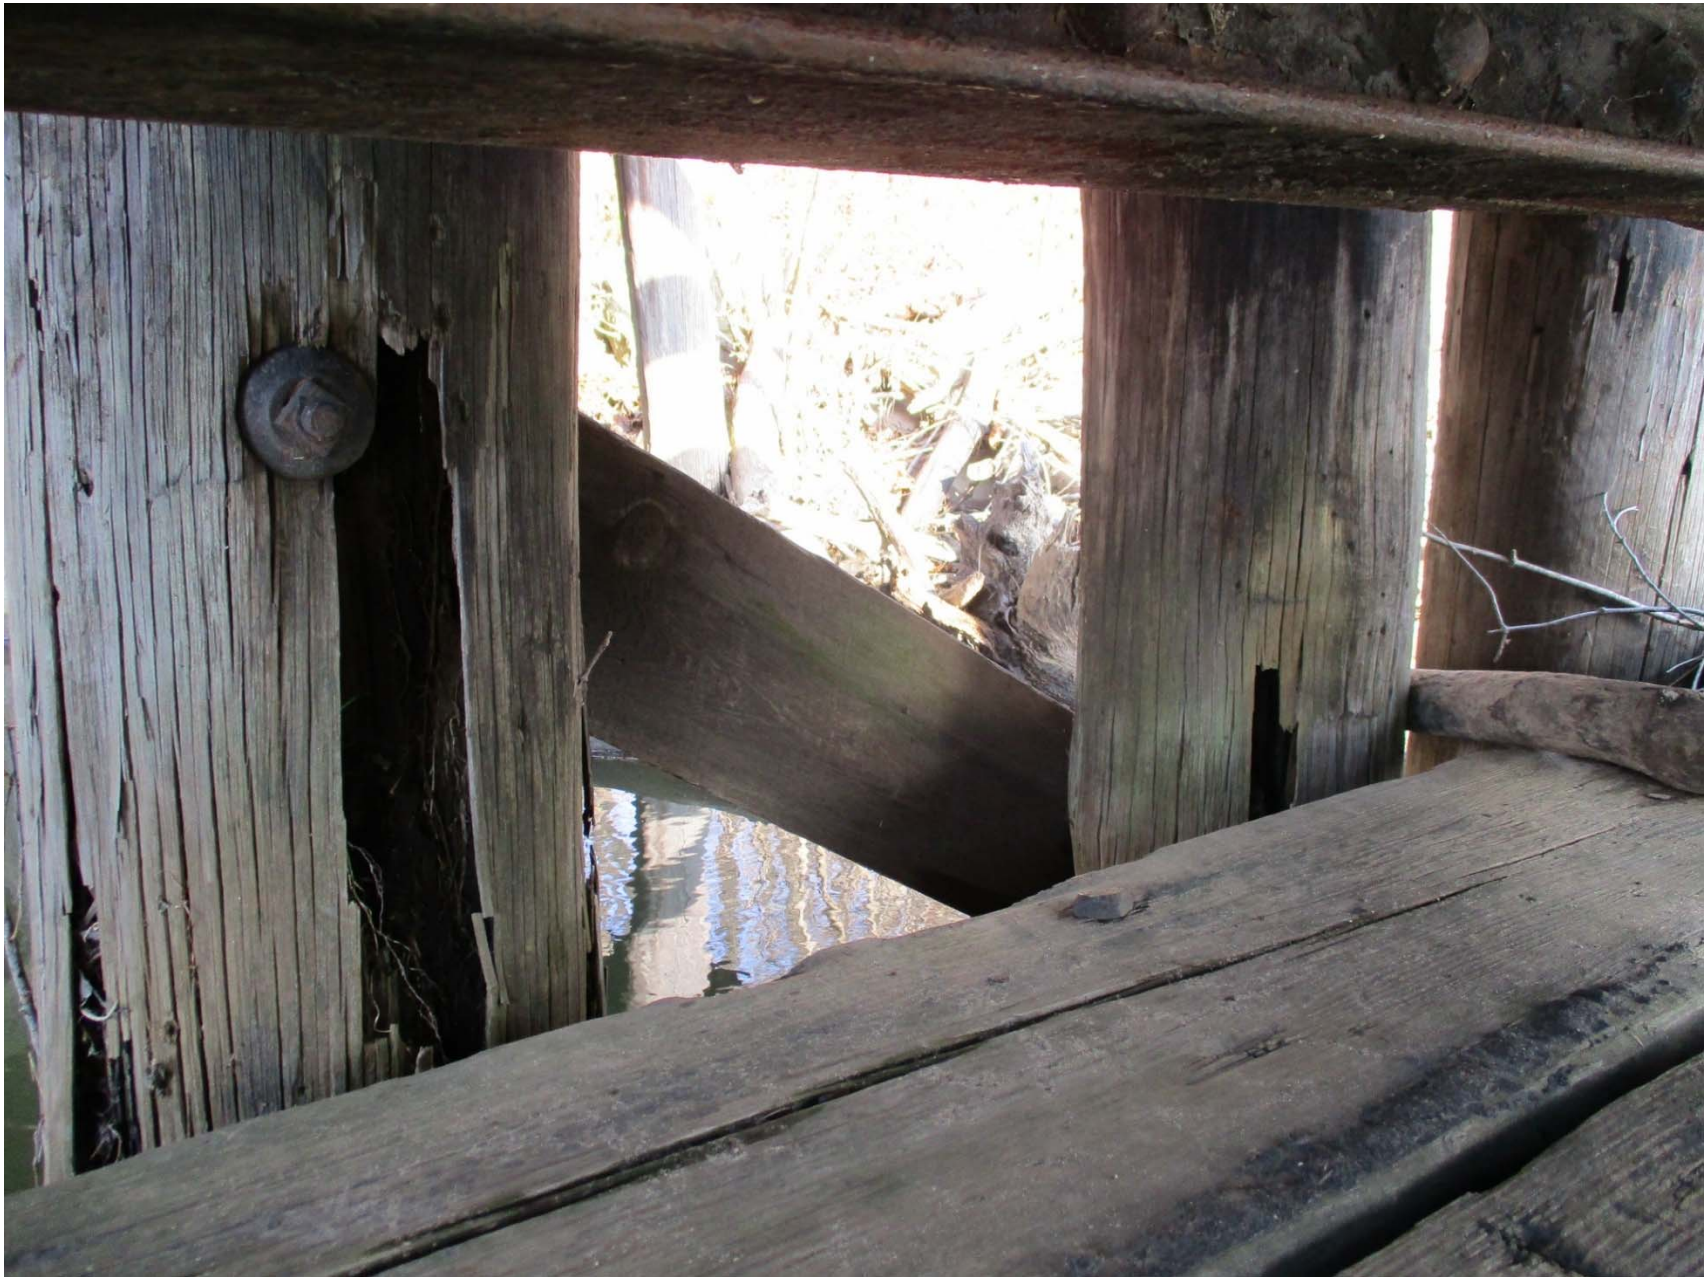
Pier 9S interior piles completely rotted through

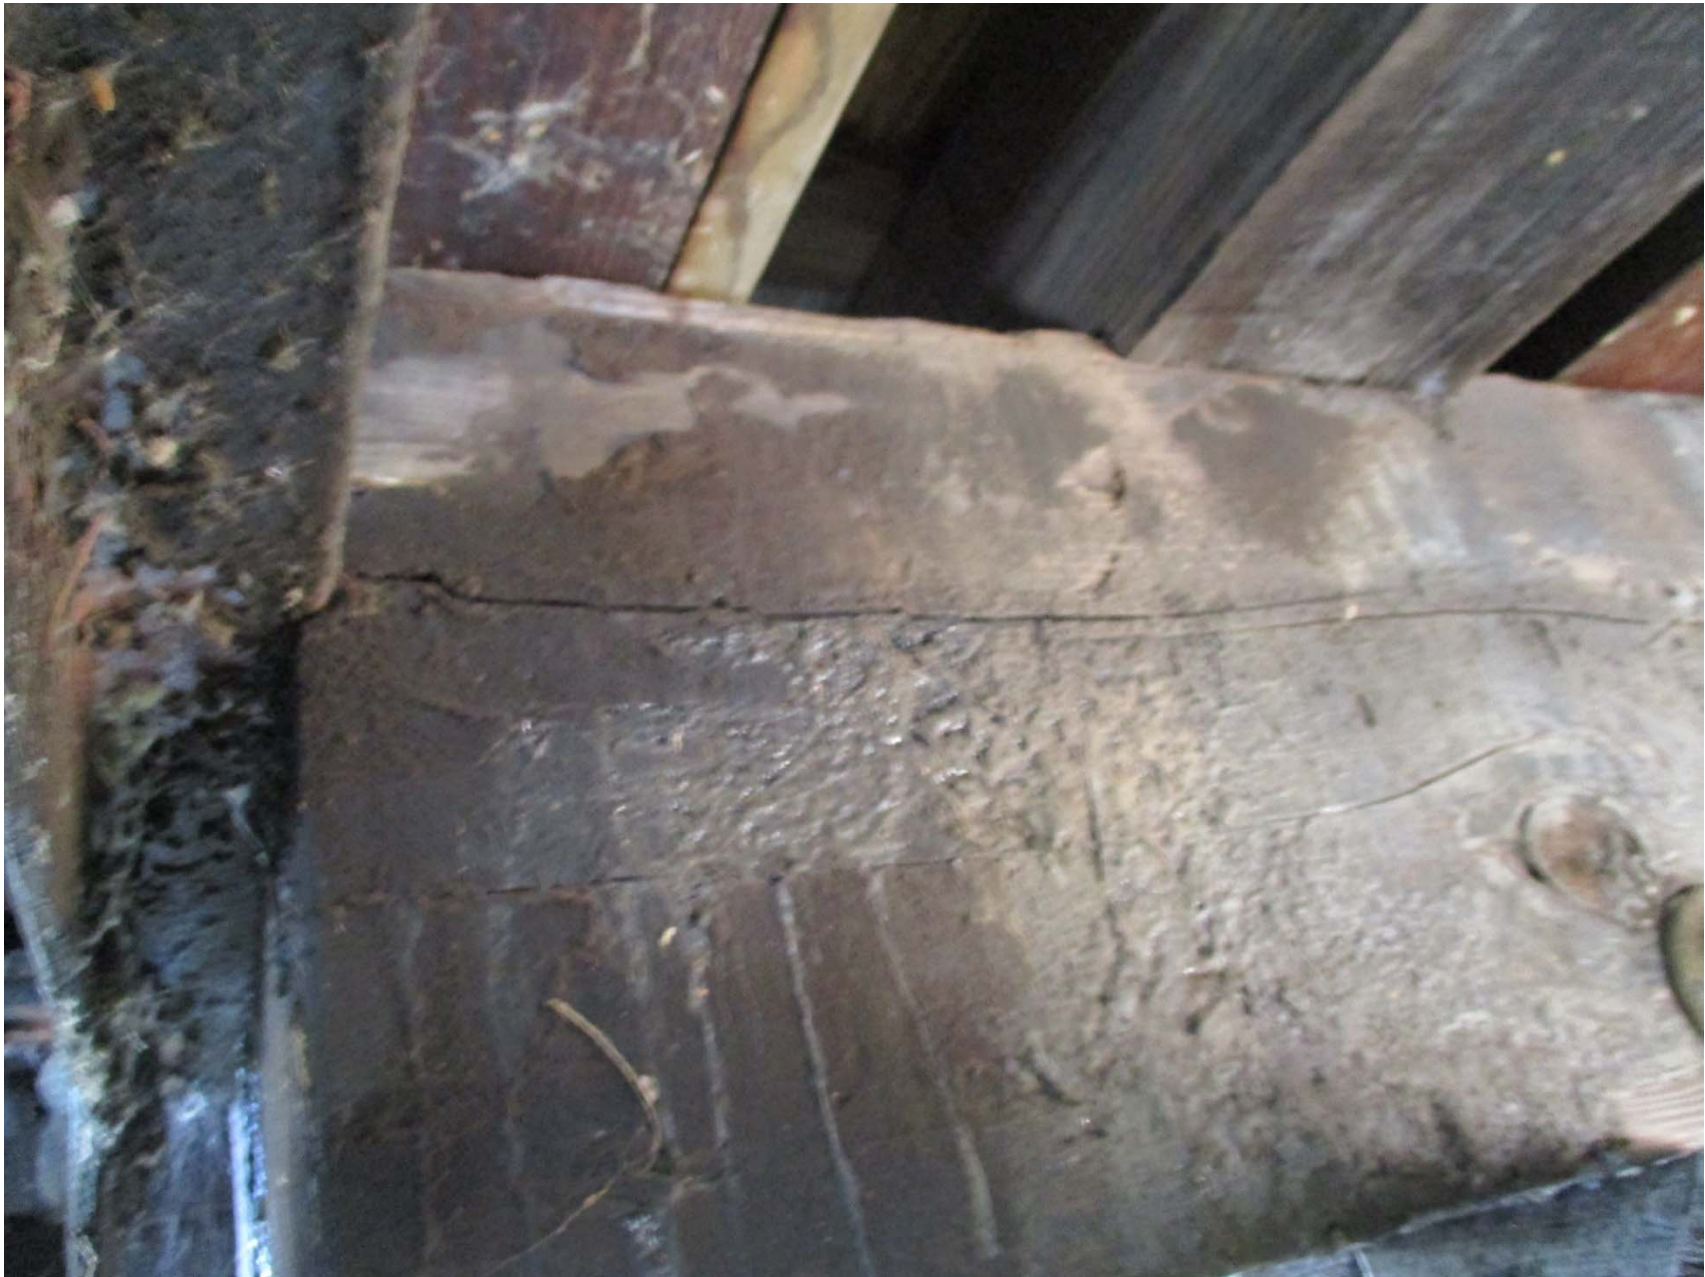
West beams splitting where bearing against the steel cross brace angle

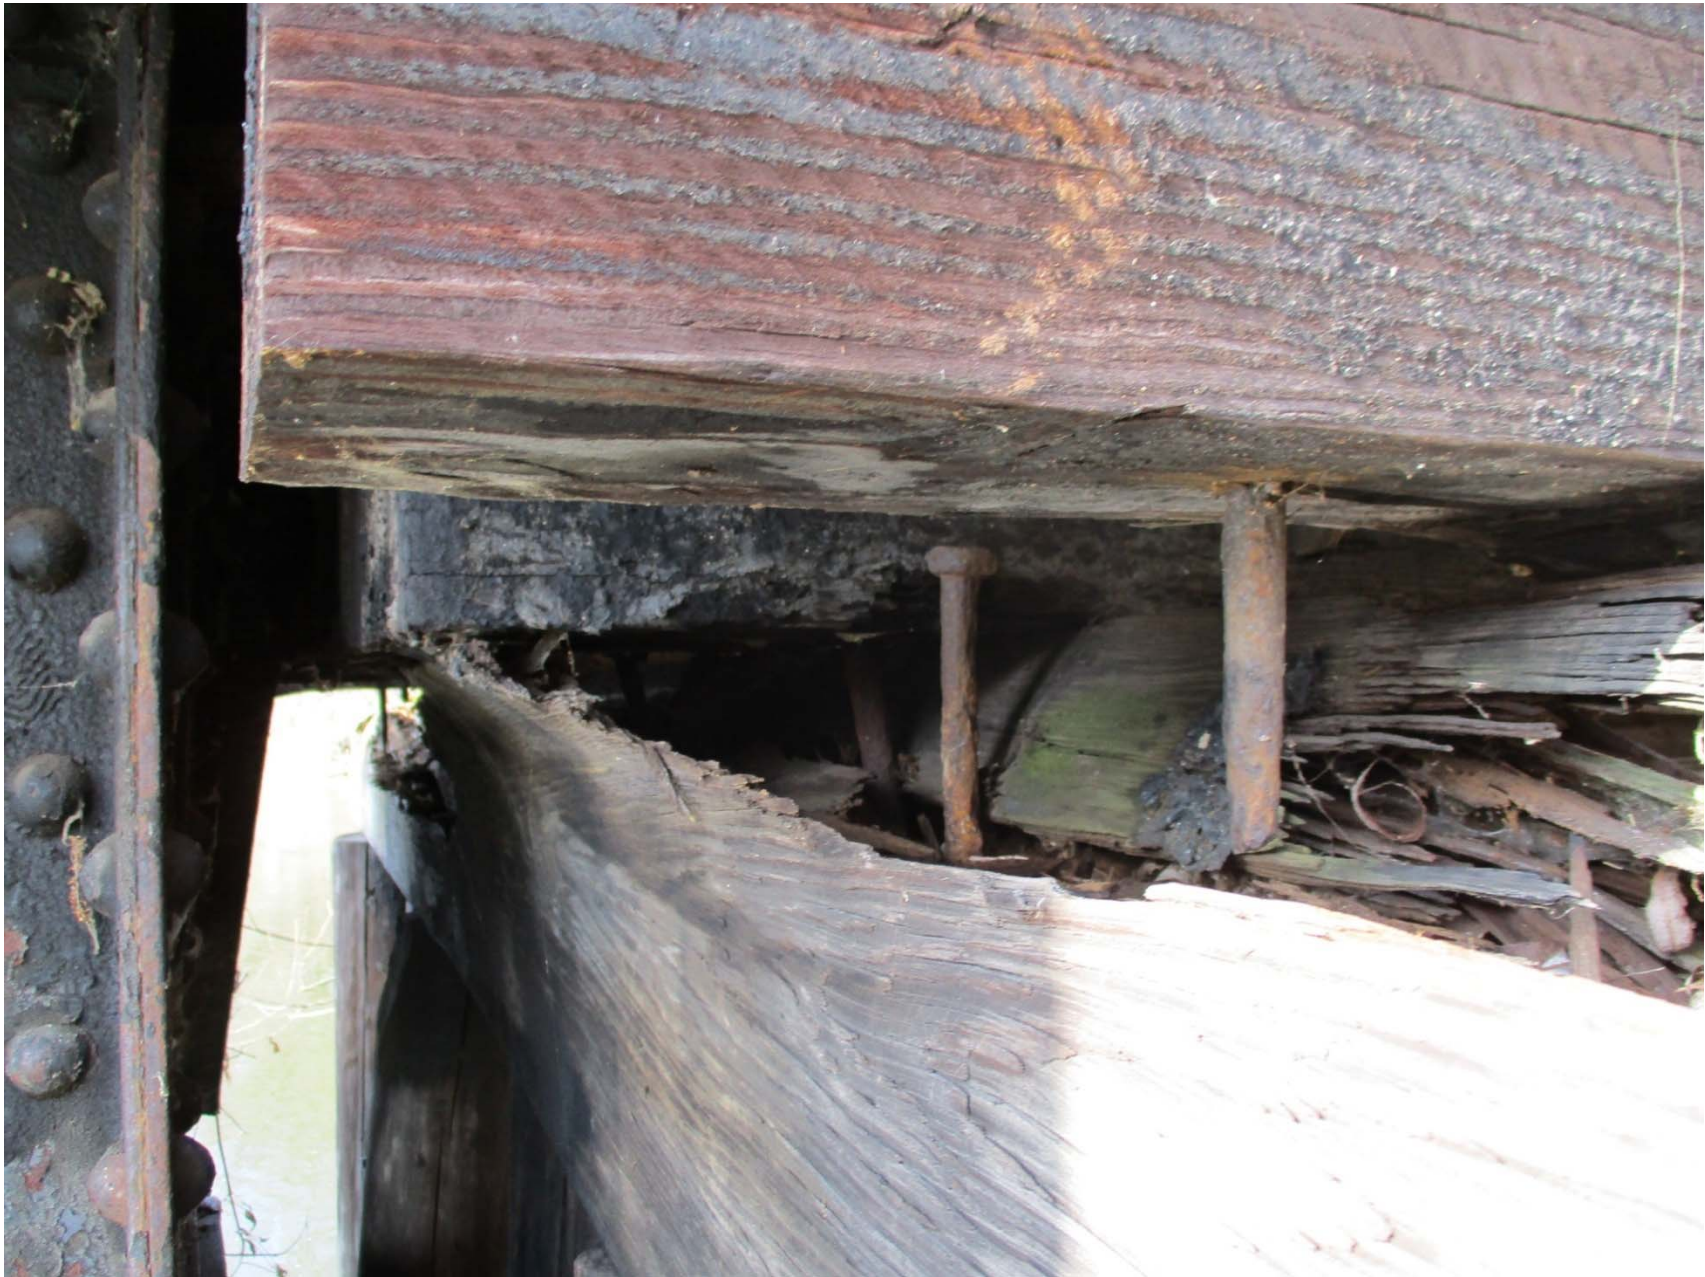
Pier 9S east end cap rot
