SUBJECT: Jaycee Park Pedestrian Bridge Inspection

A detailed inspection of the old railroad trestle in Jaycee Park over the Kalamazoo River in the City of Allegan was completed on December 8, 2023. Enclosed is a copy of the report and pictures for your bridge files, supplemented with the comments below.

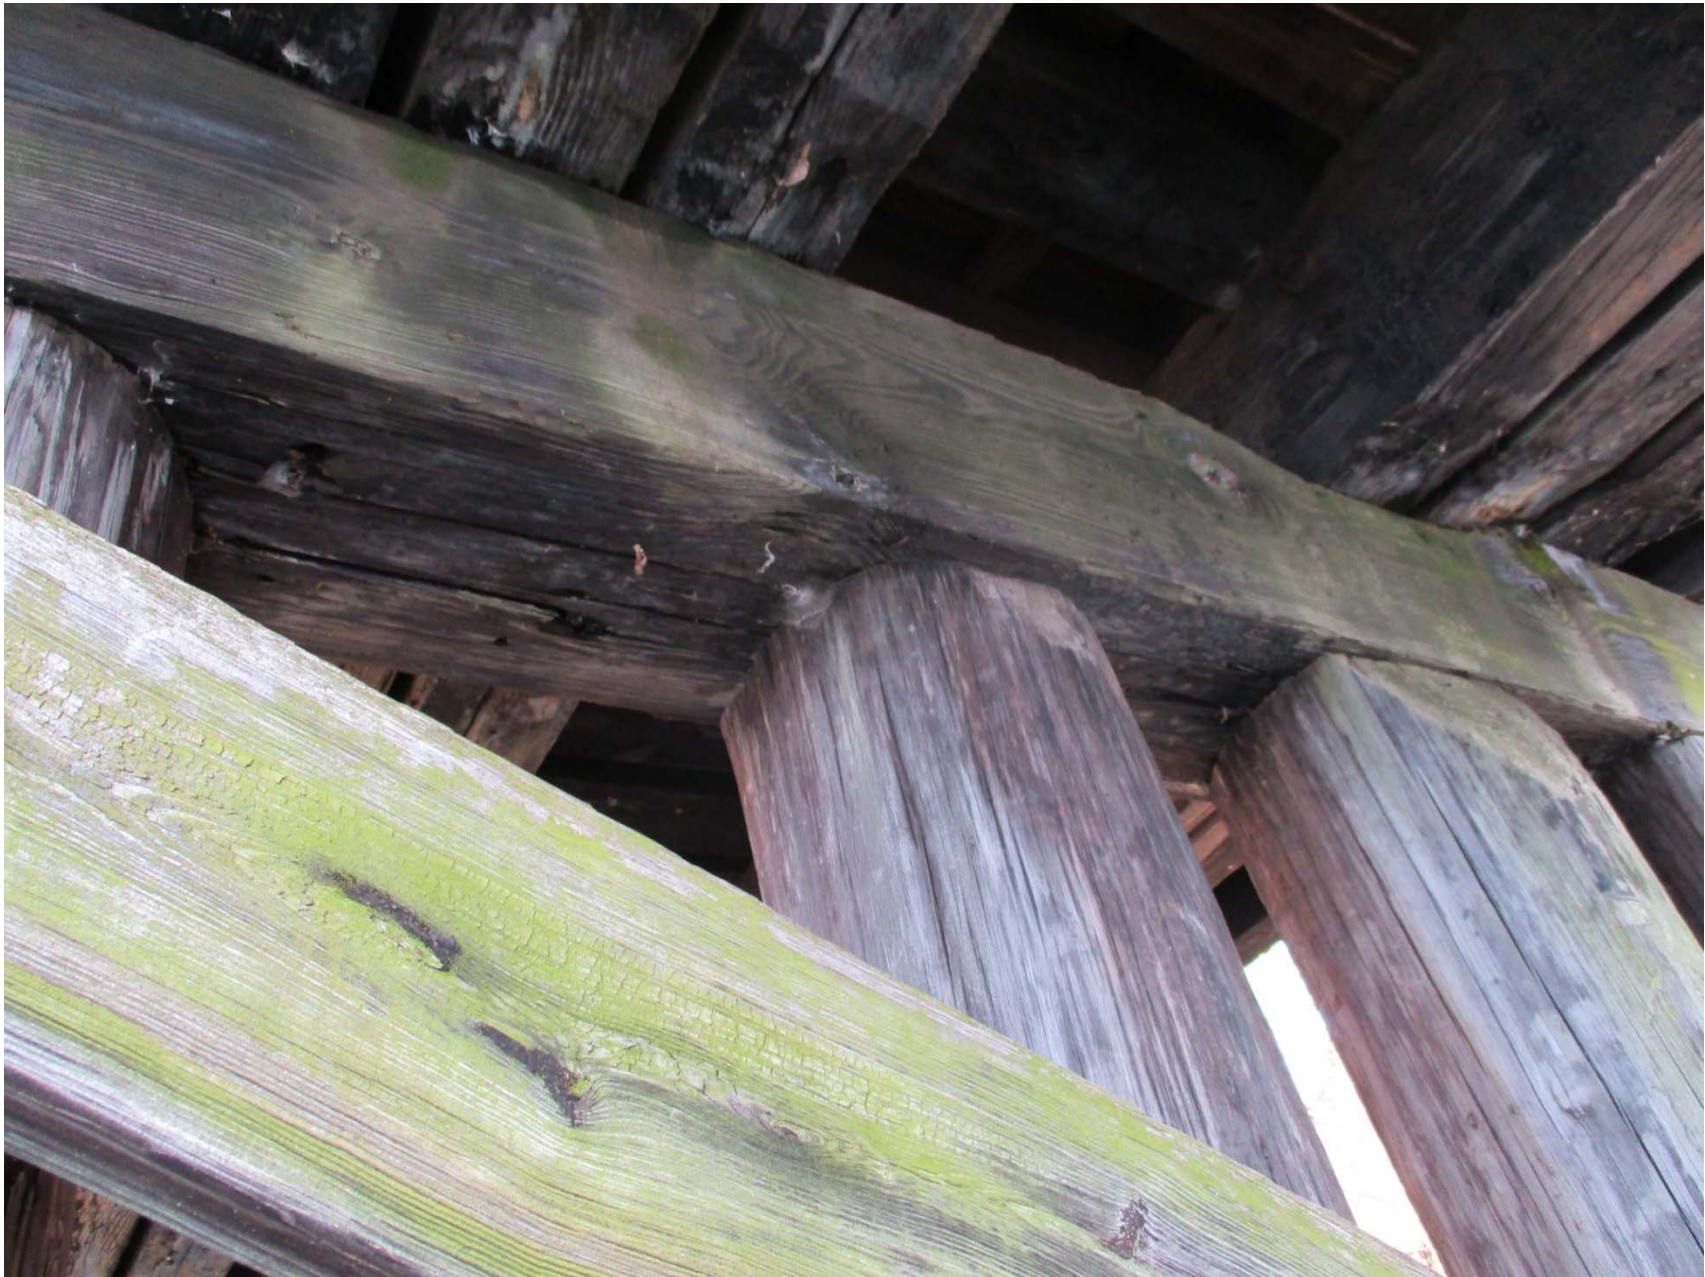
Pier 10S bottom of cap split

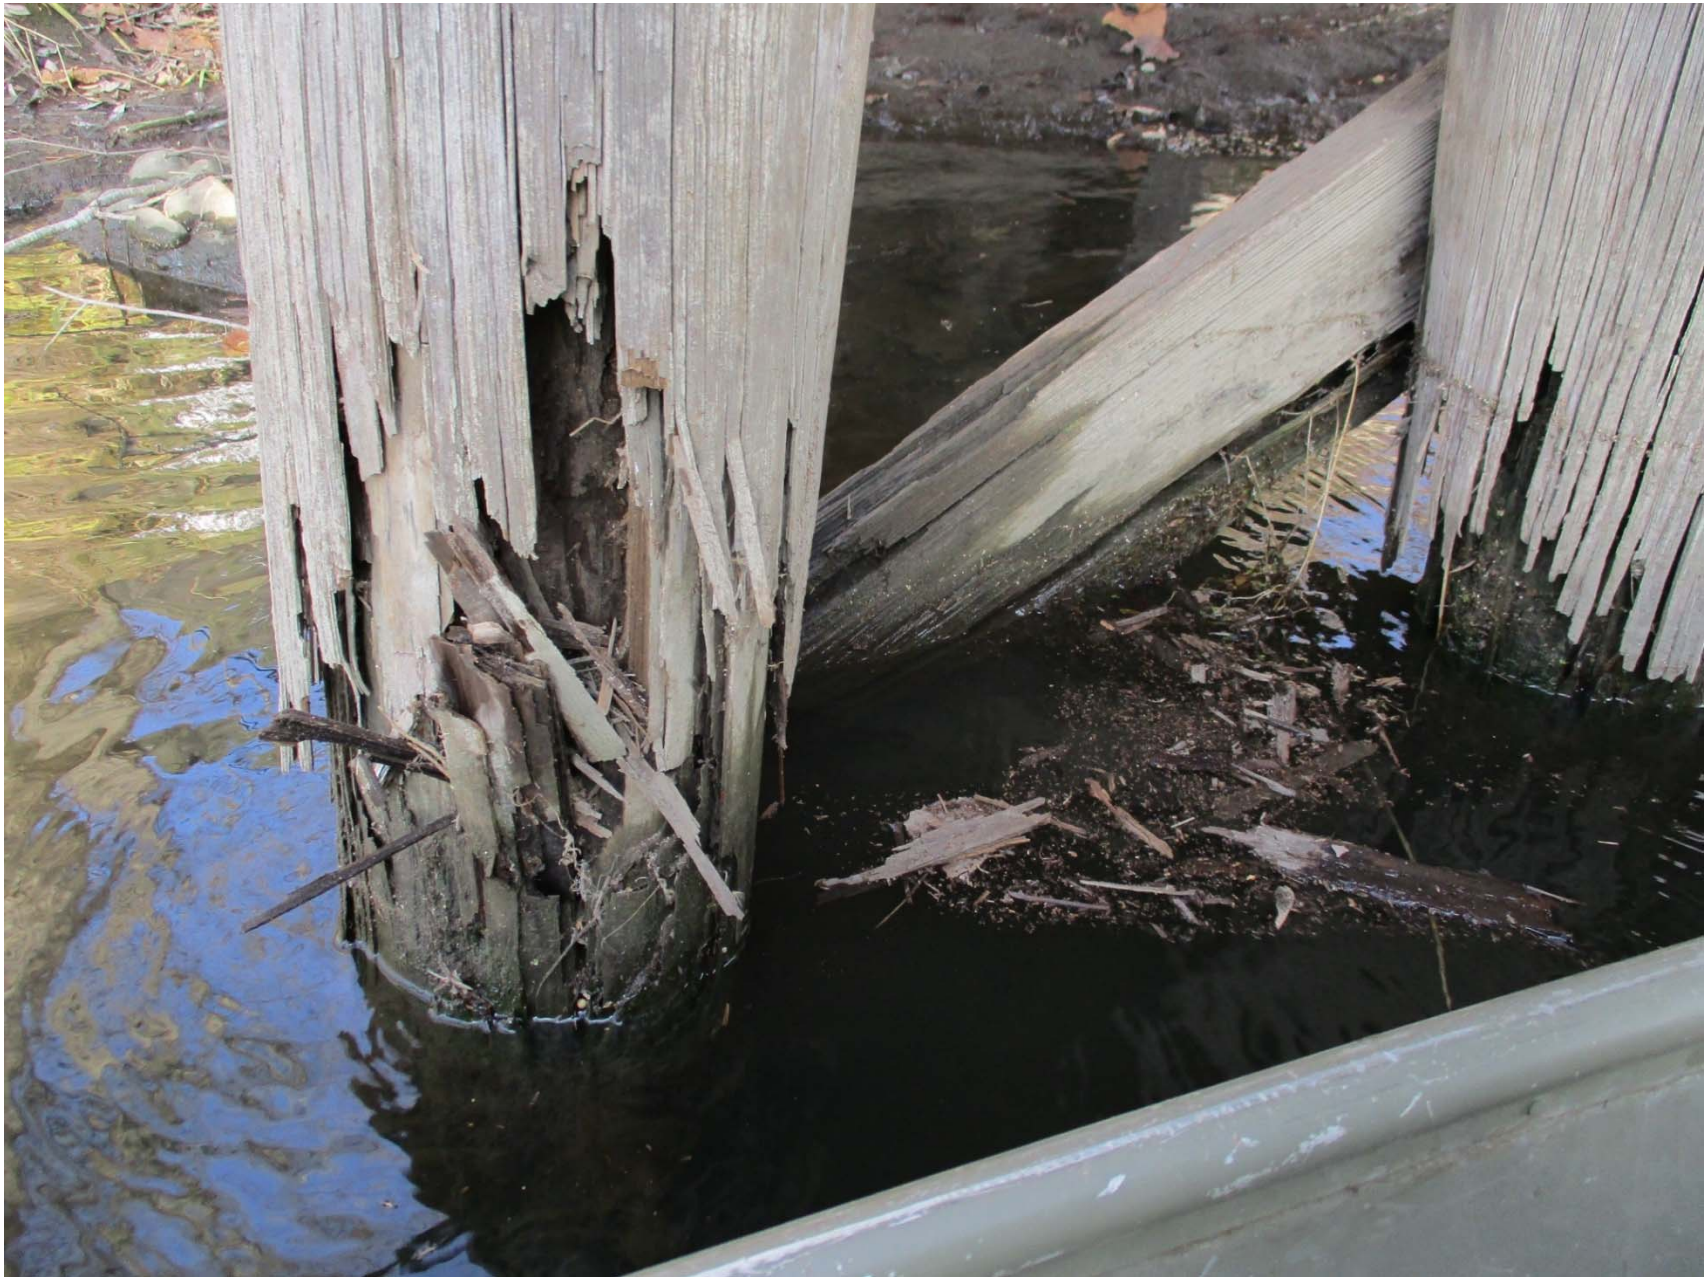
Pier 10S Pile 1W, 60-70% loss
