SUBJECT: Jaycee Park Pedestrian Bridge Inspection

A detailed inspection of the old railroad trestle in Jaycee Park over the Kalamazoo River in the City of Allegan was completed on December 8, 2023. Enclosed is a copy of the report and pictures for your bridge files, supplemented with the comments below.

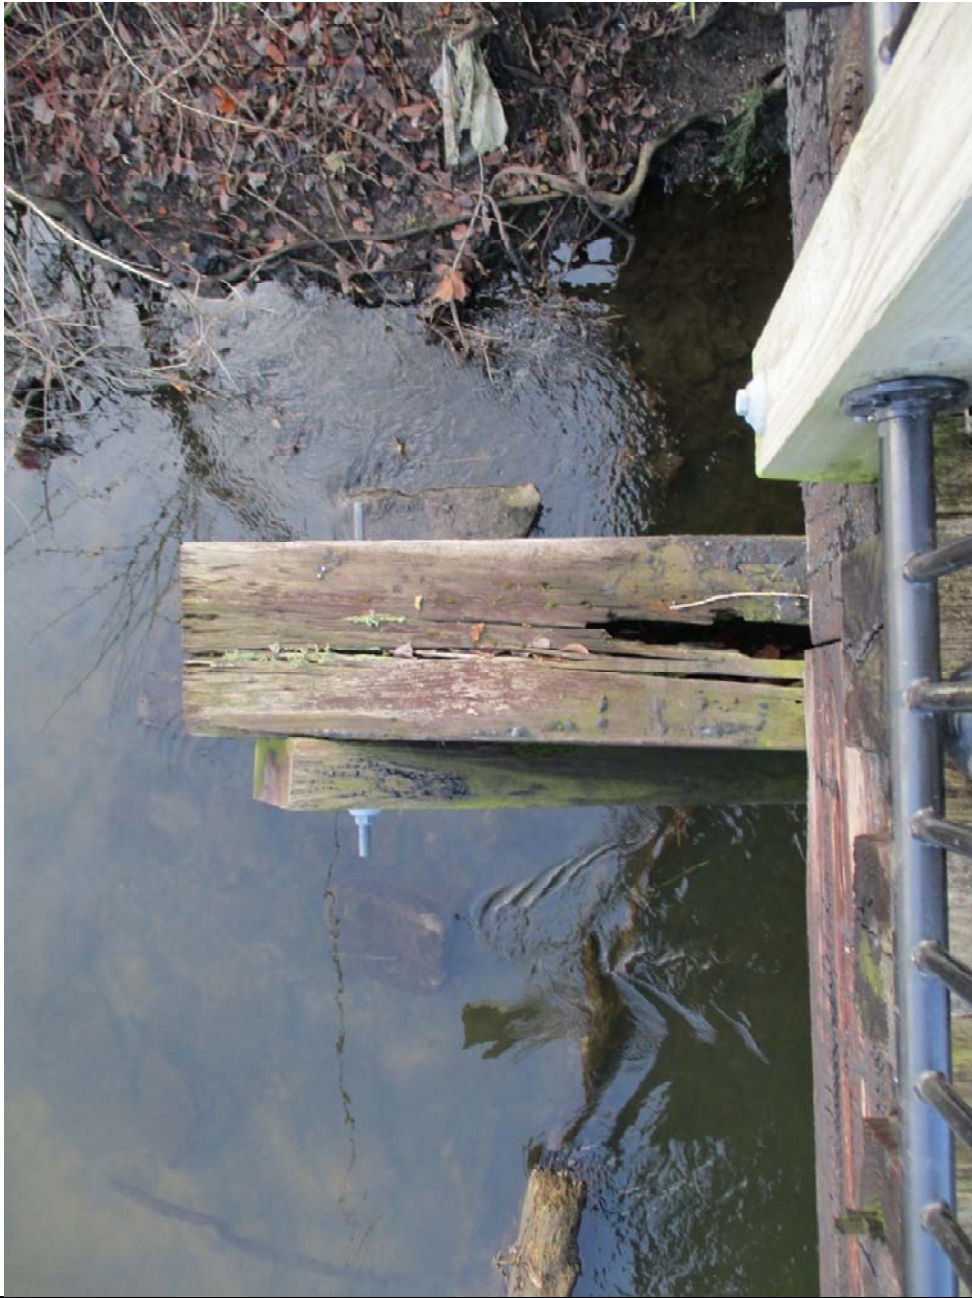
Pier 1S east end rotted

Pier 1S (1st pier from south abutment): Complete interior rot of the cap with full section loss along the bottom and into the top at each end. Approximately, the outer ½"-1" of thickness remains intact. This equates to at least 85% section loss of the cap cross-sectional area. The west end of the cap is crushing (sides buckling). The timber piles have an outer loss at the water surface. Pile 2W has internal rot, only the outer 1" remains. Very little support strength is left in the cap.

With the imminent failure of the pier caps 1S, 3S, and 9S, the bridge needs to remain closed.

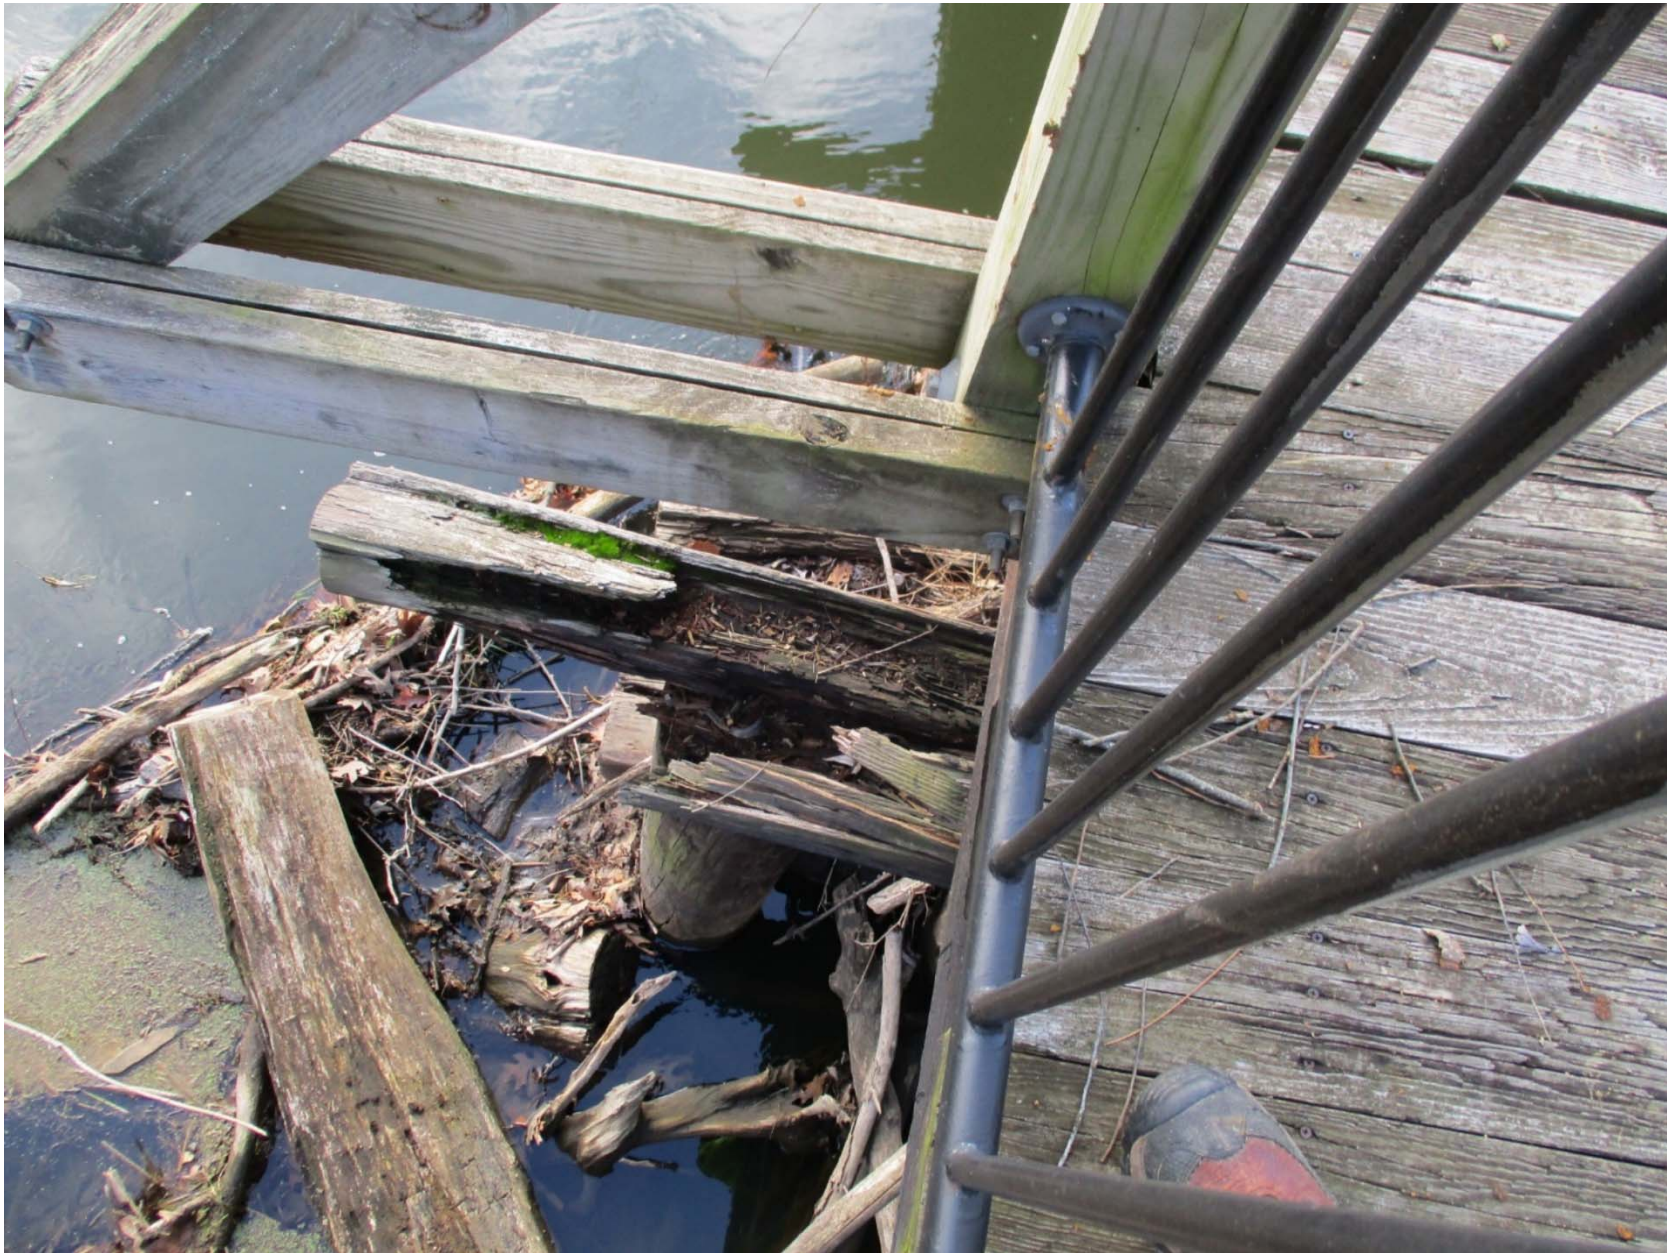
Pier 9S east end nearly rotted through

Pier 9S: The top half of the cap has rotted away. A 4ft white pine tree growing in the west end. There is no bearing support for the beams. The span is being held by west beam end pressure against the steel span cross bracing. The beams are beginning to split at the end bearing point. Extensive rot at the water surface to piles 3-5E. The adjacent cribbing supports the north end of the steel girders is rotting and has settled with rotation toward the north. The roller bears are offset from the girder bearing plates.

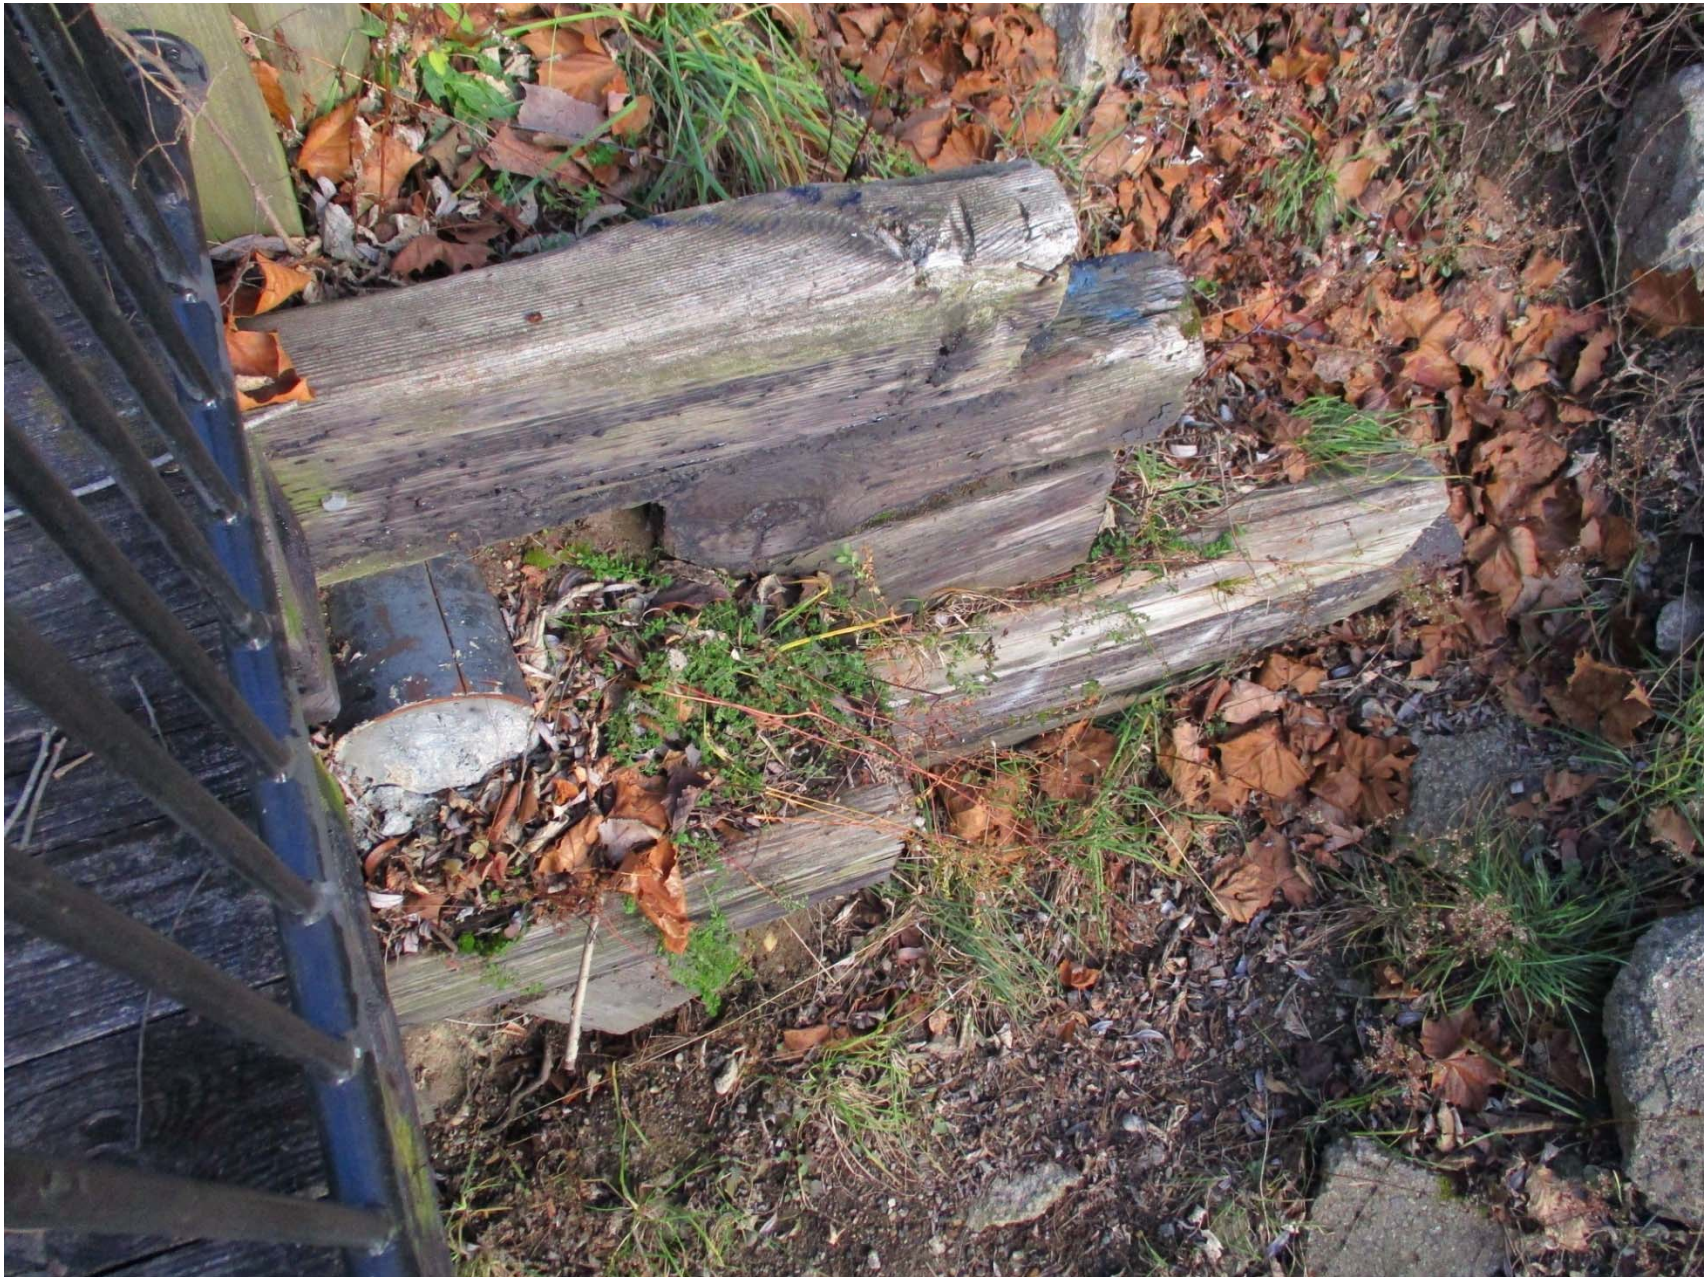
North abutment east end

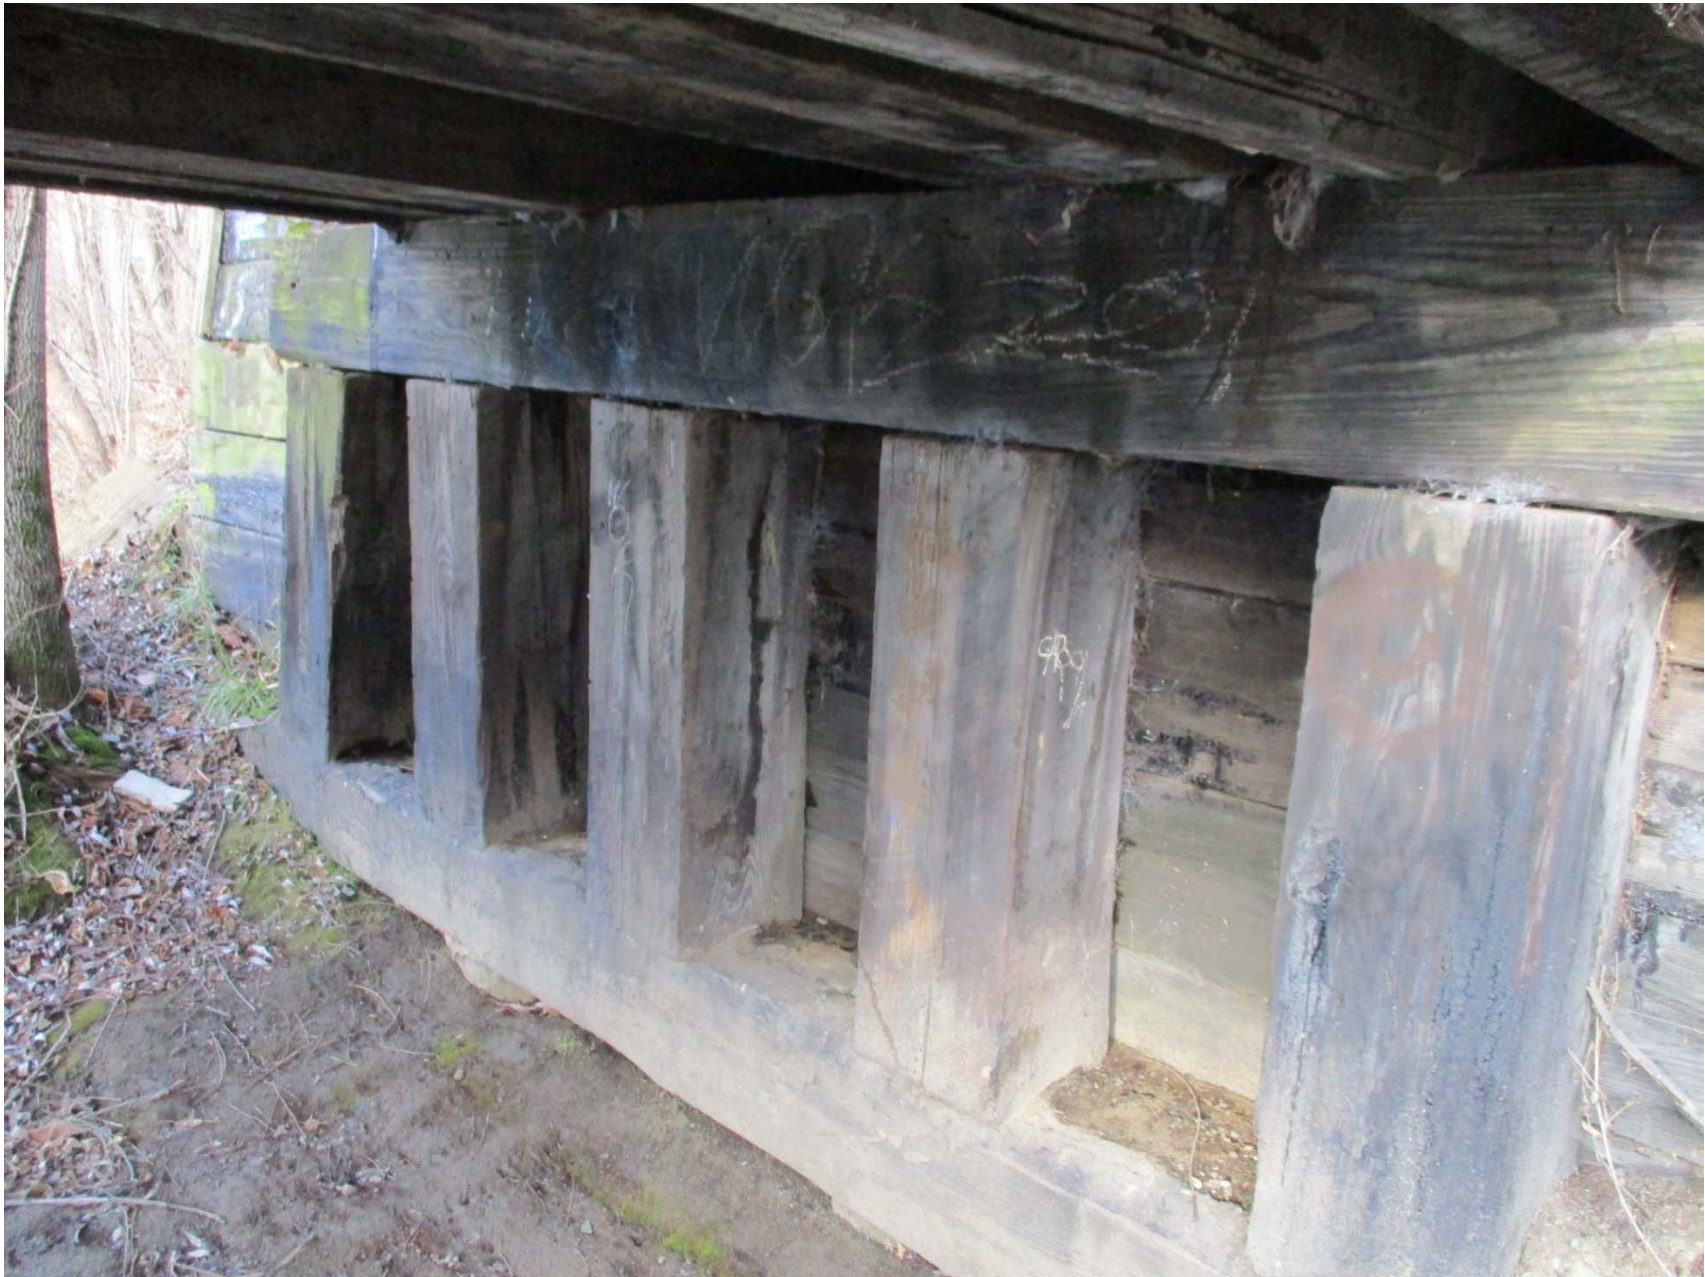
North abutment elevation

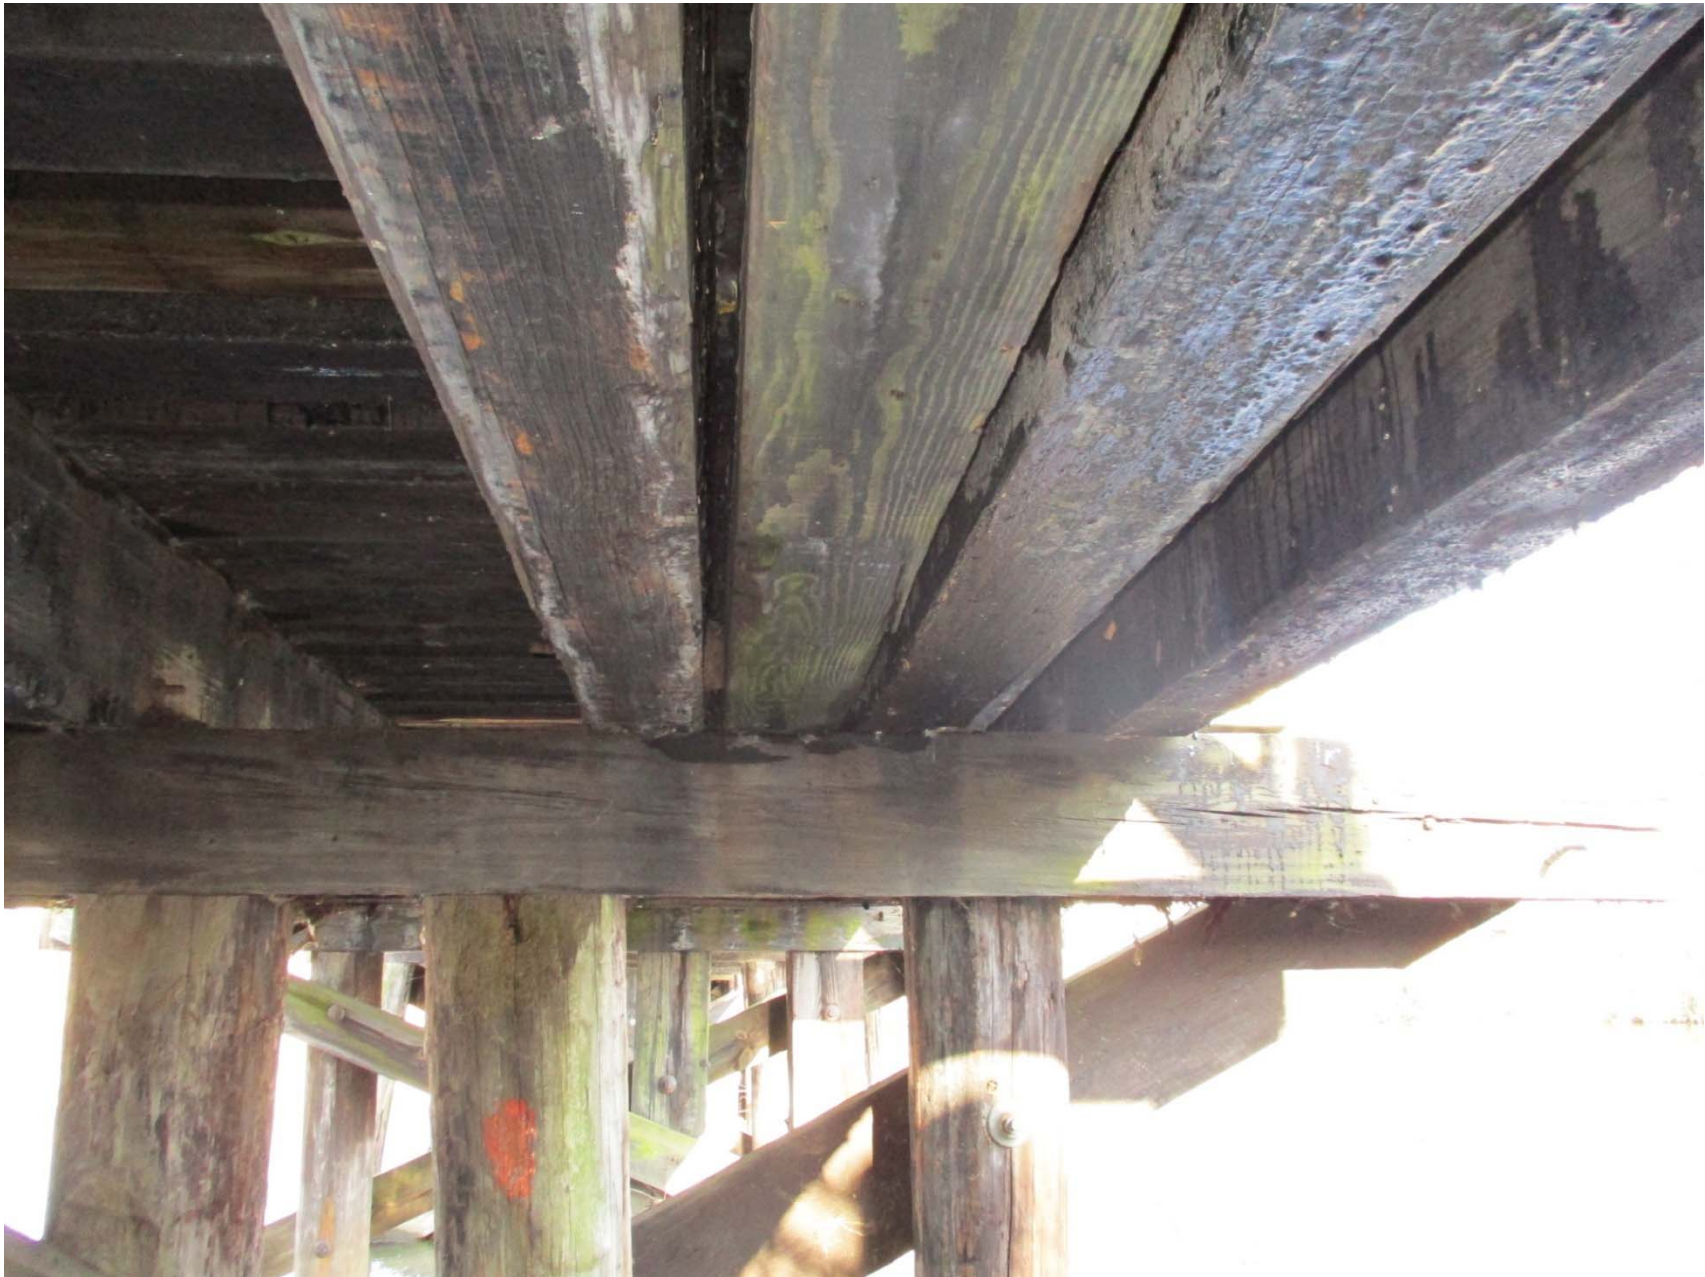
Three timber beams under past rail locations

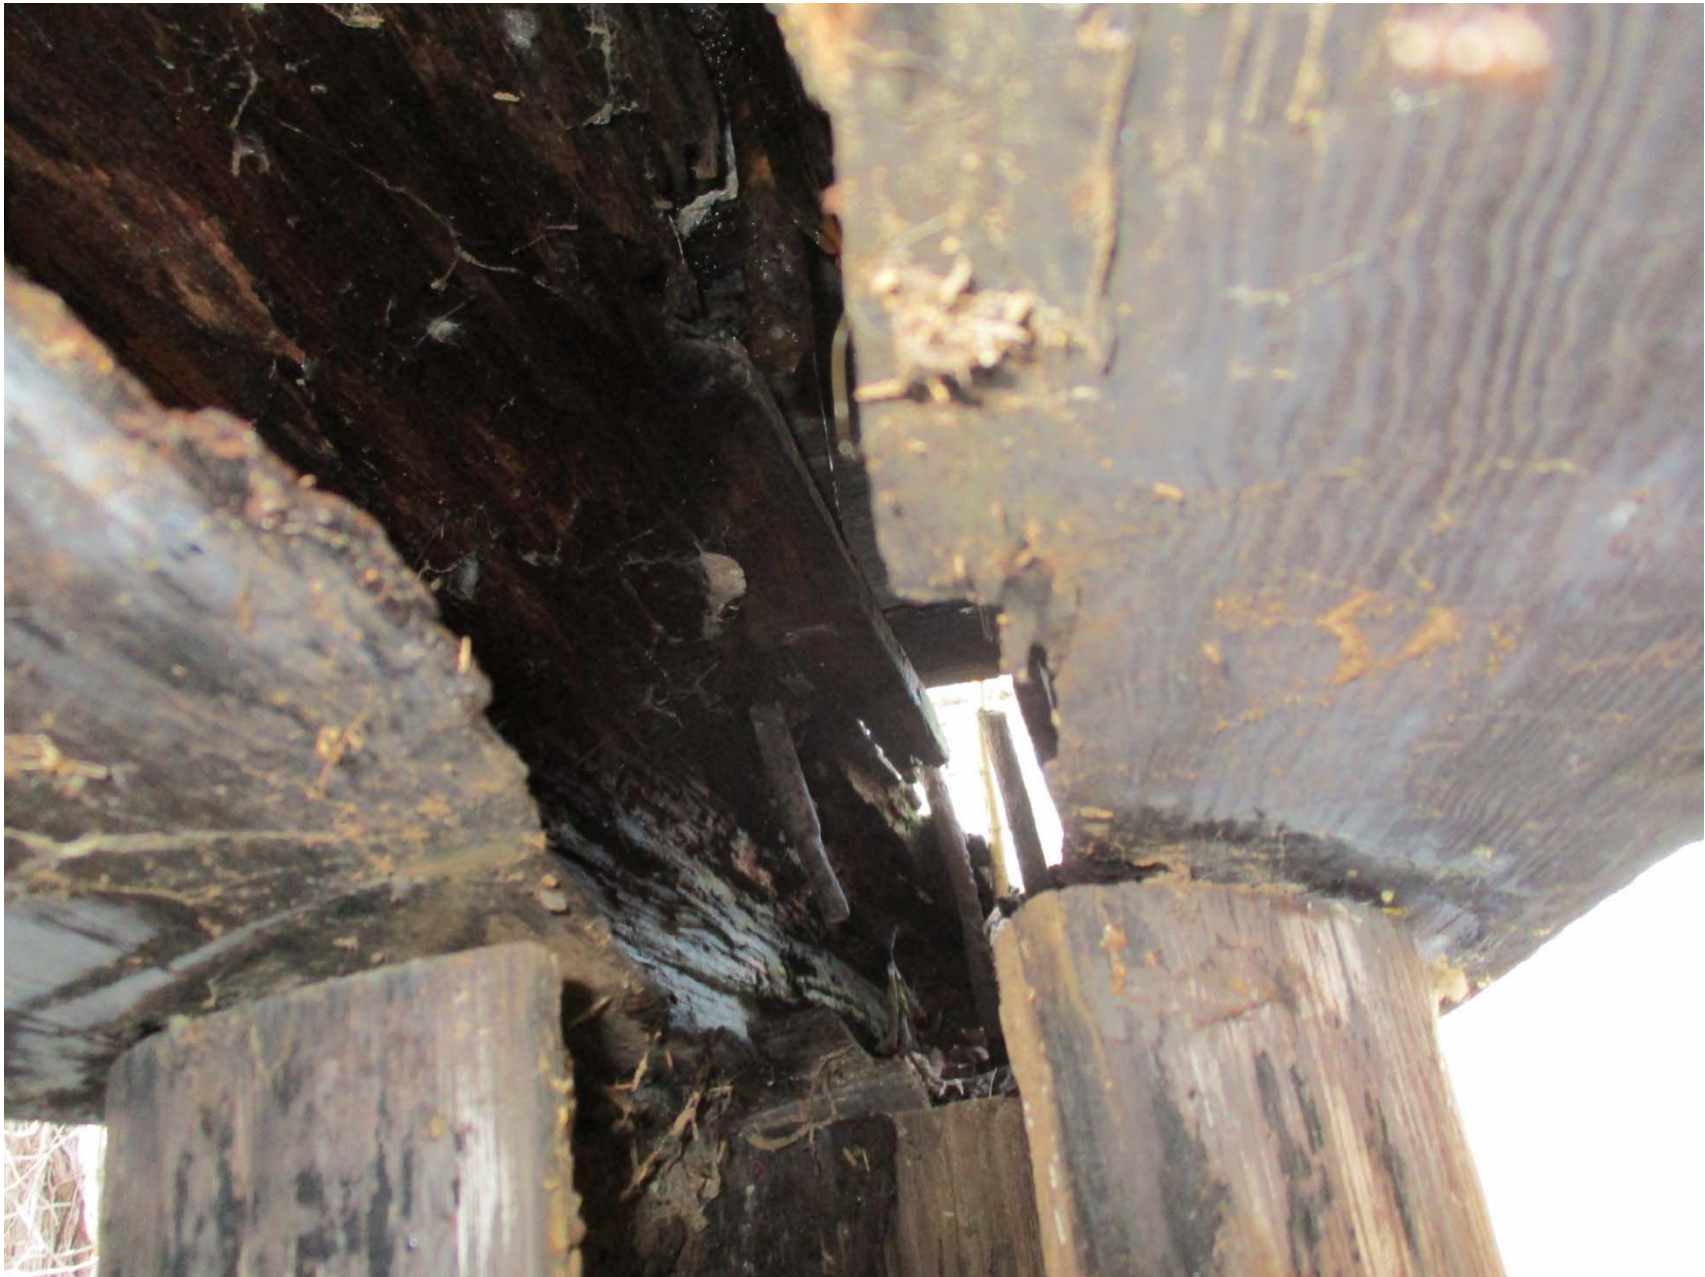
Interior view of Pile 1S west end

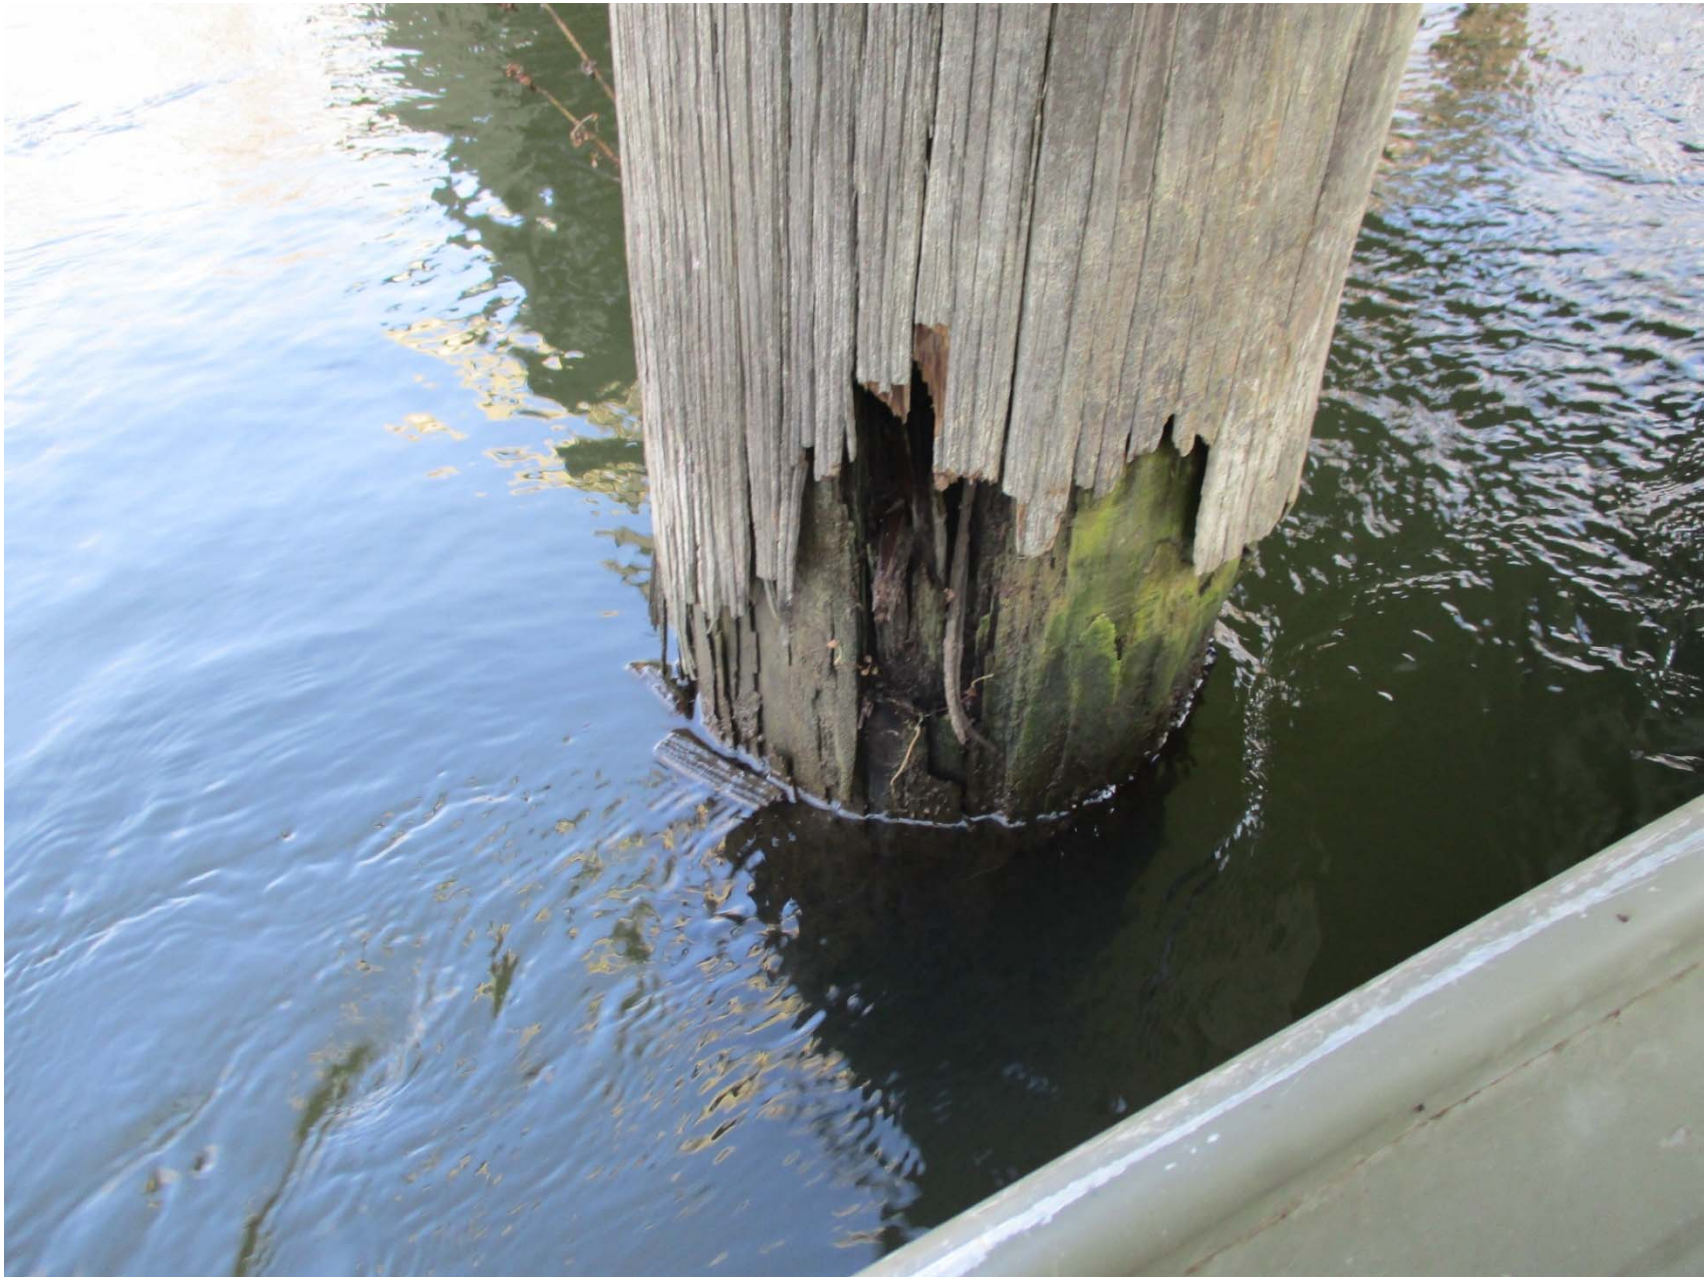
Pier 4S pile 1W

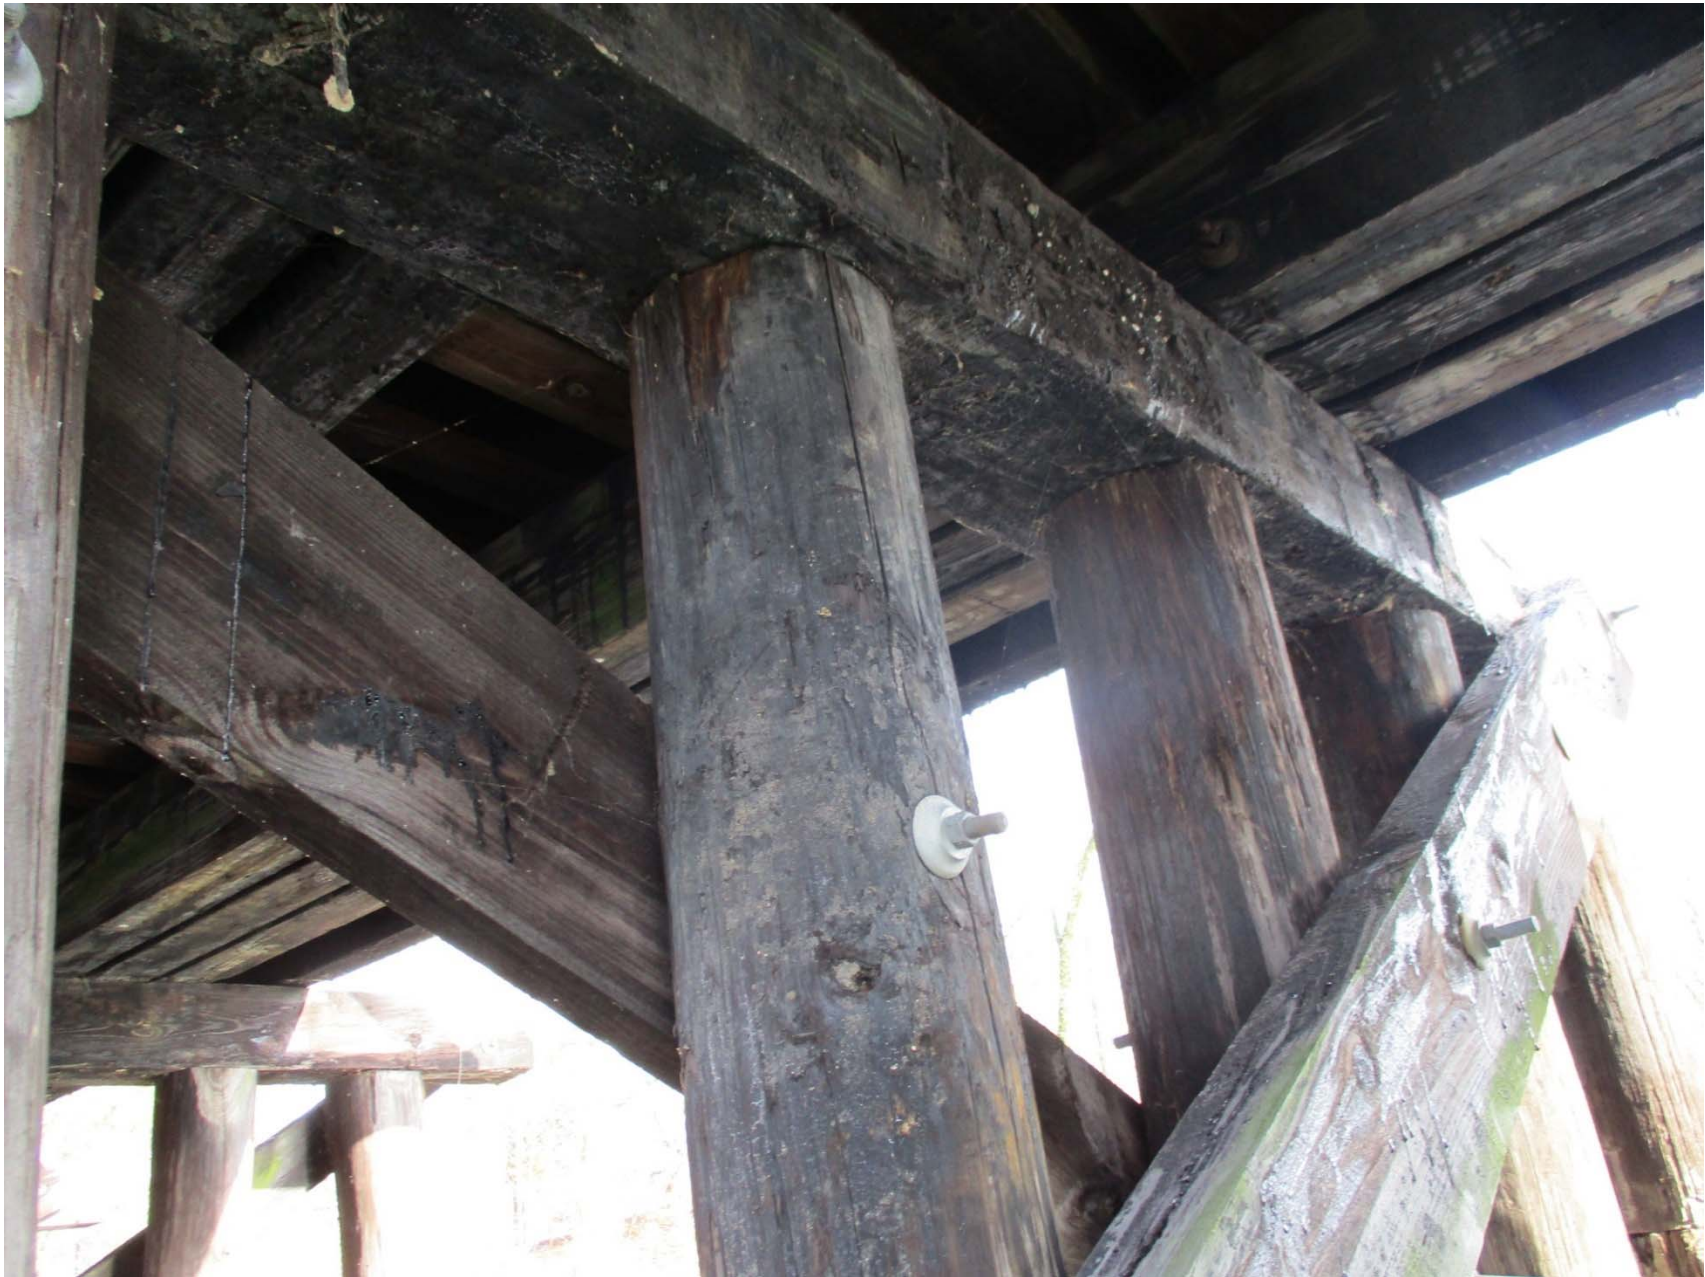
Pier 5S cap remains good

Pier 5S: Cap appears in good condition with the presence of creosote remaining. Previous fire damage was noted on Pile 1W with some grout patching at the cap, and internal rot at the water line. Pile 1E has a bolted splice, the lower west side portion is nearly rotted through. The main support for piles 2 & 3E are underwater and not visible.

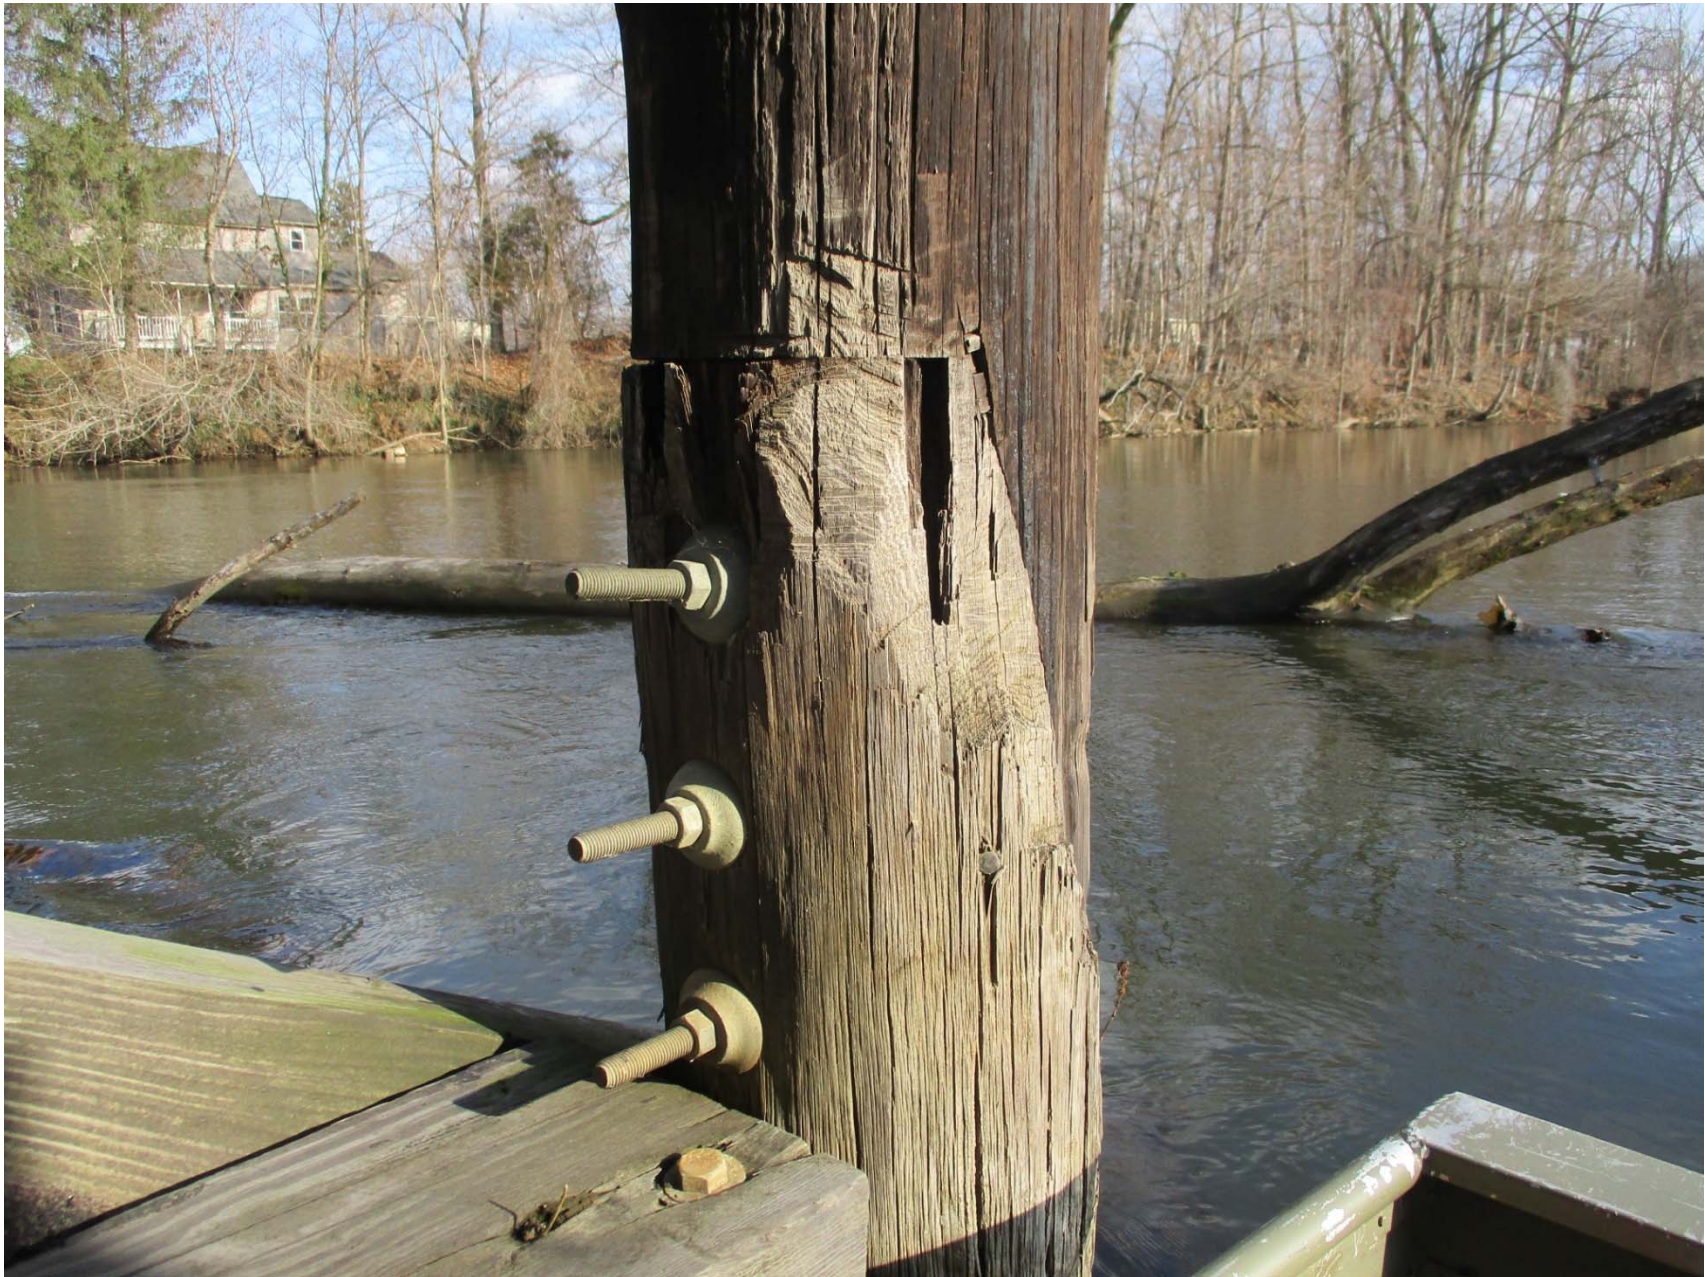
Pier 5S pile 1E bolted splice

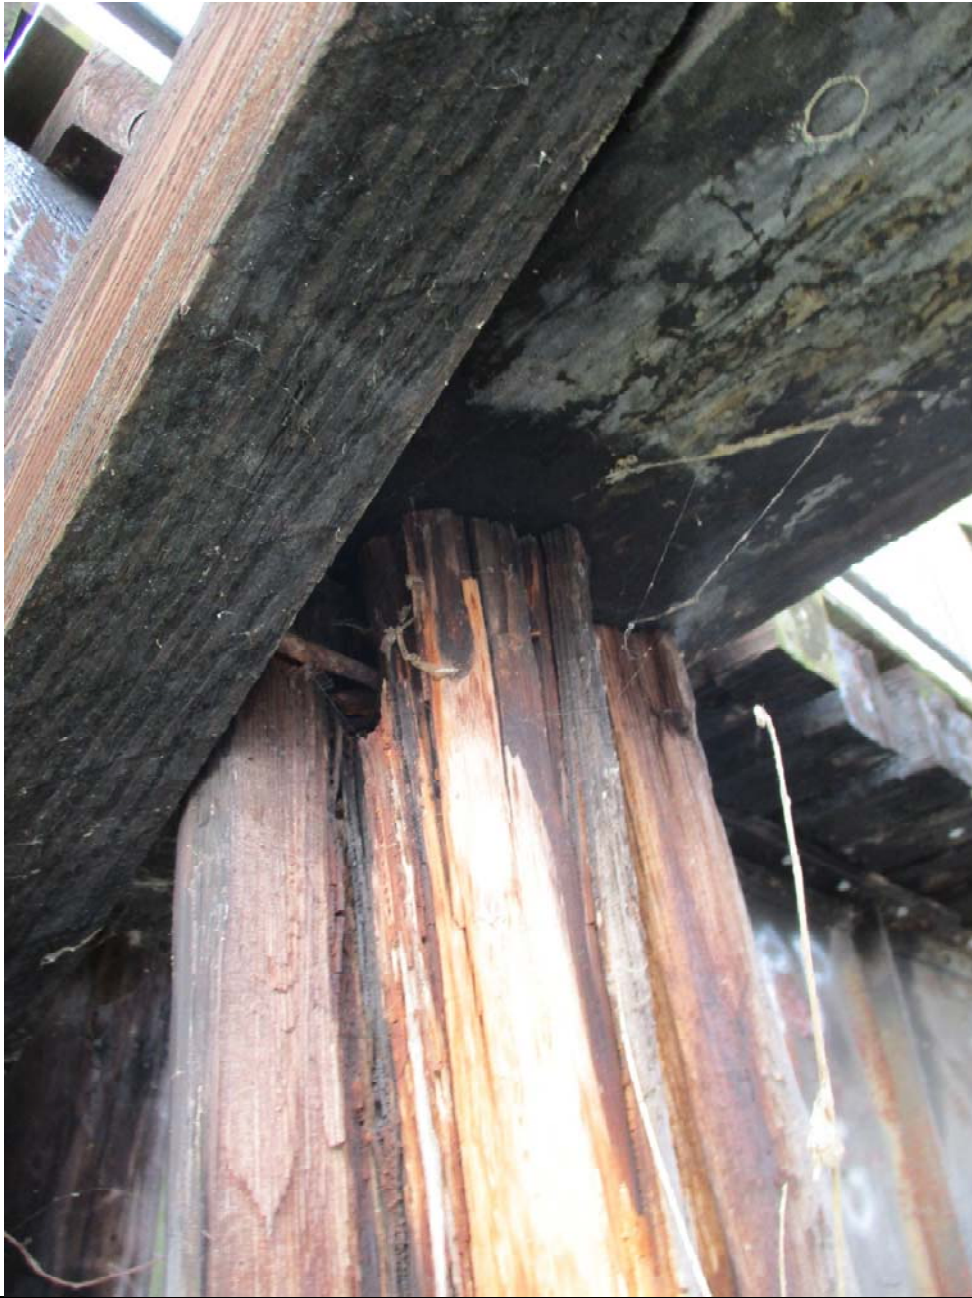
Pier 7S top of pile 1E

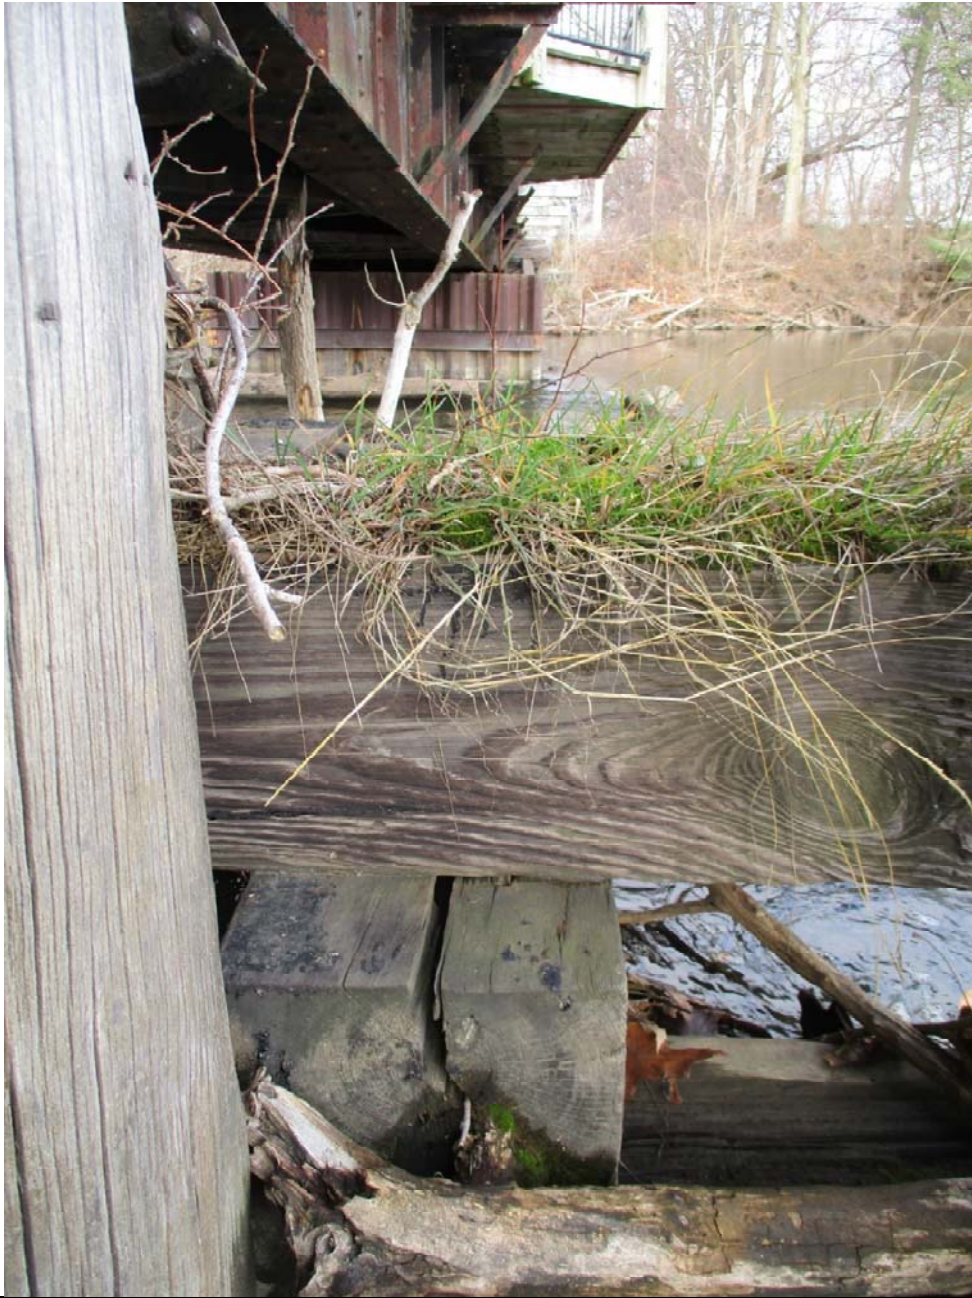
Steel beam cribbing split, vegetation growing out of upper timbers at pier 7S
