SUBJECT: Jaycee Park Pedestrian Bridge Inspection

A detailed inspection of the old railroad trestle in Jaycee Park over the Kalamazoo River in the City of Allegan was completed on December 8, 2023. Enclosed is a copy of the report and pictures for your bridge files, supplemented with the comments below.

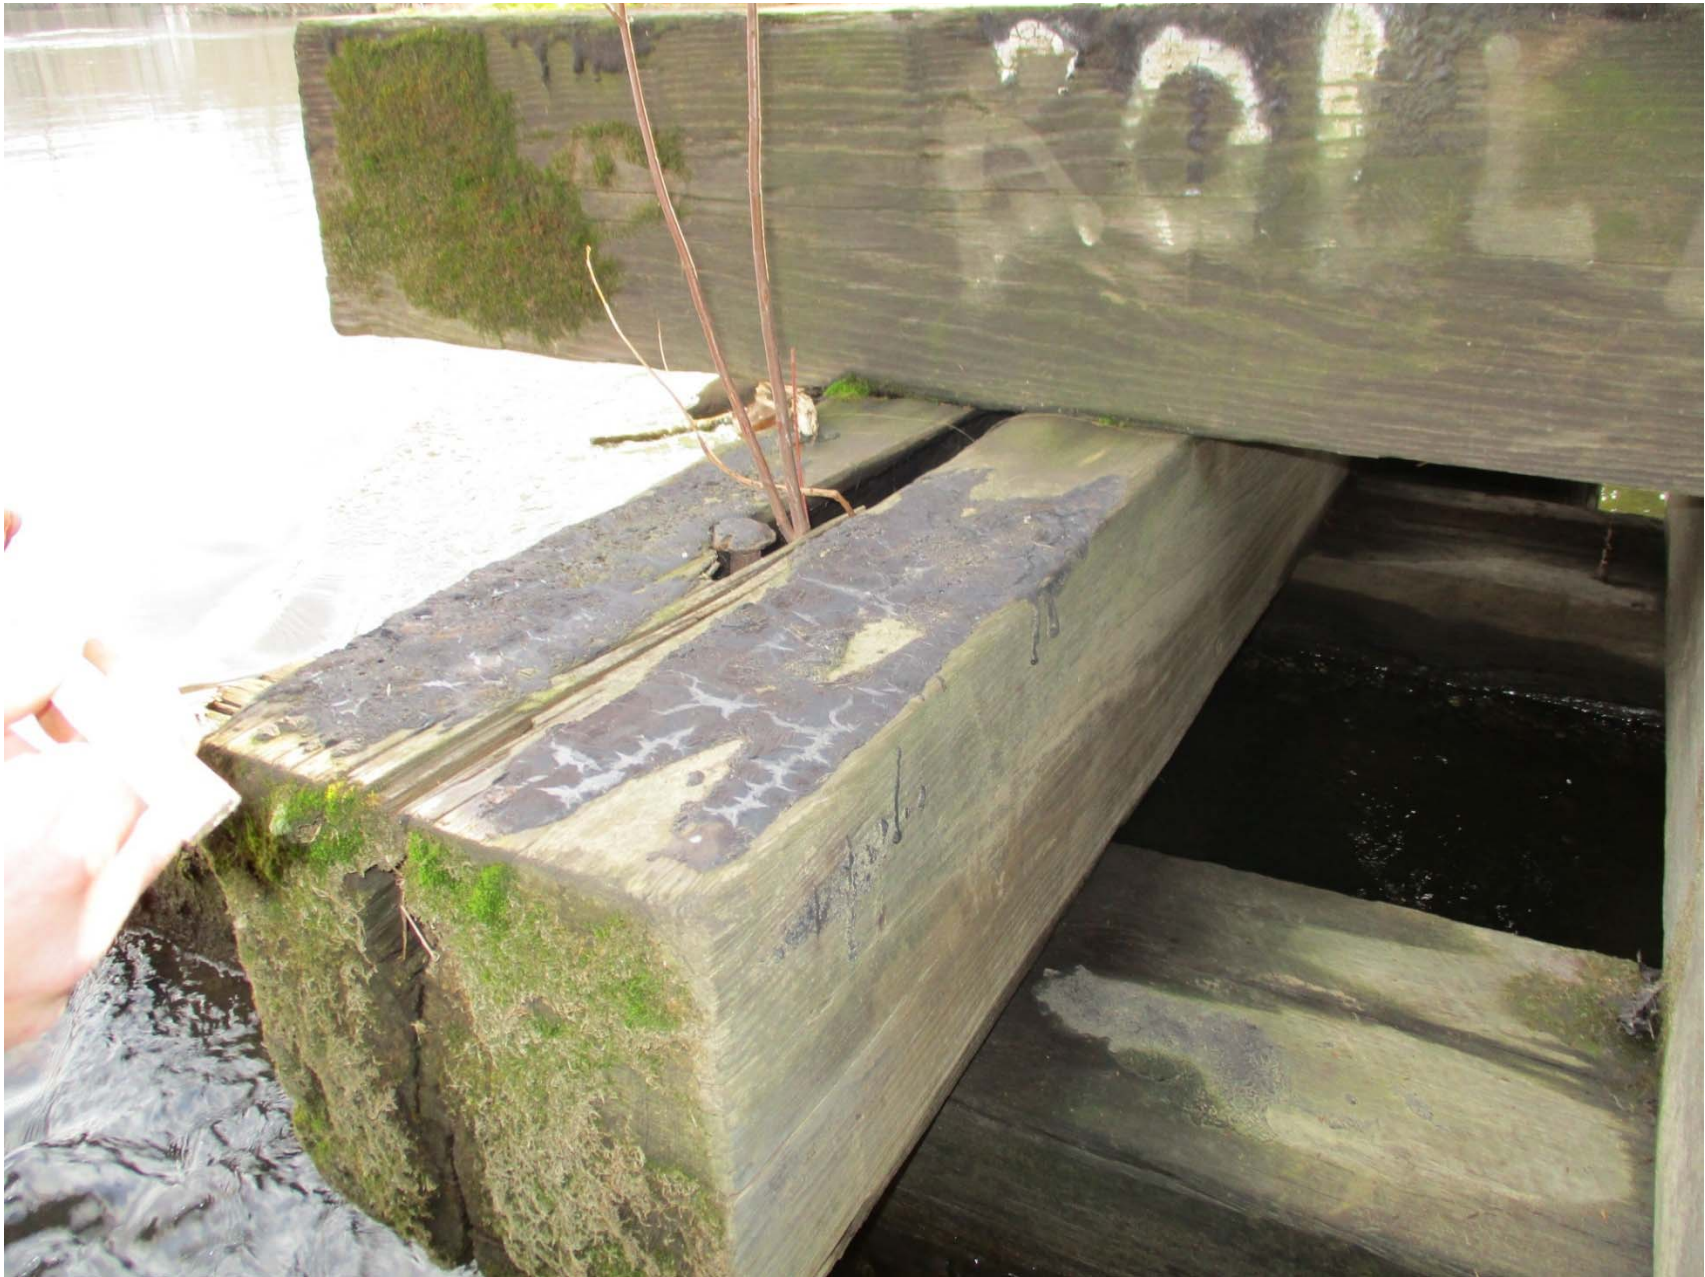
Pier 7S east end cribbing

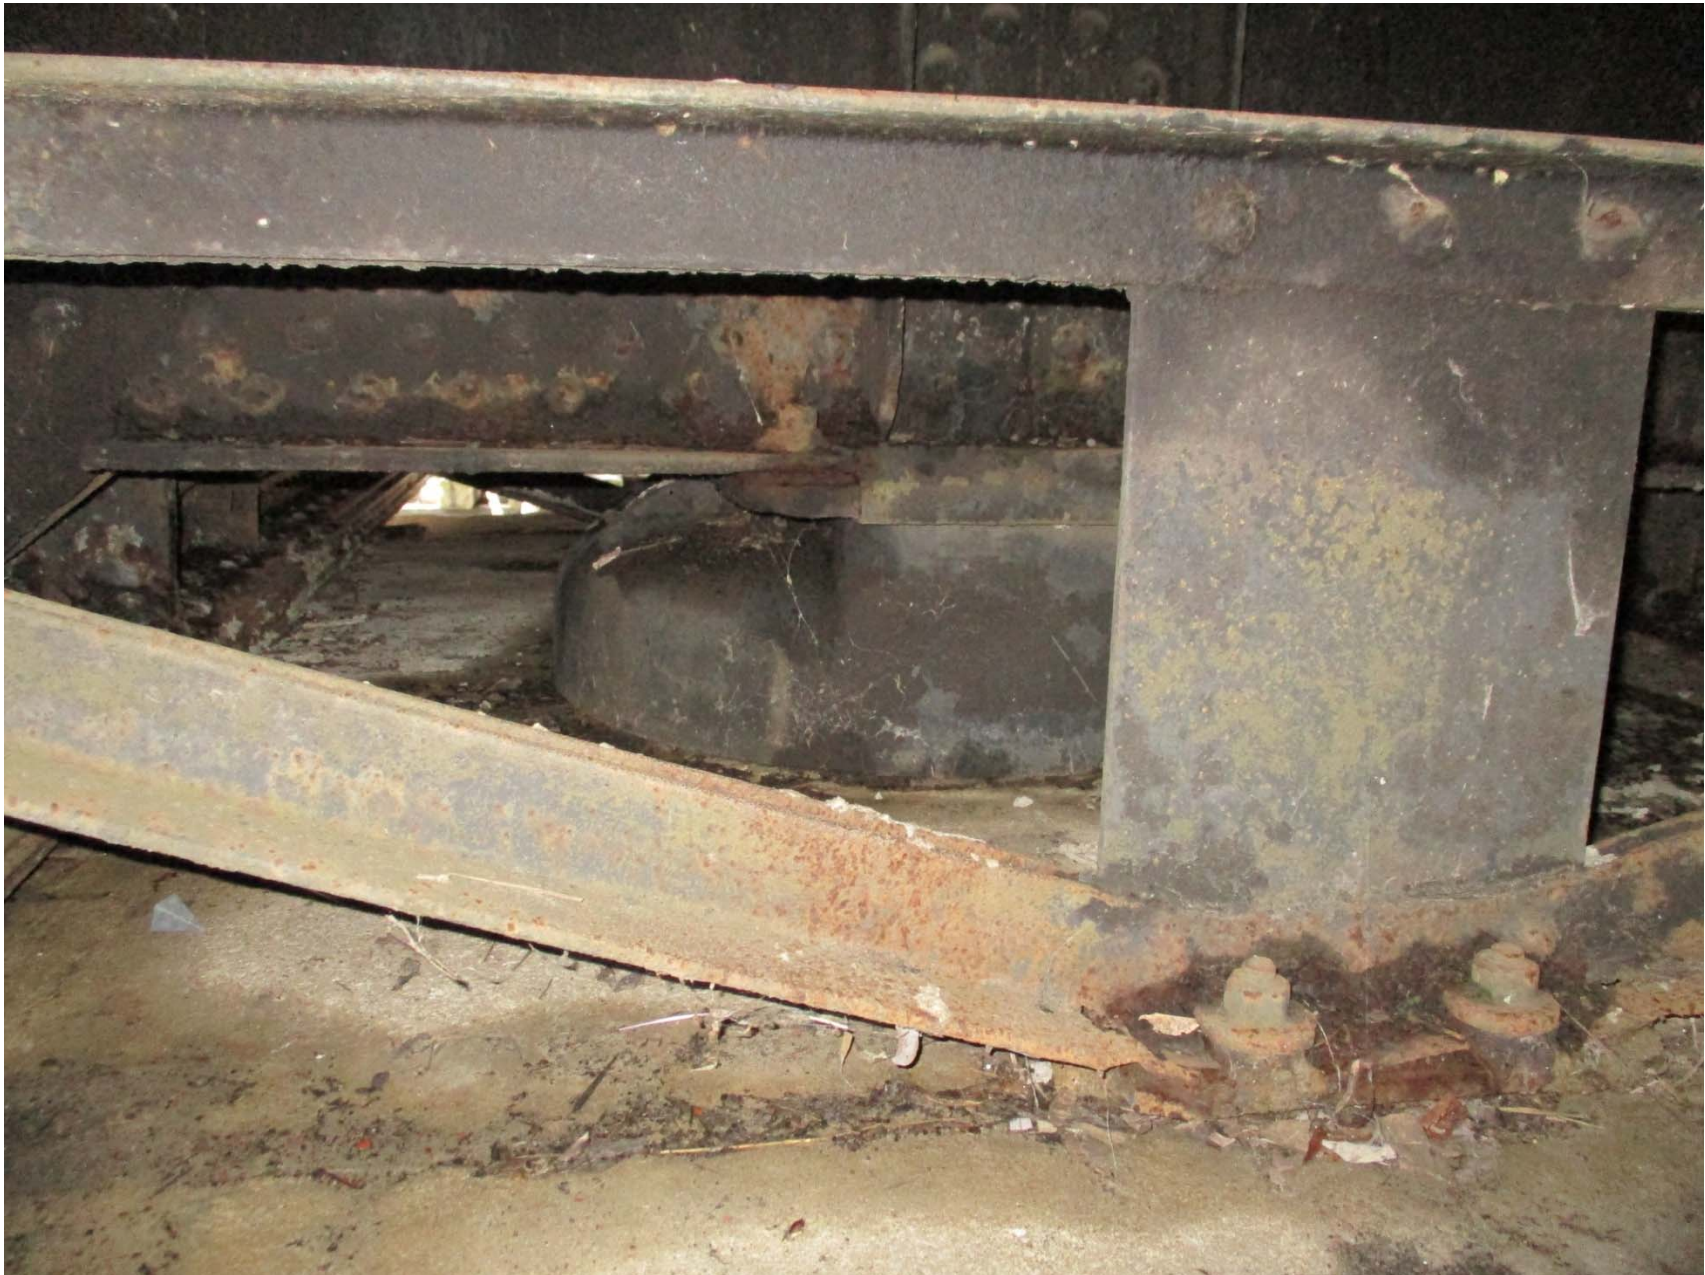
Pier 8S steel beam center support

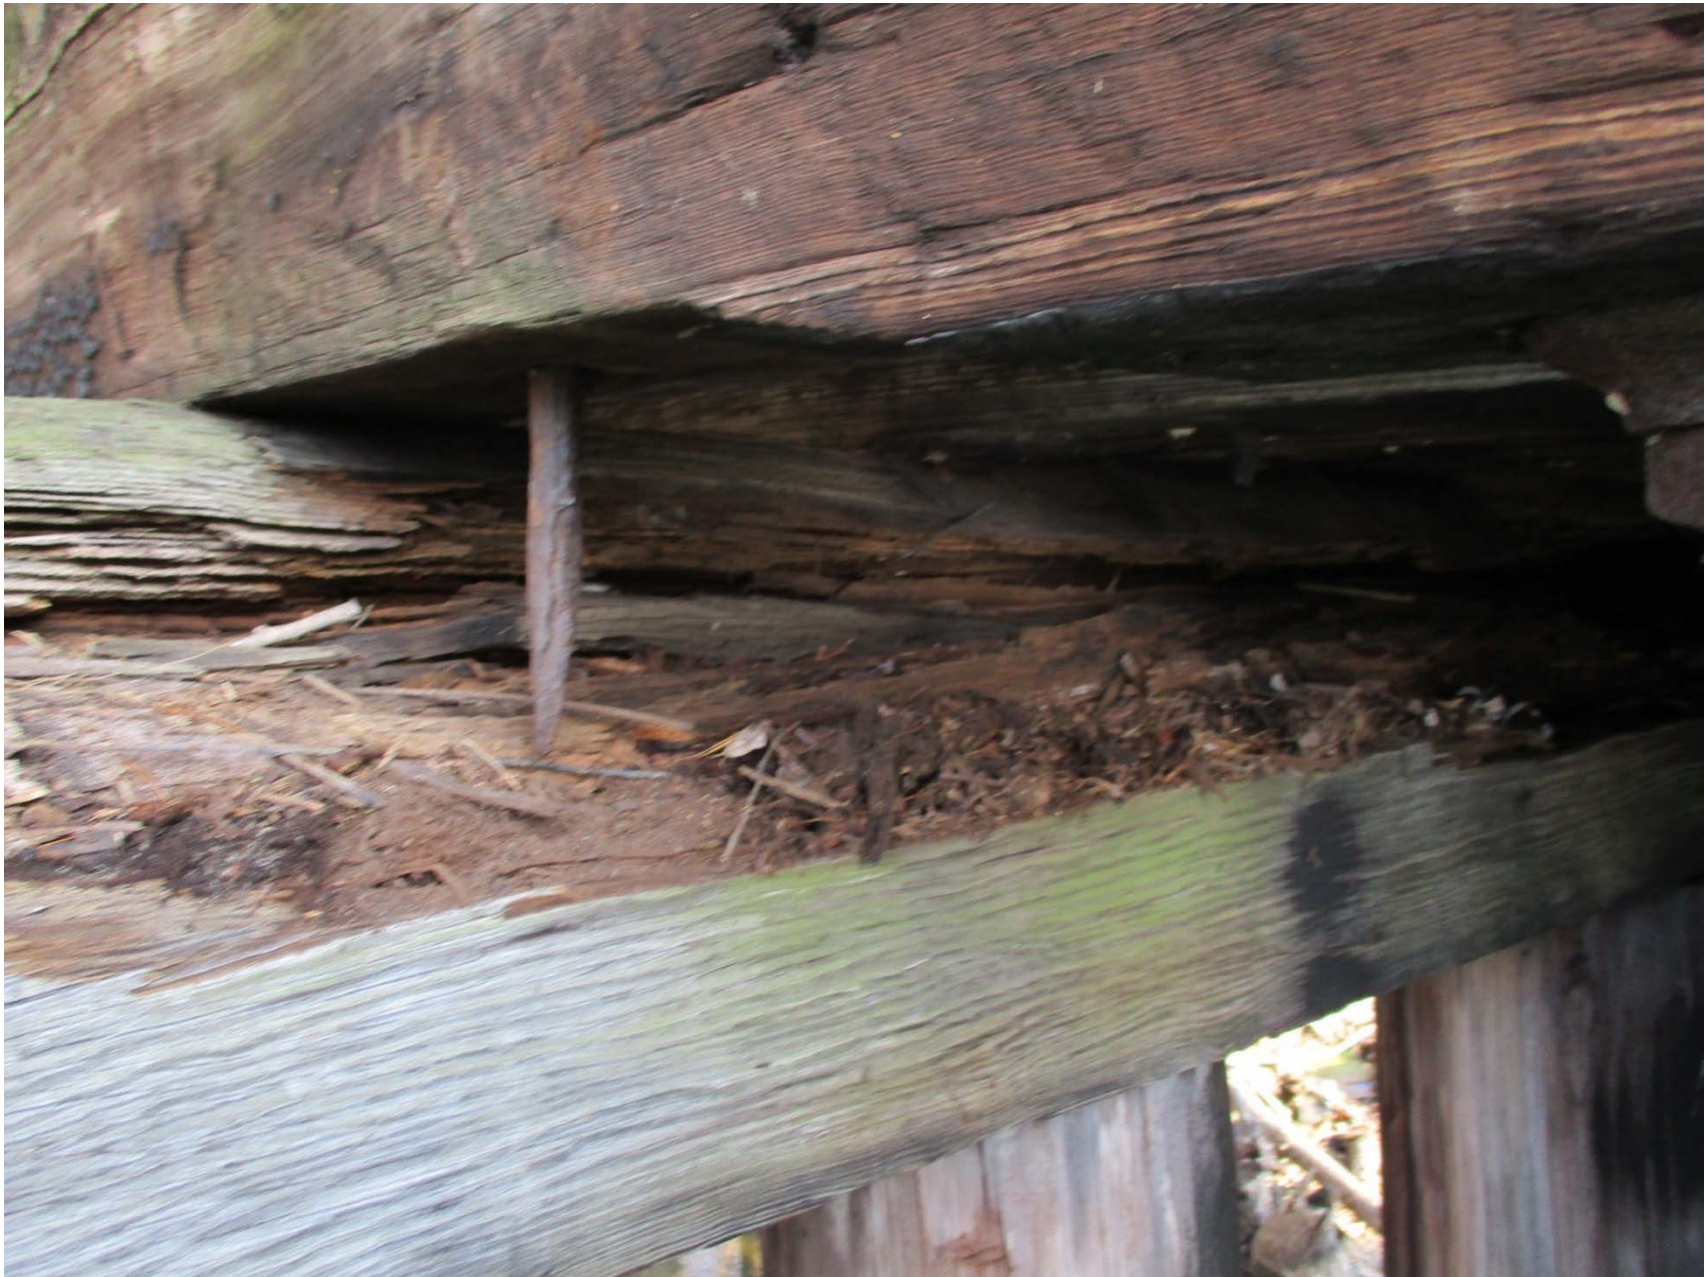
West end pier 9S cap

Pier 9S: The top half of the cap has rotted away. A 4ft white pine tree growing in the west end. There is no bearing support for the beams. The span is being held by west beam end pressure against the steel span cross bracing. The beams are beginning to split at the end bearing point. Extensive rot at the water surface to piles 3-5E. The adjacent cribbing supports the north end of the steel girders is rotting and has settled with rotation toward the north. The roller bears are offset from the girder bearing plates.

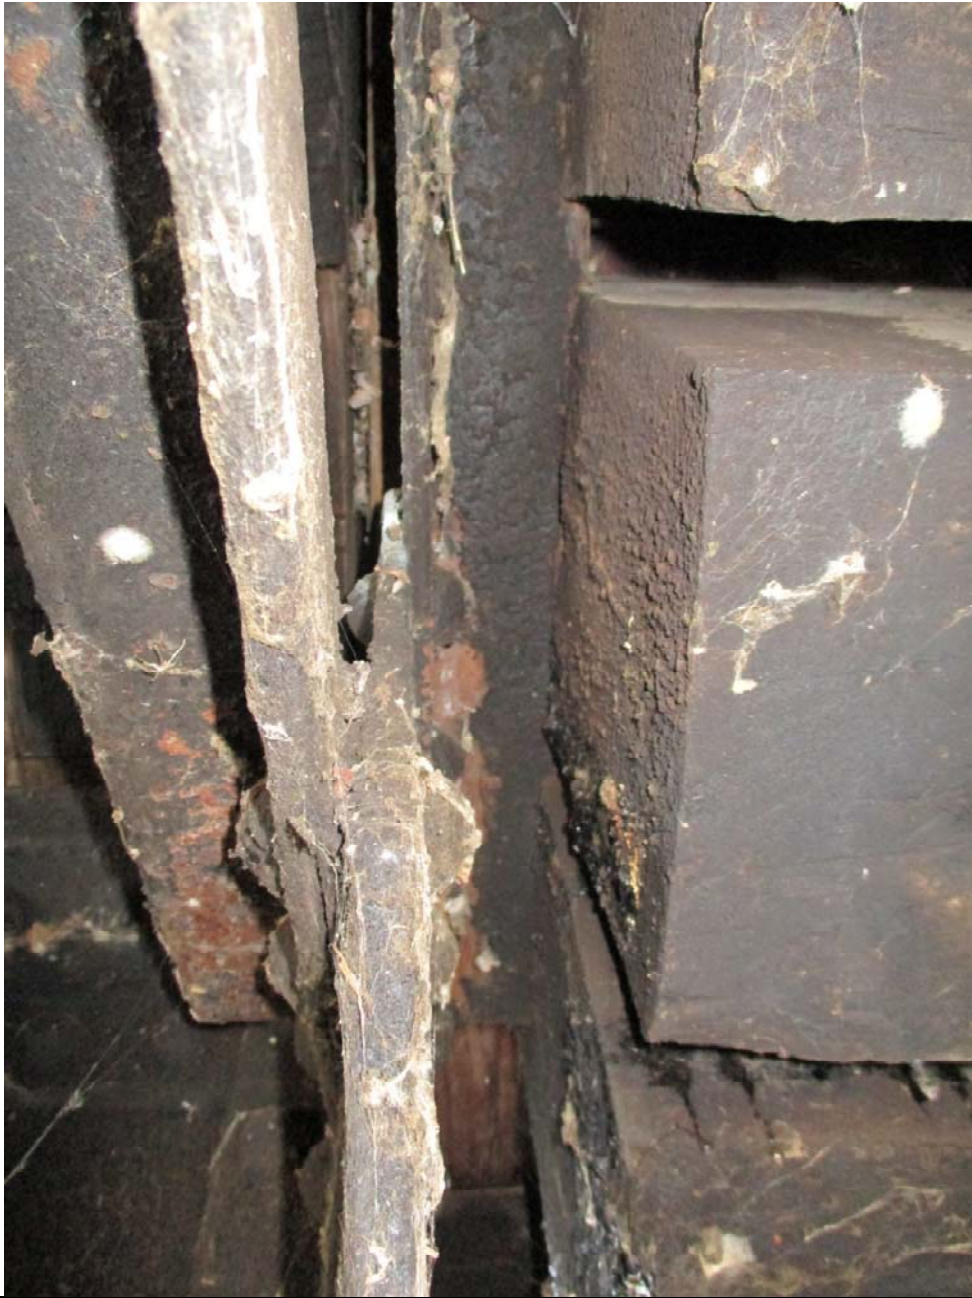
Span 10S is being held up by west beams pressing against a steel cross brace angle
