SUBJECT: Jaycee Park Pedestrian Bridge Inspection

A detailed inspection of the old railroad trestle in Jaycee Park over the Kalamazoo River in the City of Allegan was completed on December 8, 2023. Enclosed is a copy of the report and pictures for your bridge files, supplemented with the comments below.

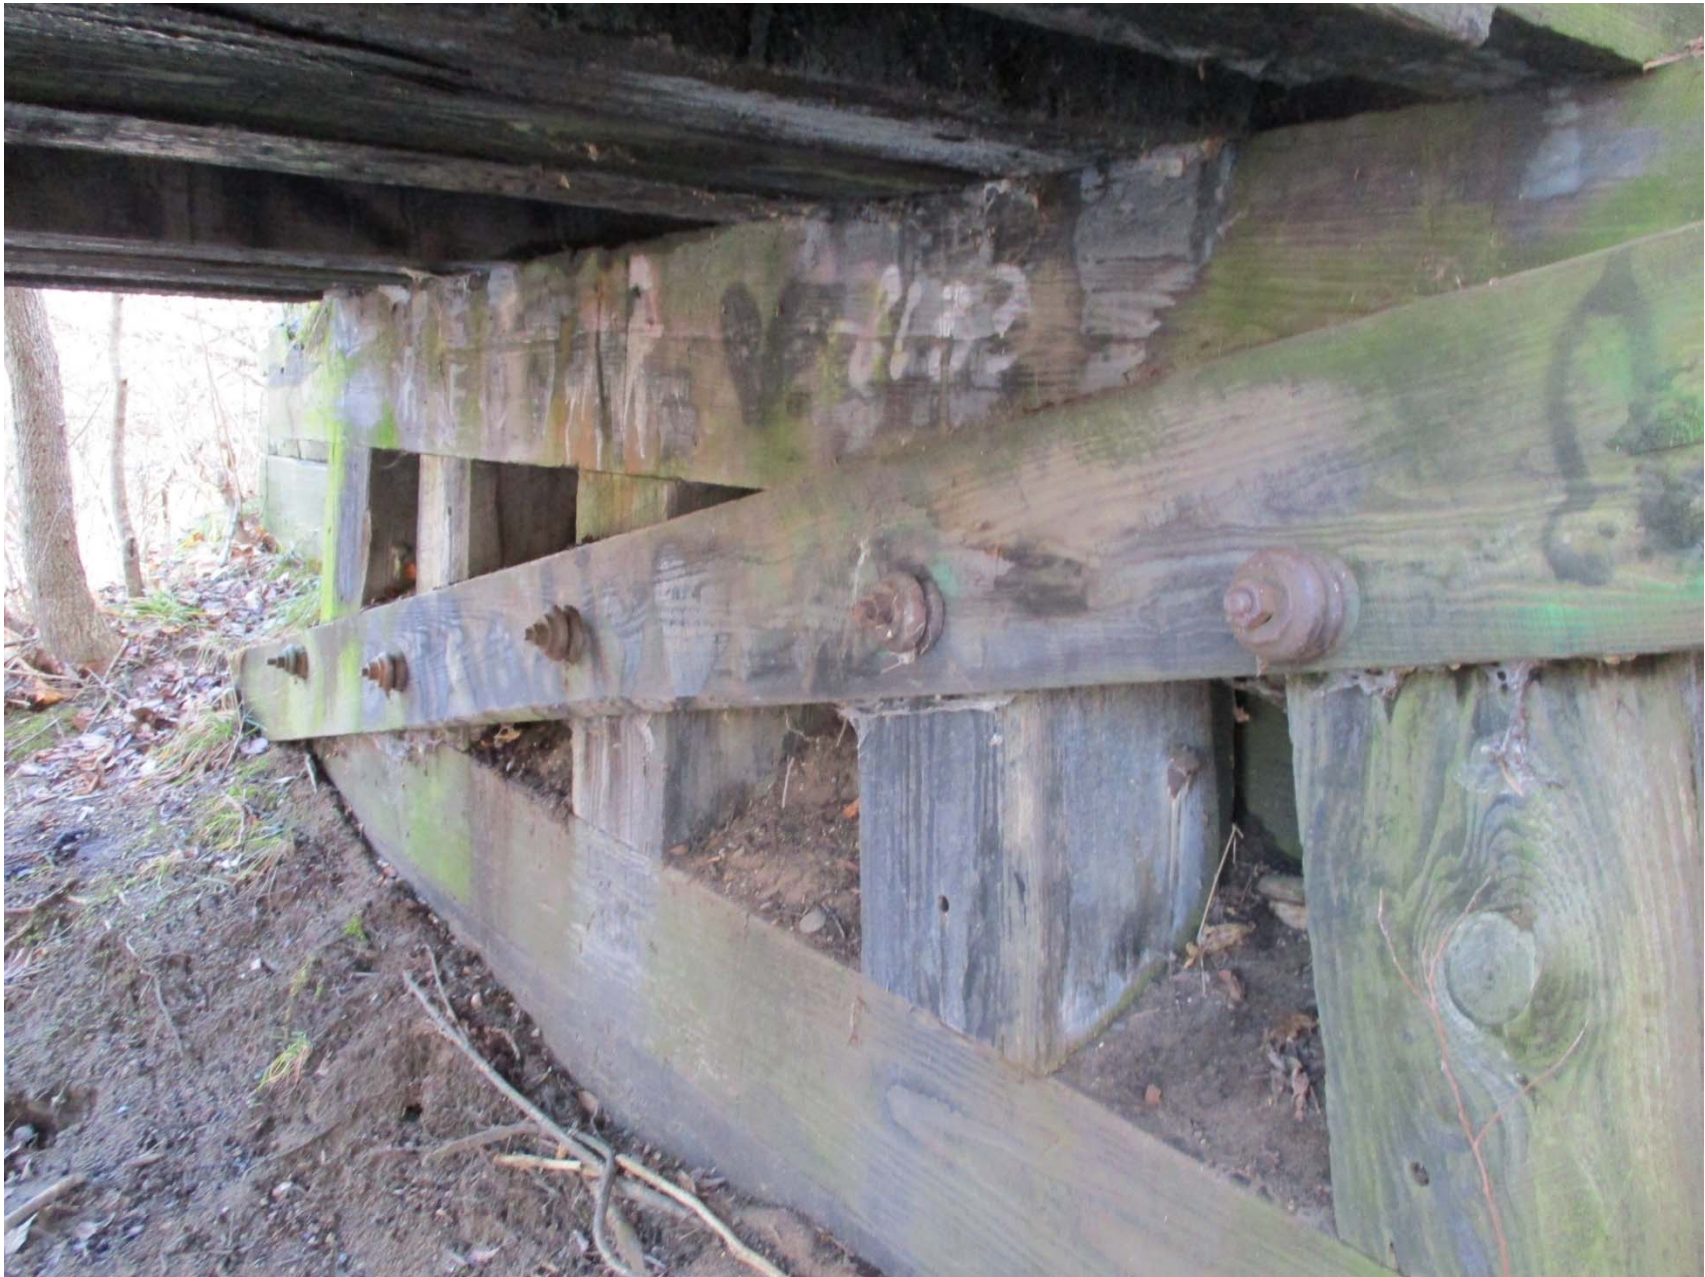
South abutment elevation

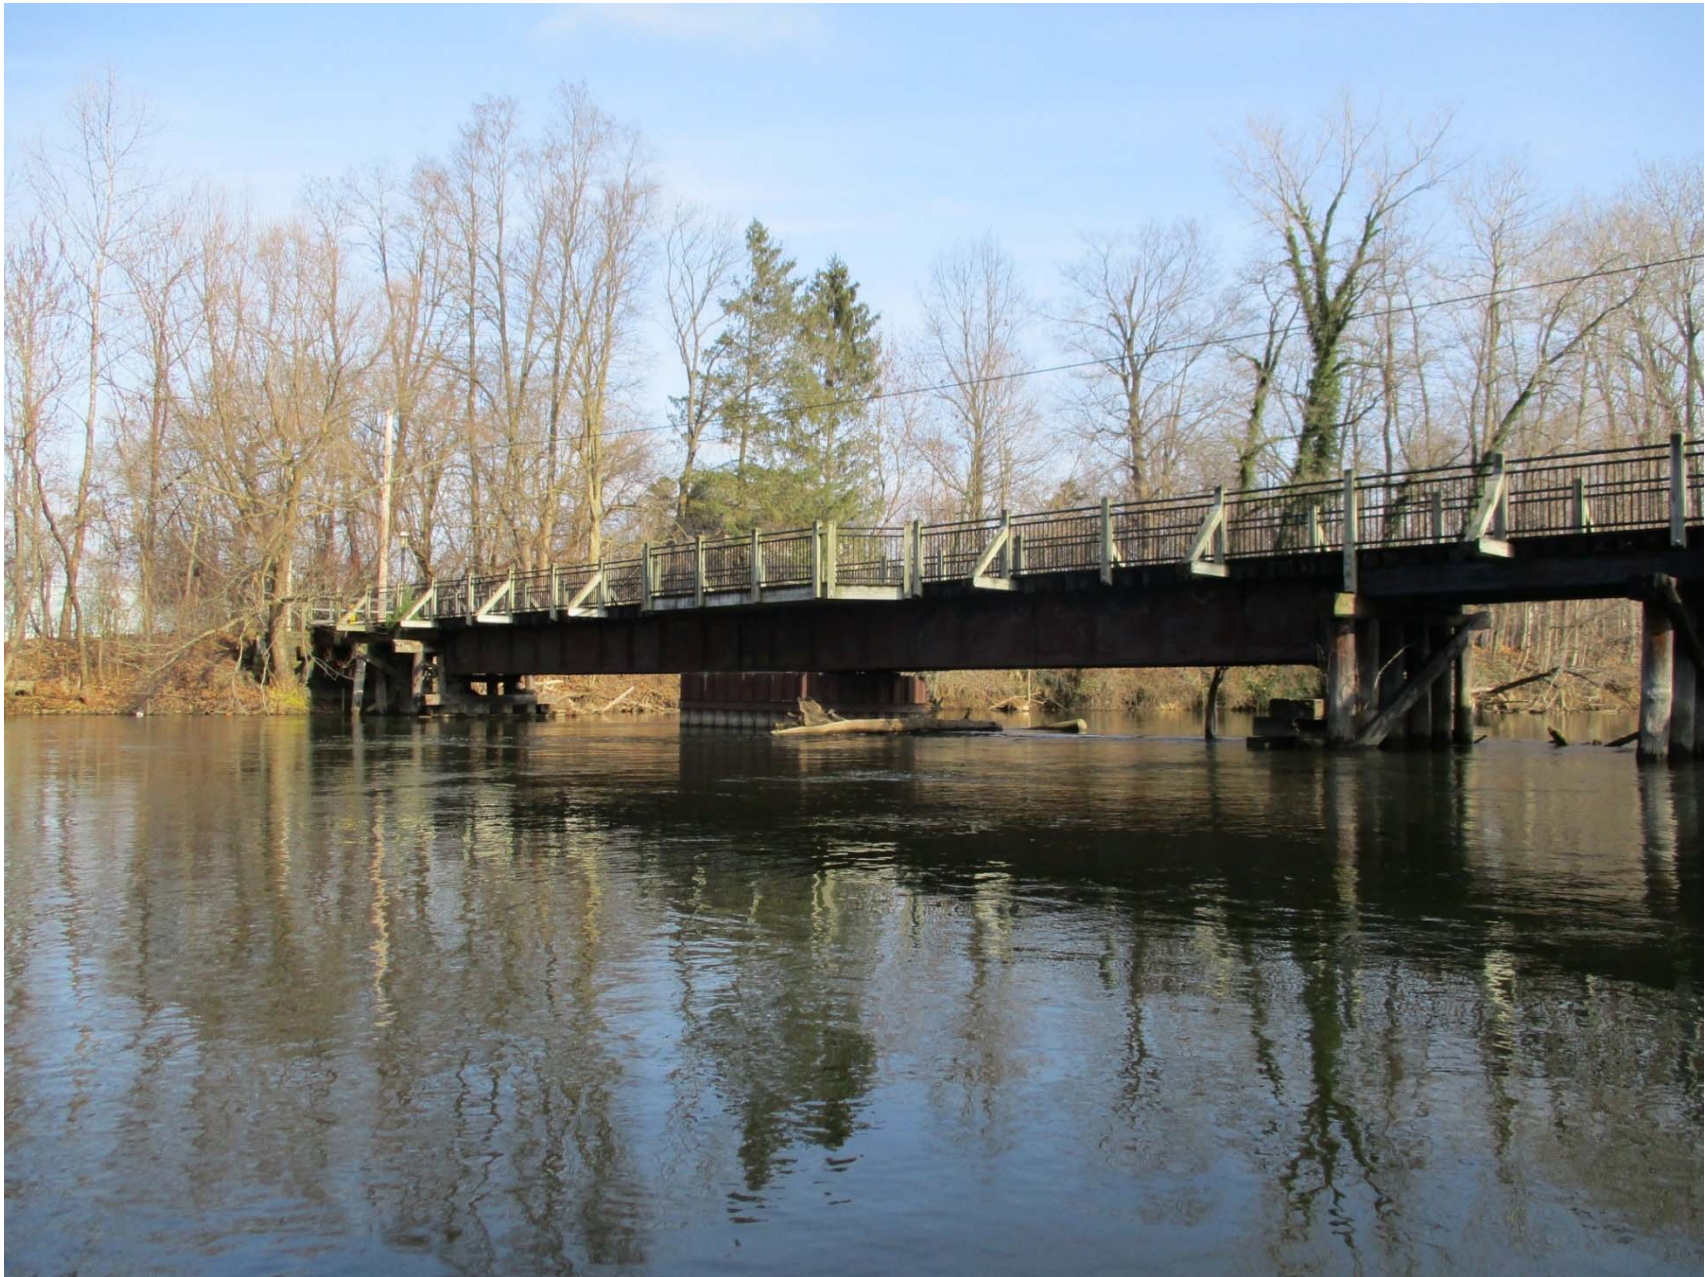
North end elevation
